Envelope Construction Progress Inspection

Date/Time	04-17-2025
Street Address	14915 Clover Meadow Ln
City	Montgomery
State	Texas
Zip Code	77316
Builder	Tri Pointe Homes
Superintendent Name	Bart Mills
Superintendent Email Address	bart.mills@tripointehomes.com
Superintendent Attendance	Not Present
Inspection Type	Final
Is this project a re-inspection?	No
Inspection Iteration	1st
Report Information	This report was prepared for a builder or other entity in accordance with the builder's requirements. The report is not intended as a substitute for an inspection of the property by an inspector of the buyer's choice. Standard inspections performed by a Texas Real Estate Commission licensee and reported on Texas Real Estate Commission promulgated report forms may contain additional information a buyer should consider in making a decision to purchase.

Cladding Systems:	Stucco/Adhered Masonry Siding Brick/Masonry
Stucco System Finish:	Acrylic
Stucco Trim Type:	Expanded Polystyrene (EPS)

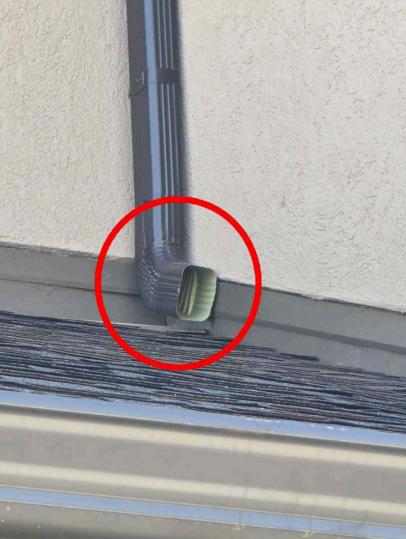
Photo Description	Roof
Condition	Action Item
Action Item	Gutter downspouts improperly discharge directly onto structure or roof covering. Ensure that downspouts direct water away from structure and roof.

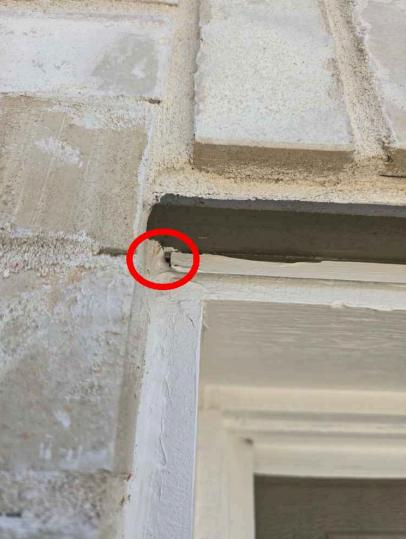
Photo Description	Door
Condition	Action Item
Action Item	Missing, insufficient or improperly installed sealant at doors or windows. Ensure sealant is properly toolled, bonded and free of gaps or voids.

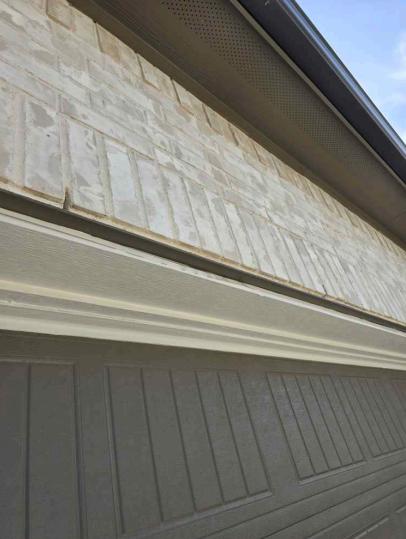
Photo Description	Door
Condition	General Observation
General Observation	Weep holes above lintels are present and appear open and unobstructed.

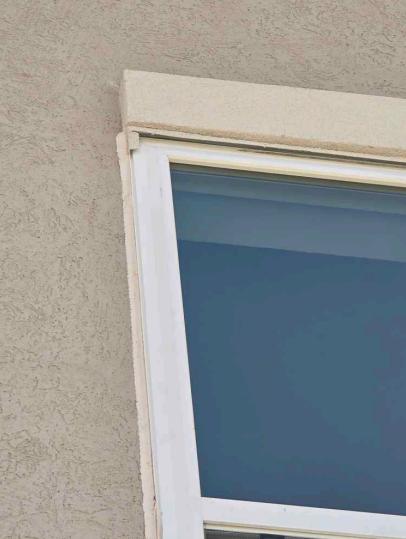
Photo Description	Door
Condition	General Observation
General Observation	Sealant at doors or windows. Ensure sealant is properly tooled, bonded and free of gaps or voids and weep holes are open and unobstructed.

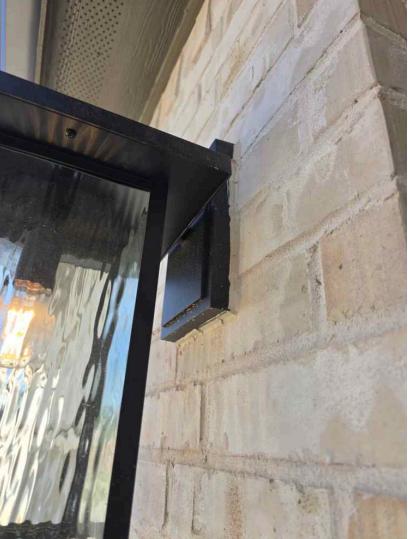
Photo Description	Penetration
Condition	General Observation
General Observation	Sealant at system penetrations.

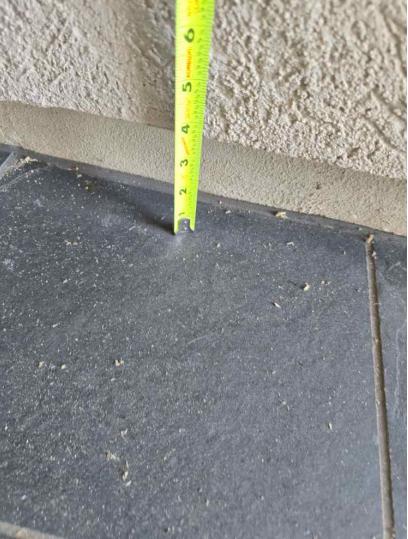
Photo Description	Wall
Condition	General Observation
General Observation	Clearance of cladding system to finished hard surfaces.

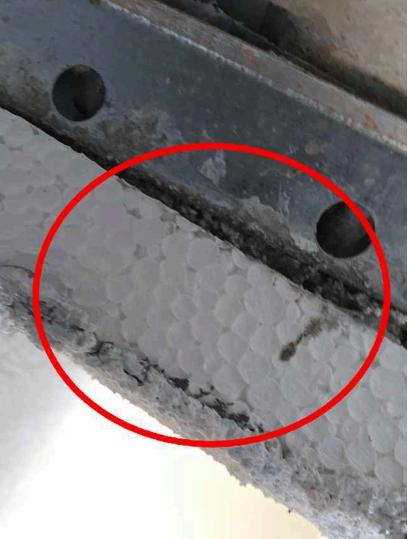
Photo Description	Termination
Condition	Action Item
Action Item	Incomplete mesh and base coat and/or exposed expanded polystyrene (EPS) trim termination.

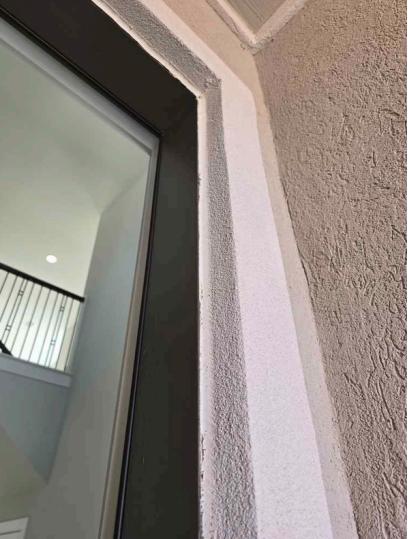
Photo Description	Door
Condition	General Observation
General Observation	Sealant at doors or windows. Ensure sealant is properly tooled, bonded and free of gaps or voids and weep holes are open and unobstructed.

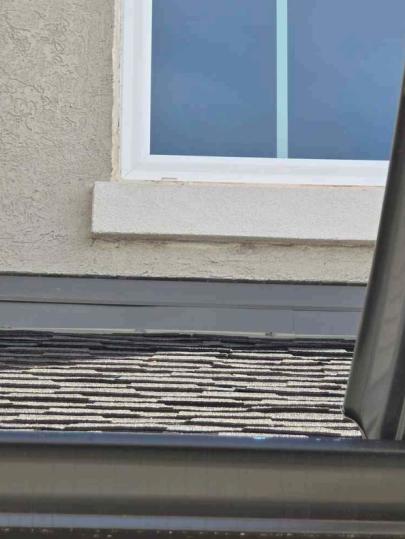
Photo Description	Roof
Condition	General Observation
General Observation	Clearance of cladding system to roof system.

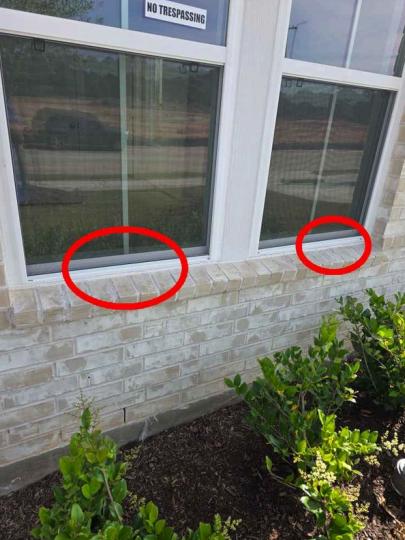
Photo Description	Window
Condition	Action Item
Action Item	Missing, insufficient or improperly installed sealant at doors or windows. Ensure sealant is properly tooled, bonded and free of gaps or voids.

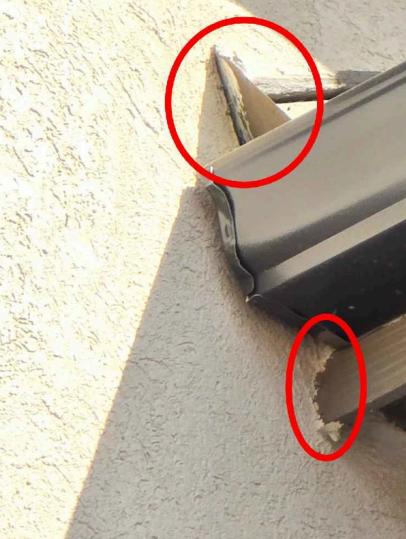
Photo Description	Roof
Condition	Action Item
Action Item	<p>Missing, insufficient or improperly installed sealant at system material transitions.</p> <p>Missing, insufficient or improperly installed sealant at eave to wall (kickout) or diverter flashing.</p>

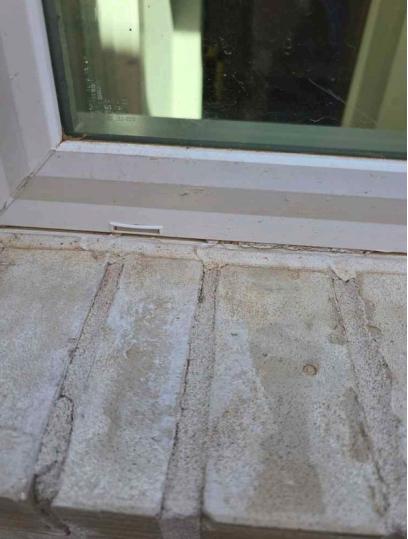
Photo Description	Window
Condition	General Observation
General Observation	Weep holes at window sills appear open and unobstructed.

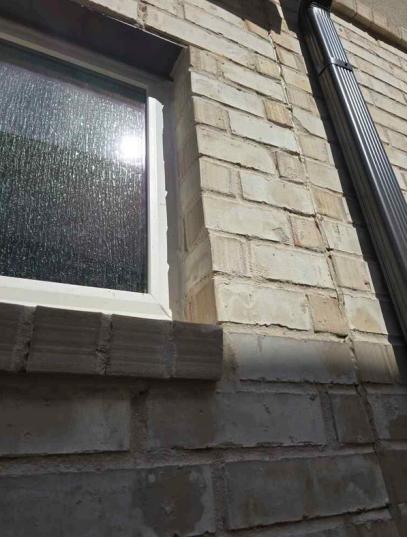
Photo Description	Window
Condition	General Observation
General Observation	Sealant at doors or windows. Ensure sealant is properly tooled, bonded and free of gaps or voids and weep holes are open and unobstructed.

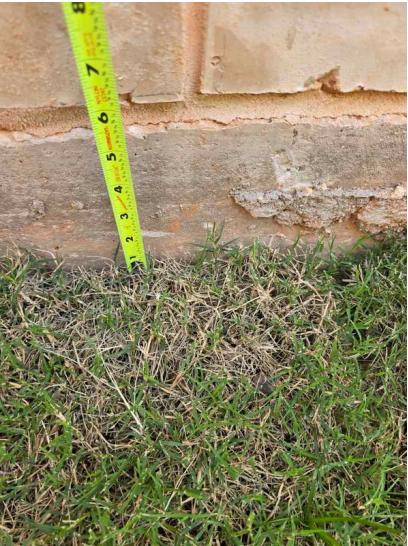
Photo Description	Wall
Condition	General Observation
General Observation	Clearance of cladding system to finished grade.

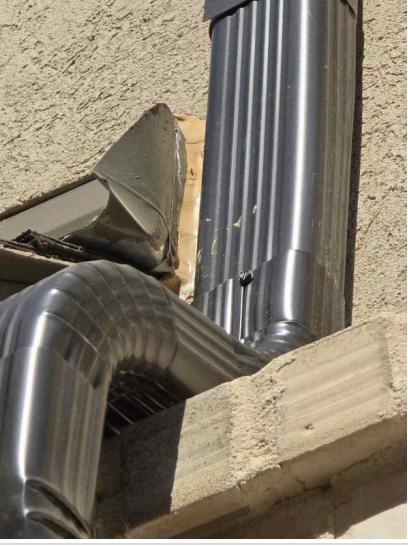
Photo Description	Roof
Condition	General Observation
General Observation	Sealant at eave to wall (kickout) or diverter flashing.

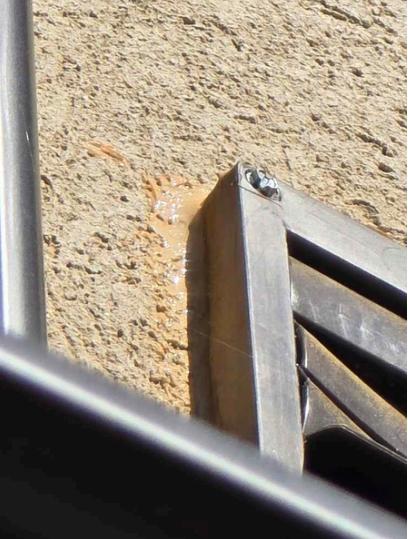
Photo Description	Penetration
Condition	General Observation
General Observation	Sealant at system penetrations.

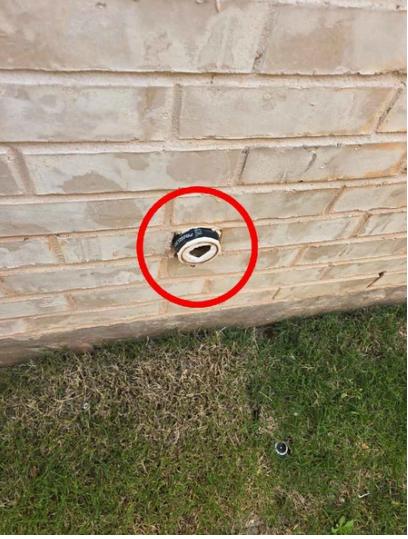
Photo Description	Penetration
Condition	Action Item
Action Item	Missing, insufficient or improperly installed sealant at system penetrations. System penetrations should be sealed and/or fasteners embedded in sealant.

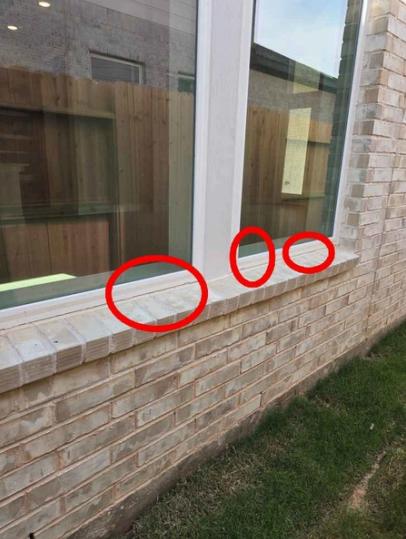
Photo Description	Window
Condition	Action Item
Action Item	Missing, insufficient or improperly installed sealant at doors or windows. Ensure sealant is properly toolled, bonded and free of gaps or voids.

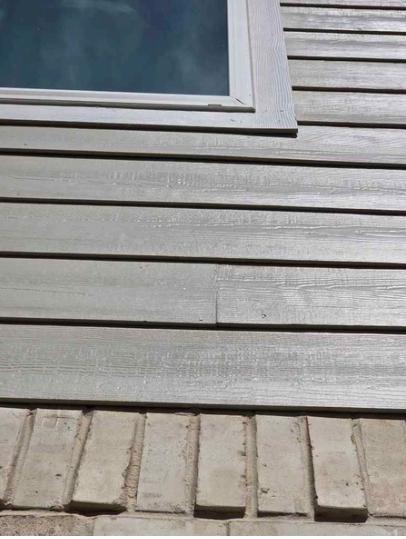
Photo Description	Wall
Condition	General Observation
General Observation	Finish coverage.

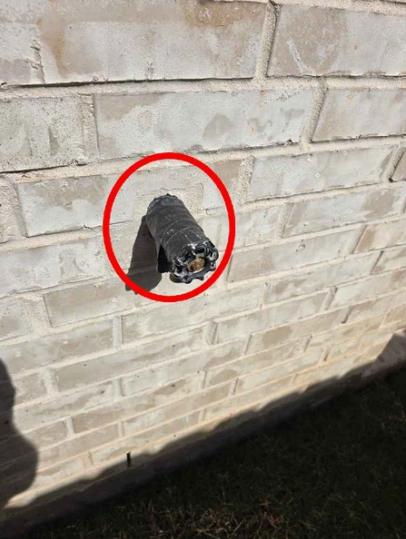
Photo Description	Penetration
Condition	Action Item
Action Item	Missing, insufficient or improperly installed sealant at system penetrations. System penetrations should be sealed and/or fasteners embedded in sealant.

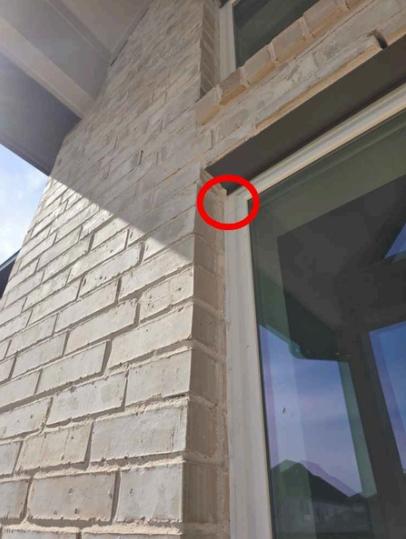
Photo Description	Window
Condition	Action Item
Action Item	Missing, insufficient or improperly installed sealant at doors or windows. Ensure sealant is properly tooled, bonded and free of gaps or voids.

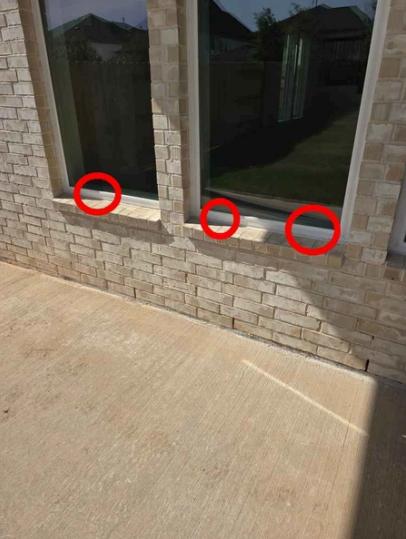
Photo Description	Window
Condition	Action Item
Action Item	Missing, insufficient or improperly installed sealant at doors or windows. Ensure sealant is properly tooled, bonded and free of gaps or voids.

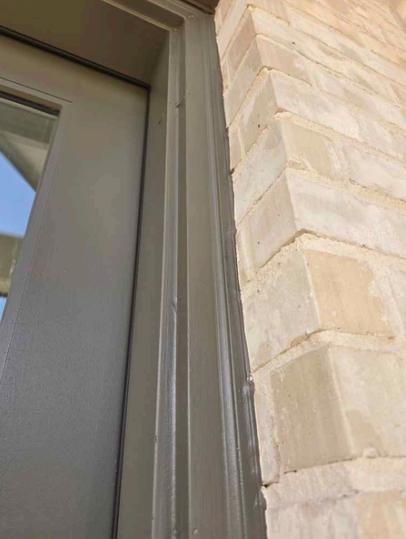
Photo Description	Door
Condition	General Observation
General Observation	Sealant at doors or windows. Ensure sealant is properly tooled, bonded and free of gaps or voids and weep holes are open and unobstructed.

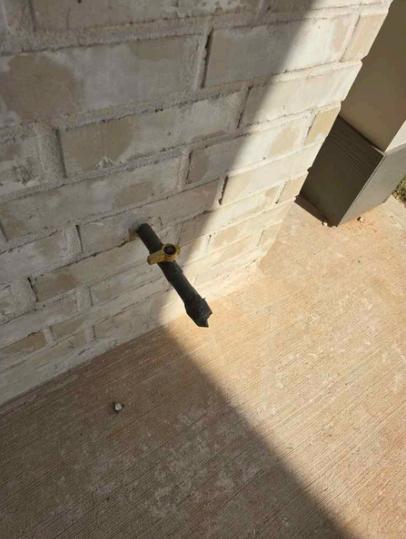
Photo Description	Penetration
Condition	General Observation
General Observation	Sealant at system penetrations.

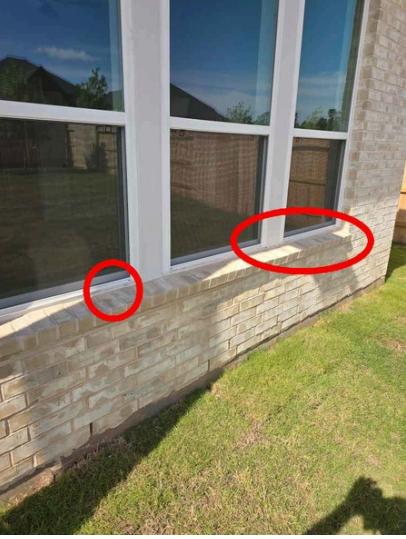
Photo Description	Window
Condition	Action Item
Action Item	Missing, insufficient or improperly installed sealant at doors or windows. Ensure sealant is properly tooled, bonded and free of gaps or voids.

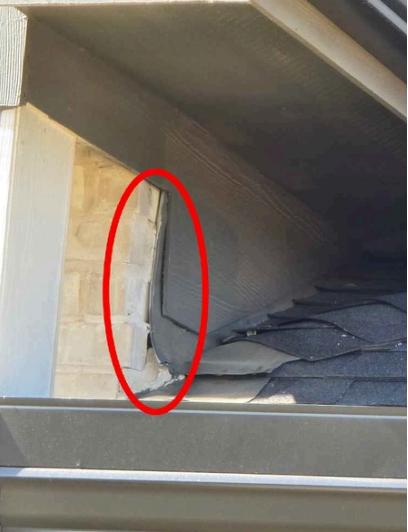
Photo Description	Roof
Condition	Action Item
Action Item	Missing, insufficient or improperly installed sealant at roof flashing or counter-flashing at masonry.

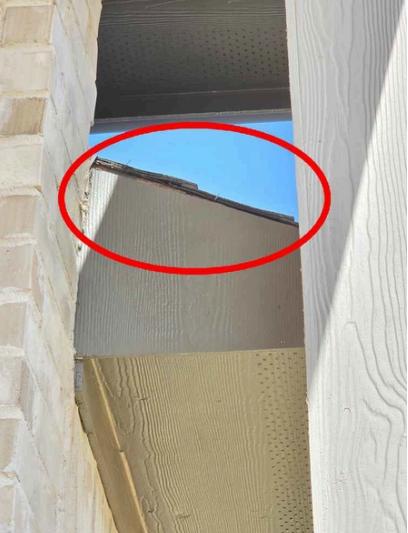
Photo Description	Roof
Condition	Action Item
Action Item	Missing flashing at roof or balcony.

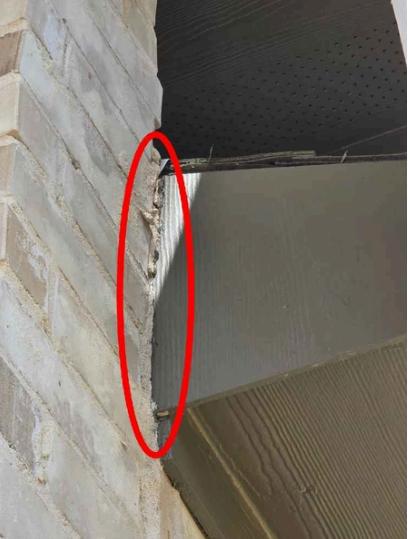
Photo Description	Wall
Condition	Action Item
Action Item	Missing, insufficient or improperly installed sealant at system material transitions.

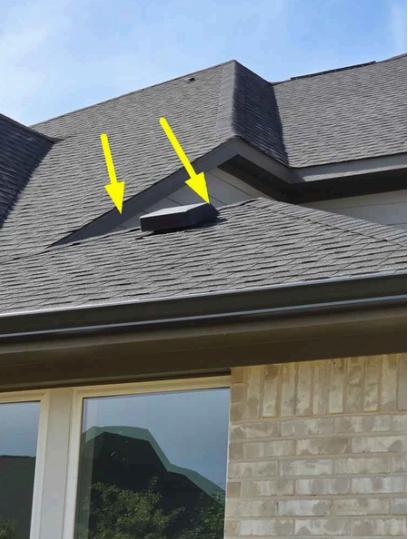
Photo Description	Wall
Condition	Action Item
Action Item	Not all system areas accessible for inspection.

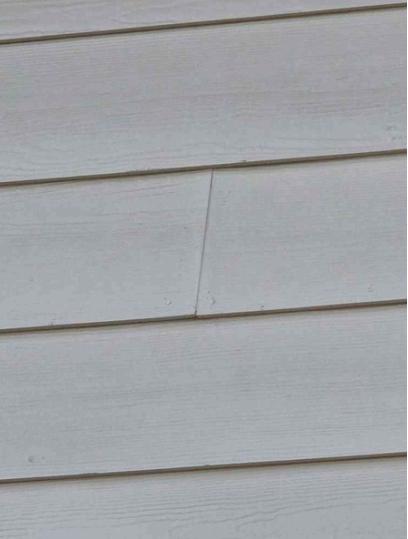
Photo Description	Wall
Condition	General Observation
General Observation	Finish coverage.

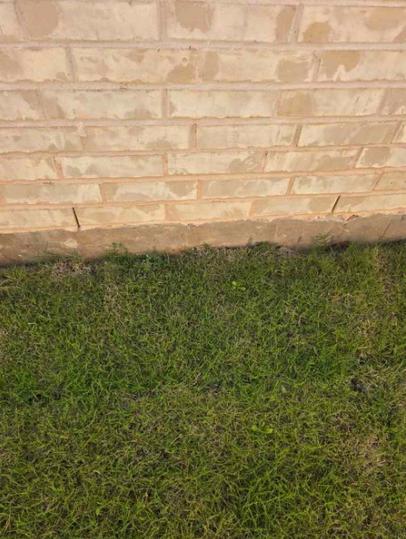
Photo Description	Wall
Condition	General Observation
General Observation	Weep holes at are present and appear open and unobstructed at foundation.

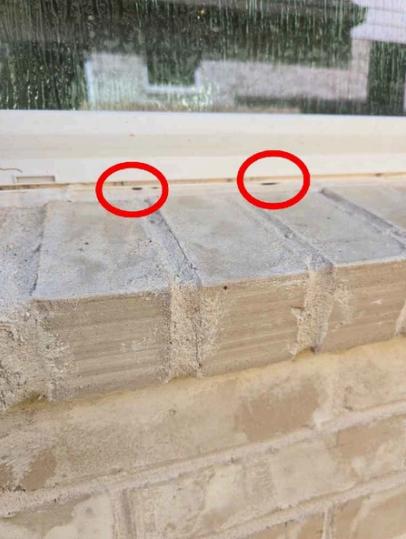
Photo Description	Window
Condition	Action Item
Action Item	Missing, insufficient or improperly installed sealant at doors or windows. Ensure sealant is properly toolled, bonded and free of gaps or voids.

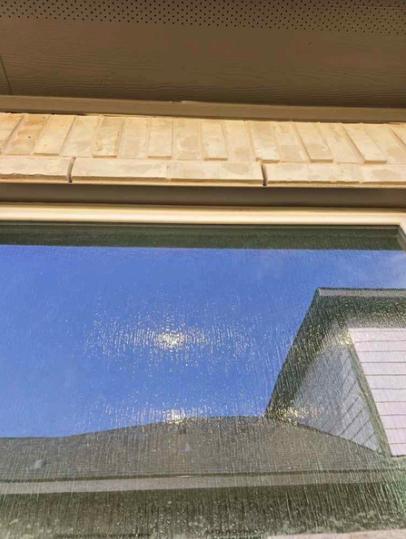
Photo Description	Window
Condition	General Observation
General Observation	Weep holes above lintels are present and appear open and unobstructed.

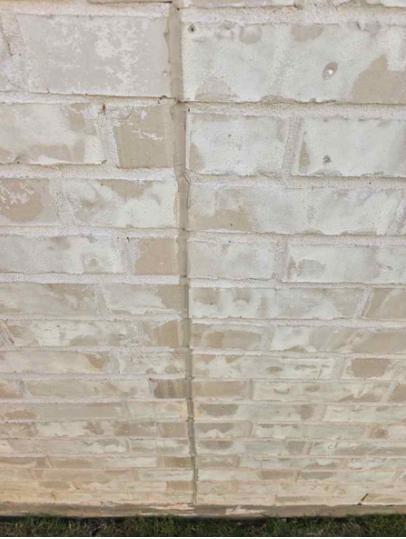
Photo Description	Wall
Condition	General Observation
General Observation	Sealant at masonry expansion joint.

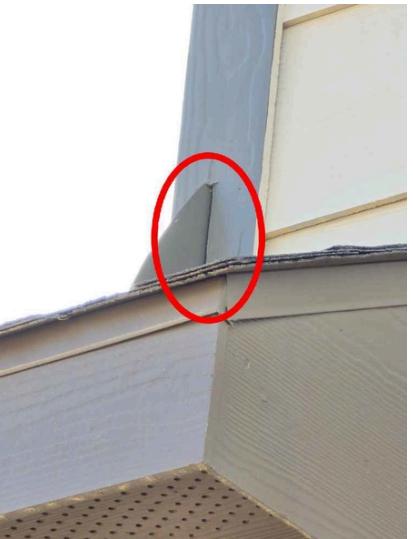
Photo Description	Roof
Condition	Action Item
Action Item	Missing, insufficient or improperly installed sealant at eave to wall (kickout) or diverter flashing.

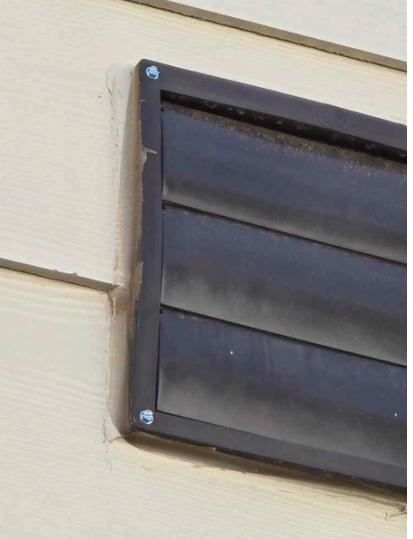
Photo Description	Penetration
Condition	General Observation
General Observation	Sealant at system penetrations.

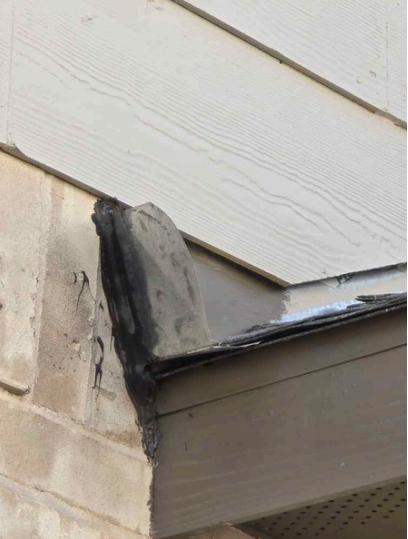
Photo Description	Roof
Condition	General Observation
General Observation	Sealant at roof flashing or counter-flashing at masonry.

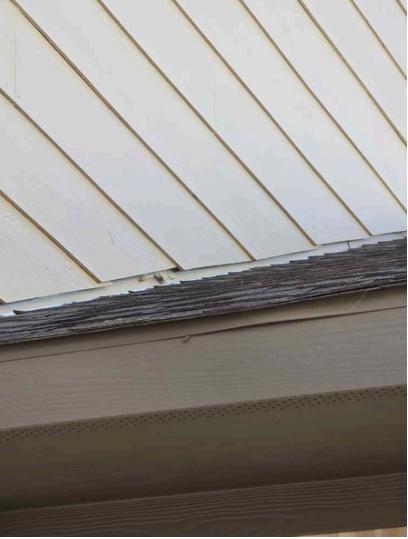
Photo Description	Roof
Condition	General Observation
General Observation	Clearance of cladding system to roof system.

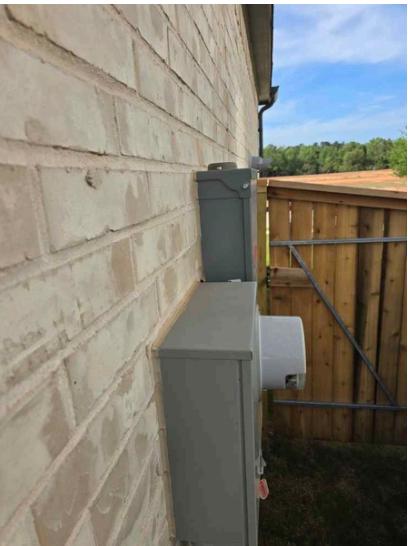
Photo Description	Penetration
Condition	General Observation
General Observation	Sealant at system penetrations.

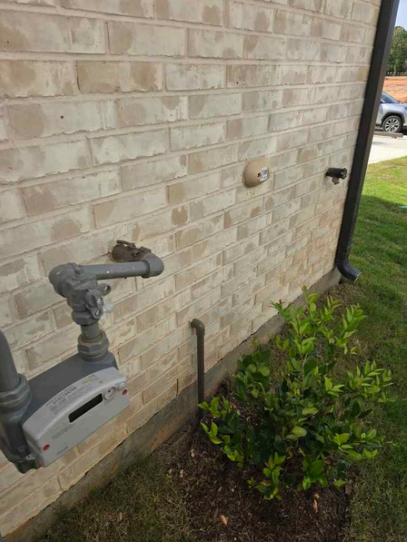
Photo Description	Penetration
Condition	General Observation
General Observation	Sealant at system penetrations.
