**ELECTRICAL SAFETY AND ENERGY AUDIT REPORT**  
**FOR**  
**INDIAN BANK – PALARIVATTOM BRANCH**  
**(2025-2026)**

*Prepared by*  
**AURA VERITAS ENGINEERING AND CONSULTANCY PRIVATE LIMITED**

| | Document No | | AVPL/IBE/25-26/ESEA-05 | |

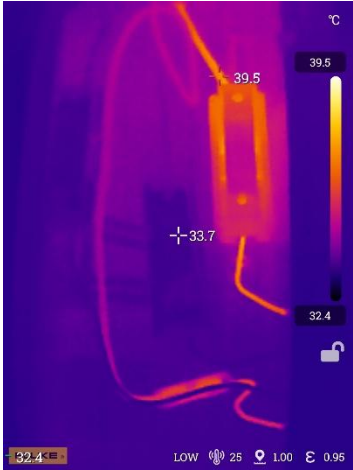
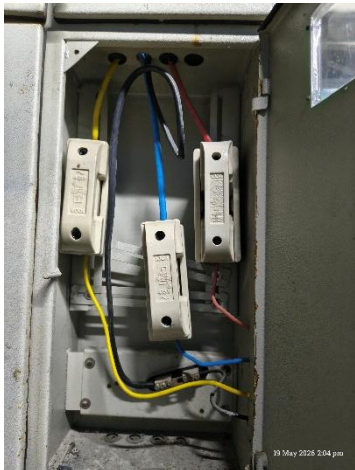
| Thermography Hotspots during Site Audit | | | |
|---|---|---|---|
| | | Fuse<br>Hot spot = 39.5 °C | Normal |

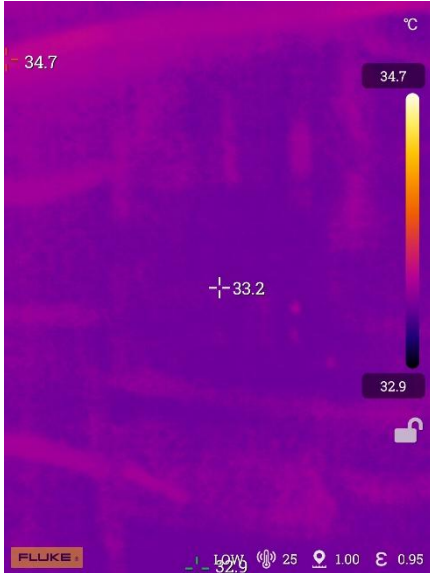
| | | Distribution boxes<br>Hot spot = 33.2 °C | <b>Normal</b> |

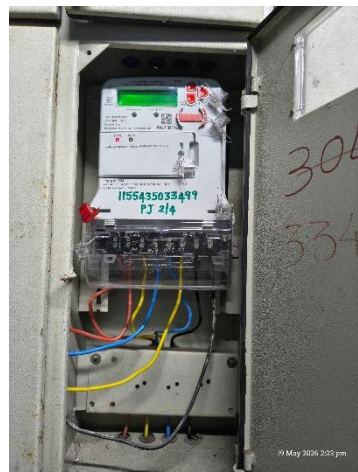
| | | EB meter<br>Hot spot = 35.7 °C | <b>Normal</b> |
