No. : K1MOA-TS-MDT-001

## **Troubleshooting Quick Guidance**

# ECS Alarm "Tacho Set A Failure"

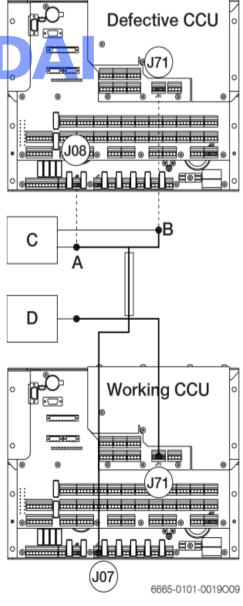
Deffective of MPC (CCU's) board

In case of CCU failure (and the CCU can not be changed immediately), activation of the ME Lubricator can be achieved as follows: In case of CCU failure, the engine is running in "Slow Down" mode

1) Connect the temporary backup cable between the defective CCU and an working CCU as follows:

2) Remove J08/J71 on the defective CCU

- 3) Connect temporary backup cable to J08/J71 on the defective CCU
- 4) Connect temporary backup to J07 (working CCU) (from J08 to J07)
- 5) Remove J71 on working CCU and connect temporary backup cable
