Eight Discipline Report (8D Report)

To: Customer	8D report No.:
From: : Chicony Power Technology	RMA claim No.: N/A
CC:	Chicony Power P/N: W033R004H
	Customer P/N:
Submit date: 2016/08/9	Product description: 33W
Receive date: 2016/08/5	Defect D/C or Lot No.:

Subject: Acoustic *2pc (transformer 中柱點膠偏差), (EMC / acoustic / 零件 /磁件/ 點膠/Glue)

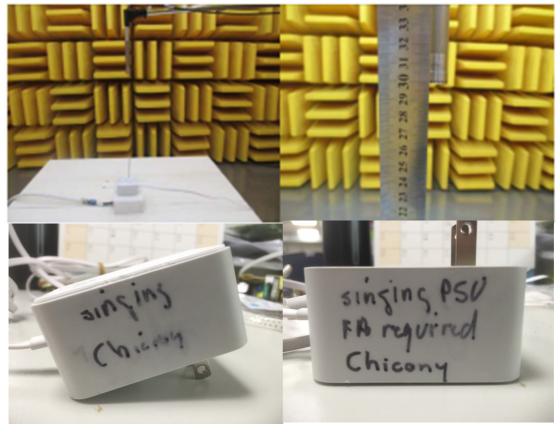
1. Setup and test condition for the analysis

Test condition:

AC input: 90V and 264V

Load condition: 0A to 2A by step of 0.1A

Microphone position: 30cm to upper center of power supply

Serial number: F185081624000958 and F185081626000364

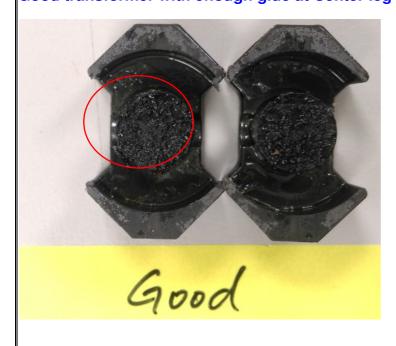
Good transformer with enough glue at Center leg of the core
