## Eight Discipline Report (8D Report)

To: 8D report No.: CPCQ20220801  
From: Chicony Power Technology RMA claim No.: N/A  
CC : N/A Chicony P/N: A111AP01P-HW01-0A  
Customer P/N:  
Submit date: 2022/08/04 updated Product description: 110W adapter  
Receive date: 2022/08/01 Defect D/C or Lot No.: 2022/02  
Subject : Adapter failed\*2pcs

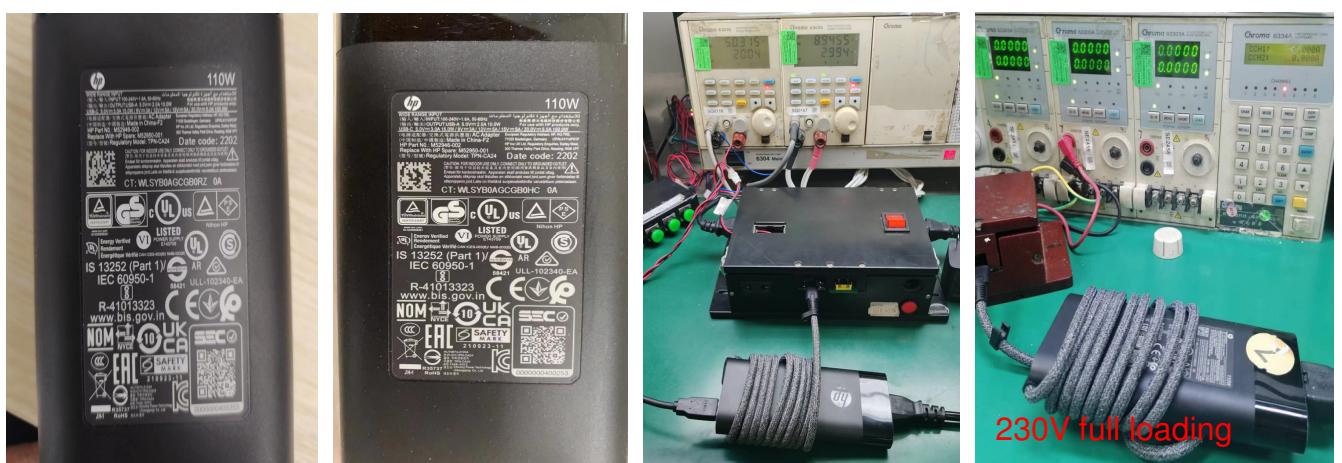
##### 2. Power on test

檢查 adapter 外觀無異常,通電測試,230V full loading 無法工作.

The appearance of adapter is normal. Power on test confirms adapter failed to work on 230V full loading.

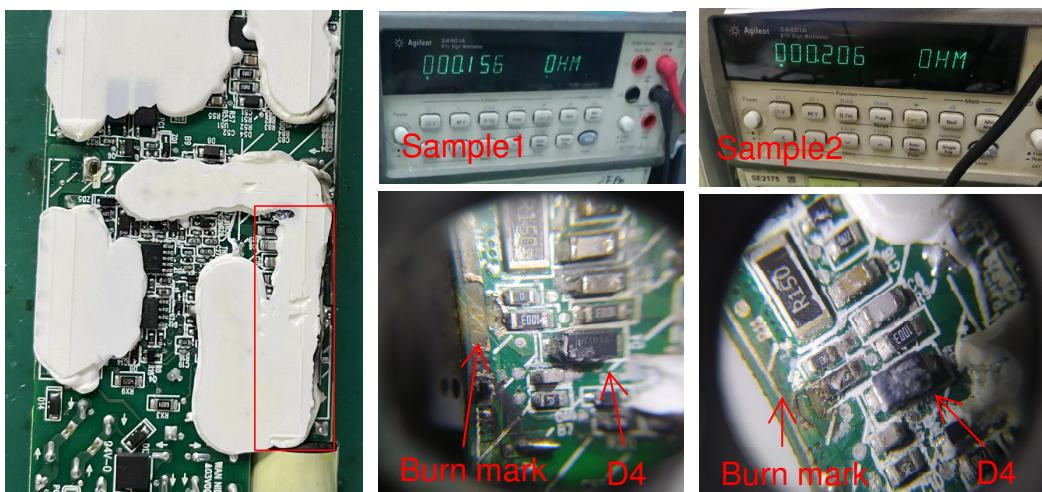
3.2. 清理錫面白膠,觀察到一次側 ground 銅箔燒毀痕跡.逐次量測錫面各個零件,發現 D4 fail(如下).

After cleaning the glue on the tin surface of the adapter, primary side ground copper foil has burn mark. PE measure each part of the tin surface one by one and found that D4 failed.
