**Eight Discipline Report (8D Report)**

То:	8D report No.: CPTP0326		
From: : Chicony Power Technology	RMA claim No.: N/A		
CC: N/A	Chicony P/N: A045R07DH		
	Customer P/N:		
Submit date: <b>2014/3/3</b>	Product description: 45W adapter		
Receive date: 2014/3/26	Defect D/C or Lot No.:

Subject: There are 0.1% productions which has voltage drop phenomenon during burn in process.

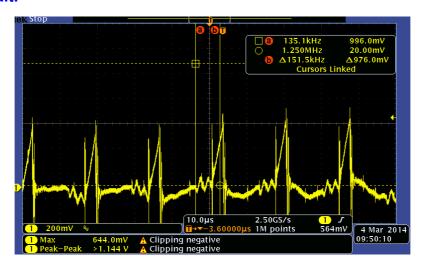
2. We measured the V<sub>sense</sub> waveform of defective sample, and find the voltage waveform has oscillating phenomenon. We infer it should be the transformer T1 interfere the control circuit.

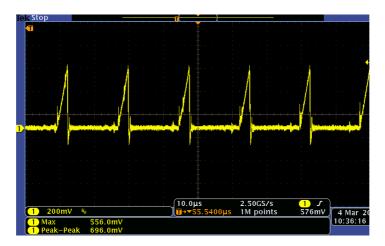
We re-tested the output voltage of defective samples, the test results and V<sub>sense</sub> waveform show as follow:

defective samples(R52=560ohm, R53=5.6kohm, R54=51kohm, remove C56)					
	Vo-no1	Vo-no2	Vo-no3	Vo-no4	Vo-no5
Before burn in(Full load)	19.39V	19.53V	19.45V	19.42V	19.37V
Burn in 2 hours(Full load)	19.37V	19.48V	19.39V	19.34V	19.31V
Different	0.02V	0.05V	0.06V	0.08V	0.06V

Modified R52/R53/R54/C56 can improve voltage drop issue.

- 4. We modified the control loop parameters of 5pcs defective samples as follow:
  - (1) R52 change from 3.6kohm to 560ohm,
  - (2) R53 change from 20kohm to 5.6kohm,
  - (3) R54 change from 15kohm to 51kohm
  - (4) Remove C56(was 1nF).

Modified the control loop parameters R52/R53/R54, and remove C56 (was 1nF).
