## Eight Discipline Report (8D Report)

To:	8D report No.:
From: : Chicony Power Technology	RMA claim No.:
CC :	Chicony Power P/N: <b>A240A005P</b>
	Customer P/N:
Submit date: <b>11/20</b>	Product description: <b>240W</b>
Receive date: <b>11/20</b>	Defect D/C or Lot No.:
<b>Subject :</b> 客戶端反映有一台 240W 樣機沒有輸出 <b>(MOSFET, Surge)</b>	
<b>D1.) 問題解決成員:Use Team Approach</b> 主持者 (Team Leader) : 內部成員 (Internal Team Members): 外部成員 (External Team Member):	
<b>D2.) 問題說明:Problem Description:</b> <i>(Note: Use who, what, when, where, why, how, how many to specify the Customer's problem.)</i>

**客戶端反映有一台 240W 樣機沒有輸出**

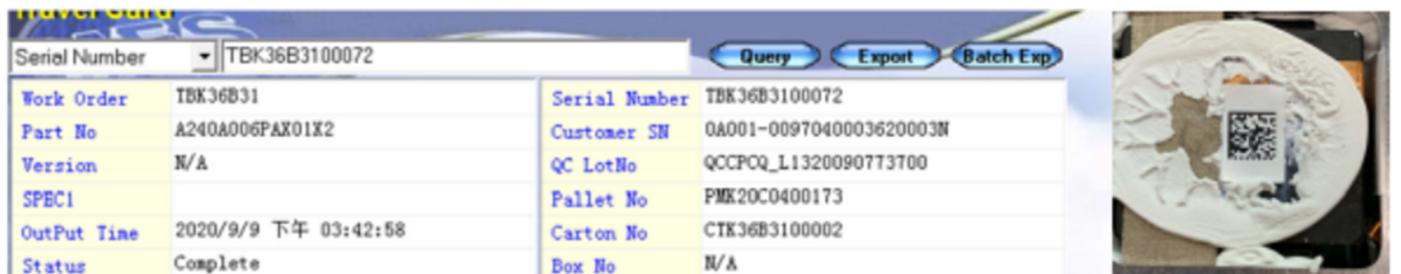
**維修紀錄查詢:**

**無維修紀錄**

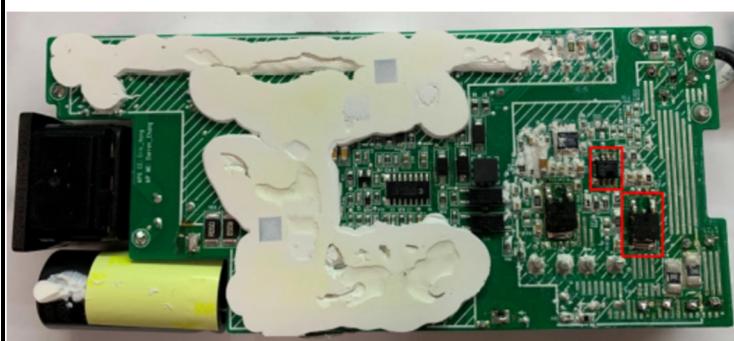
開殼分析: 量測到 Q57 short & U201 的各 Pin 對 GND 阻抗偏低

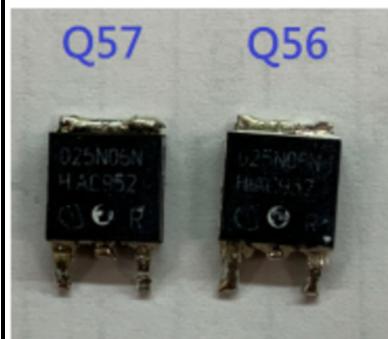
IPD025N06N 正面

Components: Q56, Q57 and U201

Q57 D-S pin short & G-S pin low impedance(125ohm).

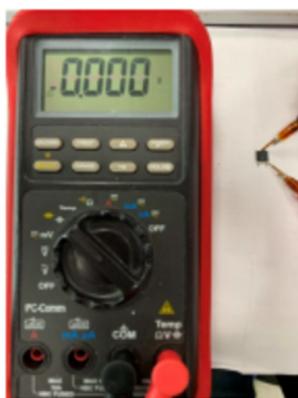
IPD025N06N不良品

Measurement Q57 D-S pin Vf

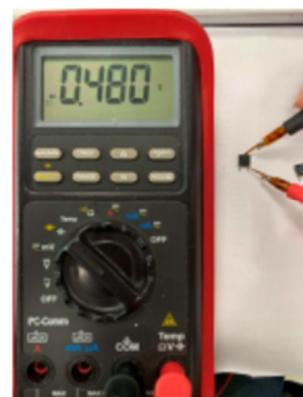
IPD025N06N良品

Measurement Q56 D-S pin Vf
