Eight Discipline Report (8D Report)

| То: | 8D report No.: | |
|---|---|--|
| CC: N/A | Chicony P/N: A135A012P-HW01-0A | |
| Submit date: 2018/5/25 | Product description: 135W adapter | |

Subject: In Q G35N system with Chicony 135W adapter condition, the radiation test margin

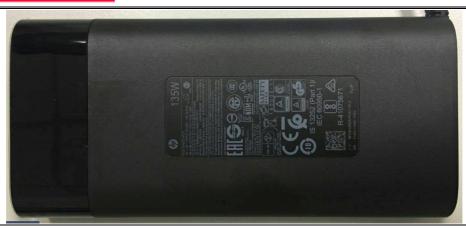
Q claimed that Q G35N system with Chicony 135W adapter failed in radiation test.

Failed sample S/N: WHAQV0AP6AP0A2
