Eight Discipline Report (8D Report)

То:	8D report No.: CPCQ0910					
From: : Chicony Power Technology	RMA claim No.: N/A					
CC: N/A	Chicony P/N: A045R00CH					
	Customer P/N:					
Submit date: 2015/9/15	Product description: 45W adapter					
Receive date: 2015/9/3	Defect D/C or Lot No.: 1507					
	Fail sample: WEJZB0BGC8X33N(Version 0B)					
	Pass sample: WEJZB0BGC8X346 (Version 0B)

Subject: 45W adapter sample fail in conduction test.

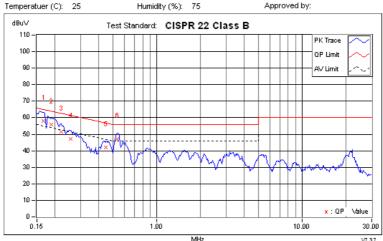
Fail sample: (WEJZB0BGC8X33N Version 0B): The test margin just 3.11dB at 534kHz.

100.12											
	Frequency	Corr. Factor		ading Bu∨	Emission dBuV		Limit dBu∨		Margins dB		Notes		
No.	MHz	dB	QP	AV	QP	AV	QP	AV	QP	AV	Notes		
1	0.16562	10.23	47.90	36.30	58.13	46.53	65.18	55.18	-7.05	-8.65			
2	0.18906	10.24	45.75	37.91	55.99	48.15	64.08	54.08	-8.09	-5.93			
3	0.22031	10.24	41.29	33.81	51.53	44.05	62.81	52.81	-11.27	-8.75			
4	0.25547	10.25	36.90	29.95	47.15	40.20	61.58	51.58	-14.43	-11.38			
5	0.44688	10.29	31.73	26.35	42.02	36.64	56.93	46.93	-14.92	-10.30			
+6	0.53409	10.30	37.01	32.59	47.31	42.89	56.00	46.00	-8.69	-3.11

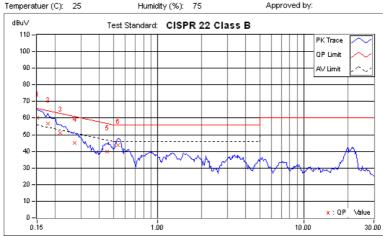
Pass sample: WEJZB0BGC8X346 (Version 0B): The test margin just 6.88dB at 537kHz.

IOID2 VI										
	Frequency	Corr. Factor		Reading dBu∨		Emission dBuV		Limit dBuV		gins 18	Notes
No.	MHz	dΒ	QP	AV	QP	AV	QP	AV	QP	AV	Notes
+1	0.15001	10.23	49.85	35.98	80.08	46.21	66.00	56.00	-5.92	-9.79	
2	0.17734	10.23	46.31	34.17	56.54	44.40	64.61	54.61	-8.07	-10.21	
3	0.21641	10.24	40.95	29.37	51.19	39.61	62.96	52.96	-11.76	-13.34	
4	0.27109	10.25	34.69	24.54	44.94	34.79	61.08	51.08	-16.14	-16.29	
5	0.45078	10.29	29.63	23.80	39.92	34.09	56.86	46.86	-16.94	-12.77	
6	0.53672	10.30	33.24	28.82	43.54	39.12	56.00	46.00	-12.46	-6.88

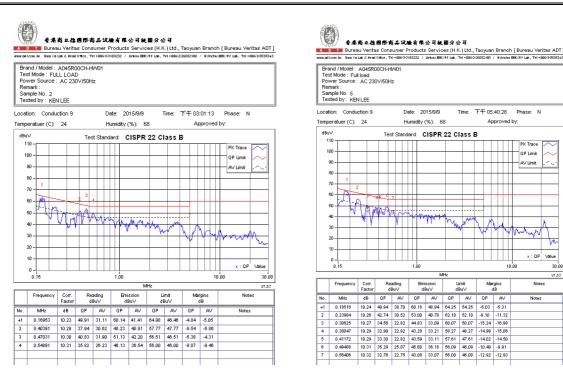
We retest the failed sample & pass sample with dummy load in 3rd party EMI Lab. And the margin has 4.31dB at 470kHz (AV) in fail sample and 9.91dB at 495kHz (AV) in pass sample. The test results are shown as below:

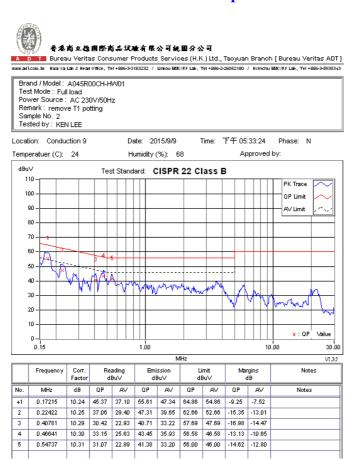
Modified Fail Sample

(1) After retest the defective adapters, we disassemble the sample case and find the glue deviation on transformer T1 (more glue on T1 for Fail Sample).

We remove the glue on the transformer of fail sample and retest it. The test margin becomes to 10.65dB at 466kHz.

According to above experiment, we infer it should be the deviation glue on transformer T1 causes the EMI issue.

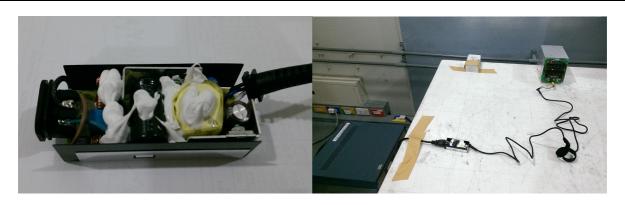
(a)More glue on the transformer without top side shielding: The test margin has 12.47dB at 498kHz.

Brand / Model: A04SR00CH
Test Mode: FULL LOAD
Power Source: AC 230V/50Hz
Remark: more glue on T1 and without top side shielding
Sample No. 1
Tested by: KEN LEE

MHz											
	Frequency	Corr. Factor		ading Bu∨	Emission dBuV		Limit dBuV		Margins dB		Notes	
No.	MHz	dΒ	QP	AV	QP	AV	QP	AV	QP	AV	Notes	
+1	0.16299	10.23	47.70	36.80	57.93	47.03	65.31	55.31	-7.38	-8.28		
2	0.26719	10.26	34.80	20.84	45.06	31.10	61.20	51.20	-16.14	-20.10		
3	0.37656	10.29	31.15	22.99	41.44	33.28	58.35	48.35	-16.92	-15.08		
4	0.49766	10.31	31.02	23.26	41.33	33.57	56.04	46.04	-14.71	-12.47		
5	5.80859	10.66	22.51	16.47	33.17	27.13	60.00	50.00	-26.83	-22.87

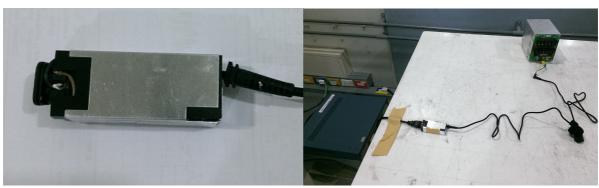
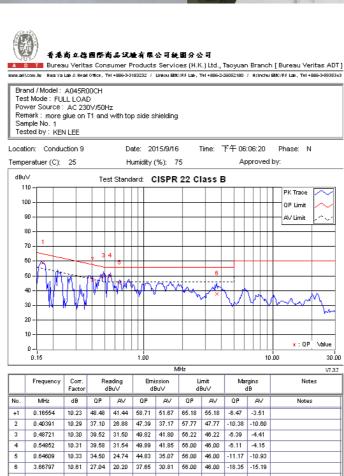
(b) More glue on the transformer with top side shielding: The test margin has 4.15dB at 548kHz.

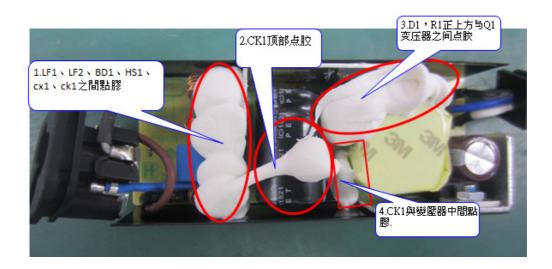
After checking, fail product was testing sample for glue machinery during regular production, and it was considered OK by checking in conformity with below W/I (similar location) – so that this product was leaked out to cause EMI margin issue.
