Eight Discipline Report (8D Report)

| То: | 8D report No.: | | | |
|---|---|--|--|--|
| Submit date: 2014/3/11 | Product description: 45W adapter | | | |

Subject: 45W adapter sample conduction test failed in 3rd party laboratory.

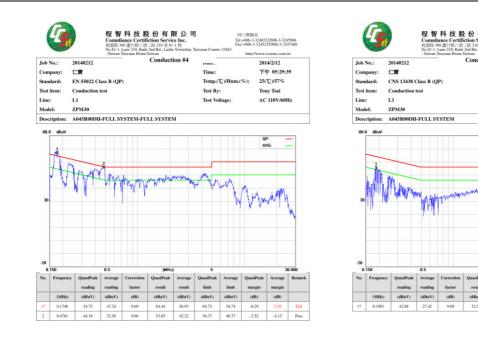
What: C claimed that CPT 45W adapter failed in the conduction test.

How many: 2pcs sample. 1pcs passed, and the other failed

Where: The 3rd party test data shows as below:

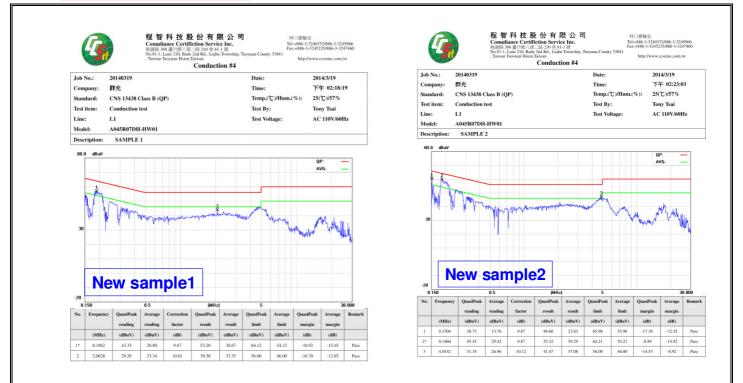
1. We provided 2pcs new sample to 3rd party lab. They can both pass the conduction test and the test margin has 8.92dB.

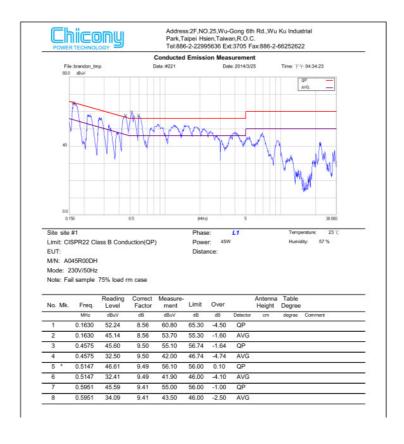
2. We retest the failed sample with dummy load and found it failed in CPT EMI Lab. Test result of failed sample is over spec 0.1dB at 515kHz(QP) and under spec 1.6dB at 163kHz(Avg). The test results are shown in below: 2014.3.25

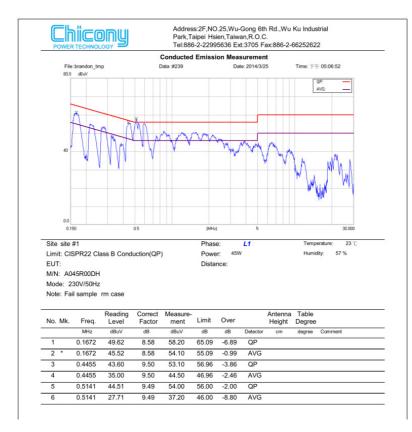
(1) After retest these defective adapter, we disassemble the sample case. And retest the failed sample in CPT EMI lab. The test margin of failed sample has 0.99dB at 167kHz. 2014.3.25

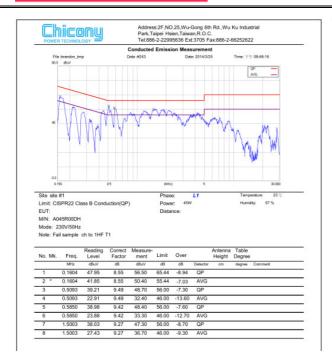
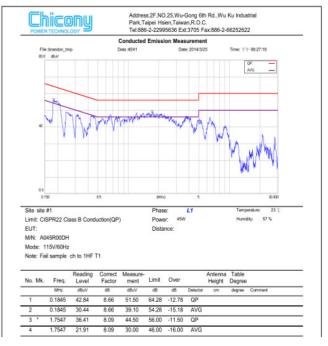
230V/50Hz 115V/60Hz

(2)We changed the modified transformer T1 to failed sample, and retest the failed sample. The test margin becomes to 7.03dB. The sample has enough margins to meet spec request.

According to above experiments, we infer it should be the transformer T1 causes the issue.

Modified the shielding S1/S2 of transformer T1 to 1.1 turns. Production revision change from 0A to 0B
