Eight Discipline Report (8D Report)

客戶端告知有 2pcs 240W 在 DC plug 移除後, 不定期插回系統端會無法充電,

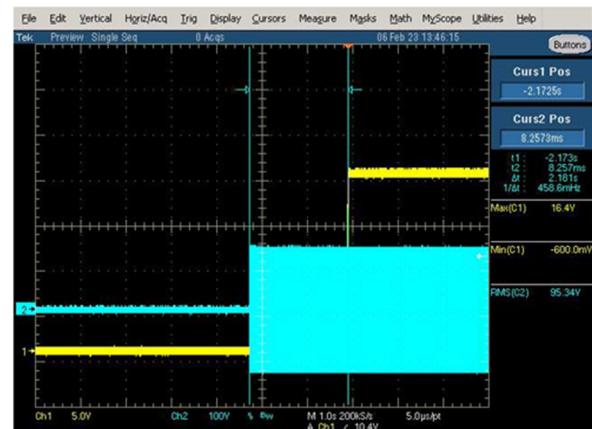
Turn on delay time(330uF)

Turn on Delay time (spec < 3S)

T_on=2.181S

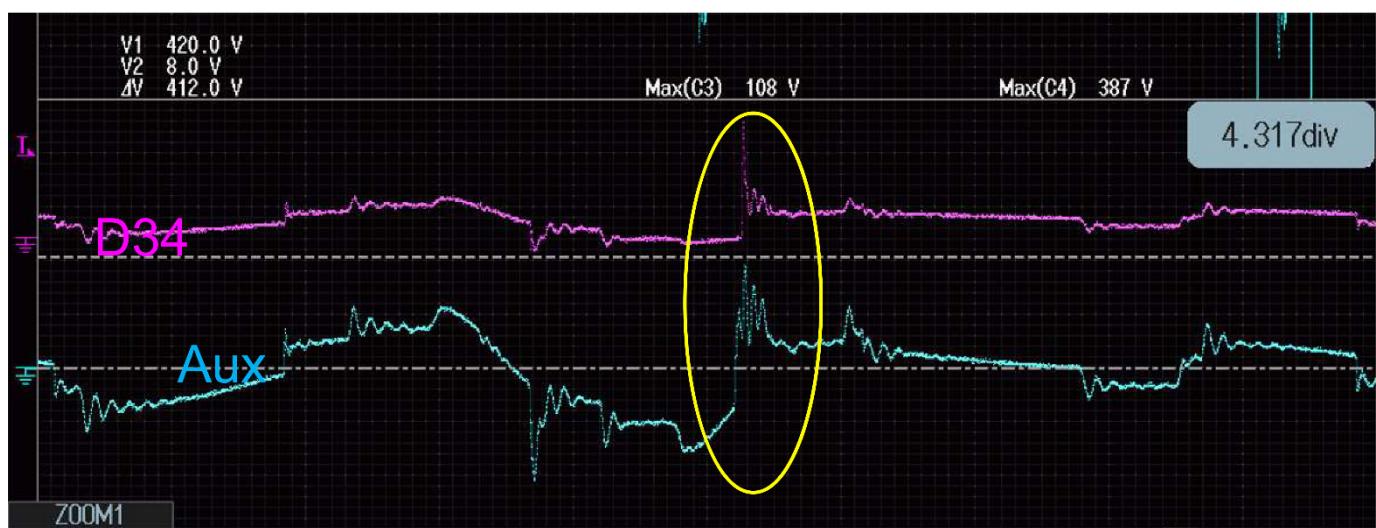
由激磁電感上的跨壓可發現D34 上的 spike是由諧振槽透過變壓器耦合到aux 上，

使 D33/D34 造成 spike。
