## **Eight Discipline Report (8D Report)**

To: customer 8D report No.: CPCQ20221208

Submit date: 2022/12/09 Product description: 120W adapter

Subject: AC 過壓, bulk cap damage, Fuse open, smoking [電容, Fuse, OVP]

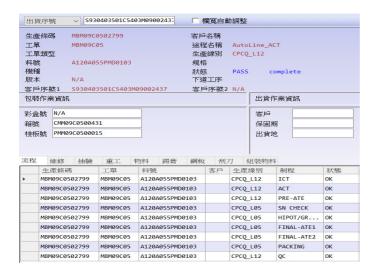
### SFCS record

根據退回產品 S/N:,查詢廠內 SFCS 記錄正常.

According to the returned adapter S/N, query SFCS record. – no abnormality was found.

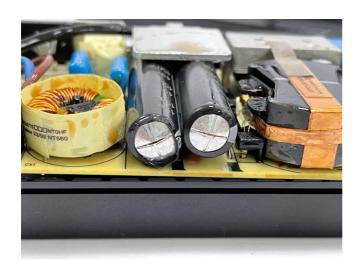
## 4. Simulation test(CK1).

輸入電壓 Input voltage:AC440V

通電後約1秒後冒煙開蓋與RMA樣機失效零件一樣CK1 & Fuse open.測試結果430Vac約30sec後冒煙後無輸出Fail(如下影片),開蓋後與RMA品一樣大電容防爆動作,Fuse open.

After the adapter is powered on about 1 second, it smoke and no output after about 30sec (as shown in the following video). Open case, CK1 bulge& Fuse open is found to be the same as the failed parts of the returned unit.

綜上所述:經模擬實驗結果,懷疑外部異常能量造成 CK1 防爆孔動作後 Fuse 啟動保護.故不排除產品應用時承受異常應用條件導致產品早期失效的可能.

Conclusion: The simulation results showed that Fuse protection was activated after CK1 failed caused by suspected external abnormal energy. Therefore, the possibility of early product failure due to abnormal application conditions cannot be ruled out.

Send failed CK1 to the vendor for analysis.
