Eight Discipline Report (8D Report)

To: ODM 8D report No.: CPG0709

Customer P/N: W16-033N1A

Subject: No output*1 (零件/ Diode, schottky diode D51 damaged)

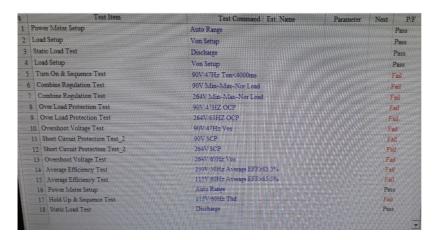
1. 2016/7/20 ODM feedback that 1pc adapter with no output was found in their site, defective phenomenon is as below:
