Eight Discipline Report (8D Report)

To: 8D report No.: CPCQ20221027
From: Chicony Power Technology RMA claim No.: N/A
CC : N/A Chicony P/N: A111AP01P-HW01 & A111AP02P-HW01

Submit date: 2022/11/11 Customer P/N:
Receive date: 2022/10/27 Product description: 110W adapter
Subject : Adapter ESD issue*4pcs Defect D/C or Lot No.: 2022/07&2022/09

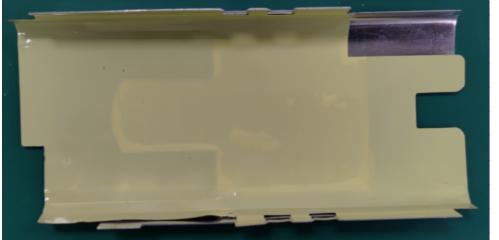
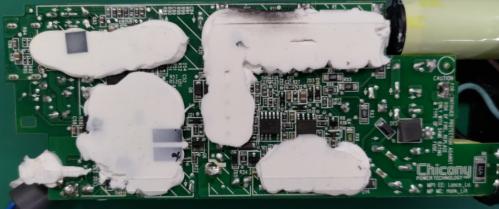
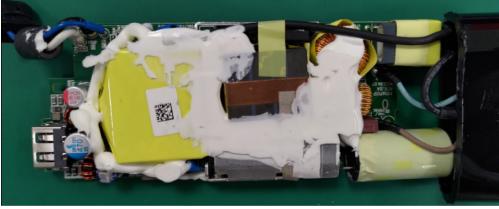
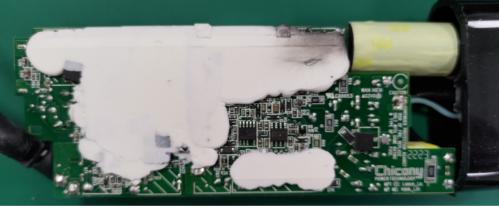
3.1. (A111AP01P) Sample1:WLSYB0BGCGV433 Sample2:WLSYB0BGCGV432

3.1.1. 開殼檢查確認零件面及錫面(如下圖)

Open the case to check the parts and tin surface

Sample1: U2、Q6、Q2、R1、Q1、U1、R11、R32、F1 fail.

Sample2: U2、Q6、Q2、R1、ZD1、R13、Q1、U1、R11、R32、F1 fail.

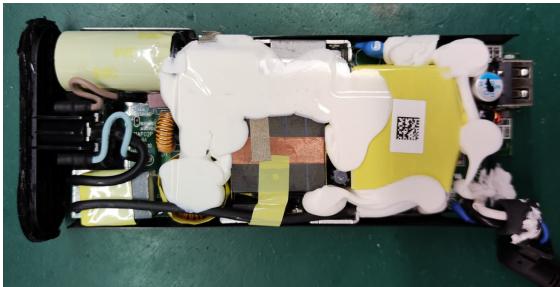
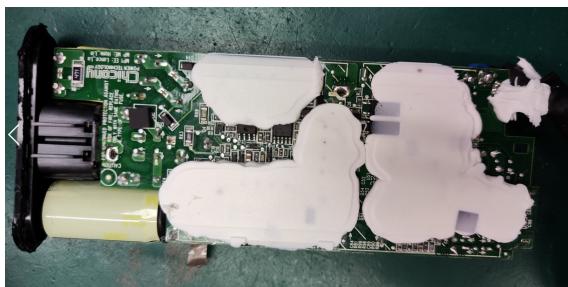
3.2. (A111AP02P) Sample3:WRLUH0AGCH208J

3.2.1.開殼檢查確認零件面及錫面(如下圖)

Open the case to check the parts and tin surface

3.2.2 檢修樣機確認 U2/Q6/ZD1 損壞,更換零件後,產品開機輸出正常.

Check the adapter and confirm that U2/Q6/ZD1 is damaged. After replacing the parts, the output of the adapter is normal .

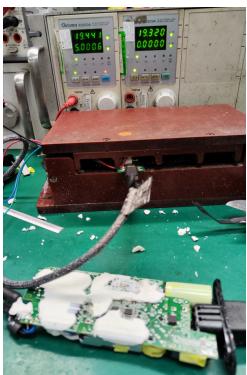
Sample3: U2/Q6/ZD1 fail.

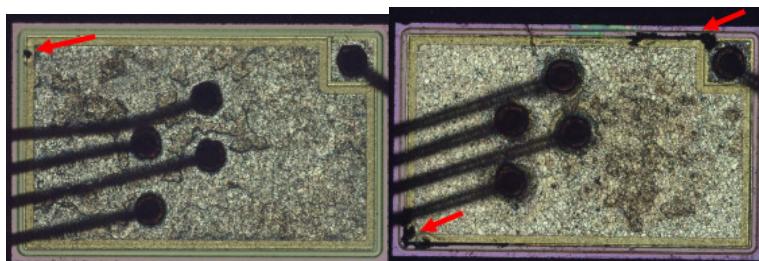
4.5.1 Q6 (AP/AP10TN135N)不良品失效材料分析結果如下

Analysis results of failed Q6 (AP/AP10TN135N) are as follows:

根據分析報告,Q6 失效主因疑似為高電壓破壞 MOS 晶體絕緣後,導致流入電流過大造成 EOS 損壞.

According to the analysis report, the main reason of Q6 failure is suspected to be the damage of EOS caused by excessive inflow current after high voltage destroys the MOS crystal insulation.

經實驗驗證,Q6 原材料 AP/AP10TN135N 在耐受 ESD 能力不平均,更換用料為 ON/FDN86246 可改善 ESD 問題.

After ESD test, it is verified that Q6 raw material AP/AP10TN135N has uneven ESD tolerance ability. Replacing the material with ON/FDN86246 can improve ESD issue.
