Eight Discipline Report (8D Report)

1 , ,
То:	8D report No.:
From: :	RMA claim No.:
CC:	Chicony Power P/N: N025A001Q-CT01
	Customer P/N:
Submit date: 2020/10/10	Product description:
Receive date: 2020/10/10

Subject: AC cable 藉由金屬環增強拉拔力,加工不良刺穿 cable 披覆,導致 AC cable 短路 [ME]

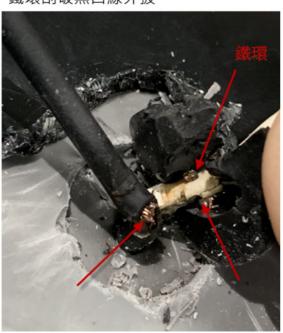
確認 AC 輸入端有焦黑痕跡,並有裸銅外露跡象

鐵環刮破黑白線外披

取消鐵環增強拉拔力的對策,改用加長 SR 長度增加接觸面積增強拉拔力

嚴禁使用金屬材質接觸與固定 AC 線材

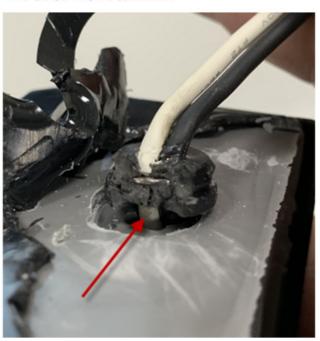
SR內側白線外披燻黑
