Eight Discipline Report (8D Report)

To: Dell	8D report No.: xxxxxx	
From: : Chicony Power Technology	RMA claim No.: N/A	
cc:	Chicony Power P/N:	
	Customer P/N:	
Submit date: 2023/10/23	Product description: PD 130W	
Receive date: 2023/10/27

Subject:After the AC power is turned off, abnormal operation of the blocking MOS causes voltage bouncing on the output voltage;輸出電壓彈跳;輸出電壓異常;輸出突波;輸出 spike;關機輸出電壓異常

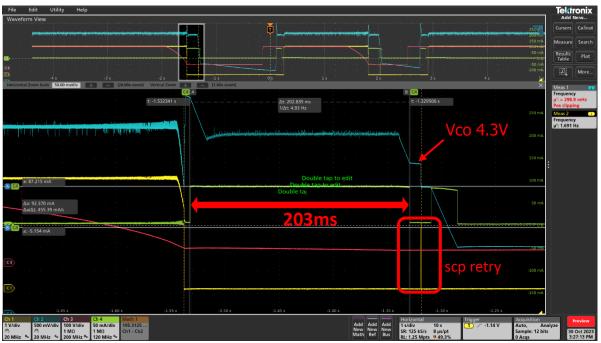
CH1: Vo CH2: Vco Ch3: Vbulk CH4: discharge current

Sample analysis when AC is turned off, Vco drops below the threshold of 3.8V, the blocking MOS is turned off. Following a discharge of 203ms, the Vco voltage is higher than the 3.8V threshold. Then, the system enters the SCP process, and the blocking MOS is turned on.

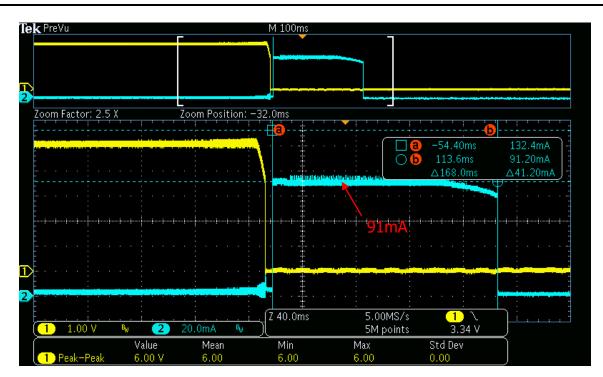
CH1: Vo CH2: discharge current

- > The root cause is the insufficient discharge capability of the PD IC, causing the Vco voltage to exceed 3.8V, triggering the SCP process, and the blocking MOS turned on again.
- Considering the IC discharge tolerance, the measured lower limit for IC discharge current is 91mA, ensuring that the test does not trigger SCP retry.

To prevent triggering SCP retry, ensure that the IC discharge current capability is at least 91mA.

OB suppliers will also implement sorting specifications on the provided IC to avoid the recurrence of the same issue.
