Eight Discipline Report (8D Report)

8D report No.: CPCQ0910
RMA claim No.: N/A
Chicony P/N: A045R00CH
Customer P/N:
Product description: 45W adapter
Defect D/C or Lot No.: 1507
Fail sample: WEJZB0BGC8X33N(Version 0B)
Pass sample: WEJZB0BGC8X346 (Version 0B)

Subject: 45W adapter sample fail in conduction test.

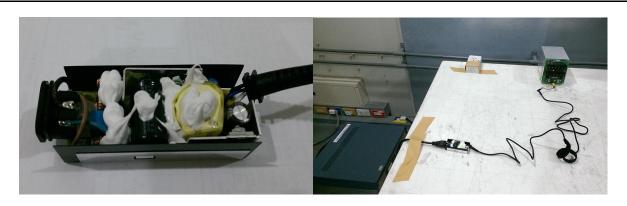
(a)More glue on the transformer without top side shielding: The test margin has 12.47dB at 498kHz.

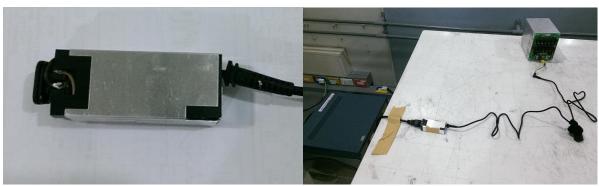
(b) More glue on the transformer with top side shielding: The test margin has 4.15dB at 548kHz.

According to above experiment, we infer it should be the deviation glue on transformer T1 causes the EMI issue.
