# **Eight Discipline Report (8D Report)**

To: customer 8D report No.: CPCQ20221208

From: Chicony Power Technology RMA claim No.: N/A

Subject: AC 過壓, bulk cap damage, Fuse open, smoking

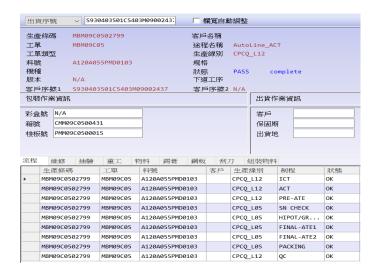
根據退回產品 S/N:,查詢廠內 SFCS 記錄正常.

According to the returned adapter S/N, query SFCS record. – no abnormality was found.

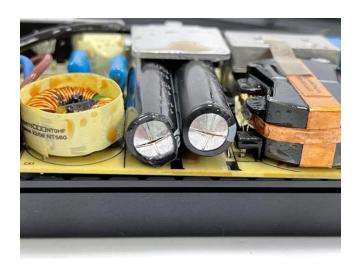
輸入電壓 Input voltage:AC440V

通電後約1秒後冒煙開蓋與RMA樣機失效零件一樣CK1 & Fuse open.測試結果430Vac約30sec後冒煙後無輸出Fail(如下影片),開蓋後與RMA品一樣大電容防爆動作,Fuse open.

After the adapter is powered on about 1 second, it smoke and no output after about 30sec (as shown in the following video). Open case, CK1 bulge& Fuse open is found to be the same as the failed parts of the returned unit.

綜上所述:經模擬實驗結果,懷疑外部異常能量造成 CK1 防爆孔動作後 Fuse 啟動保護.故不排除產品應用時承受異常應用條件導致產品早期失效的可能.

Conclusion: The simulation results showed that Fuse protection was activated after CK1 failed caused by suspected external abnormal energy. Therefore, the possibility of early product failure due to abnormal application conditions cannot be ruled out.

Send failed CK1 to the vendor for analysis.
