Eight Discipline Report (8D Report)

Subject: The shielding gap of transformer impacts the conduction in 3rd party laboratory.

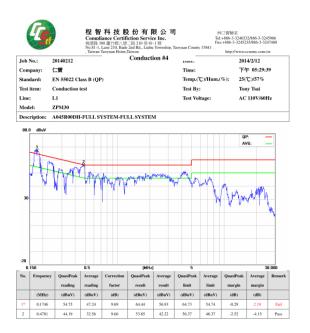
Fail sample(S/N: F2550813500000505)

What: customer claimed that CPT 45W adapter failed in the conduction test.

How many: 2pcs sample. 1pcs passed, and the other failed

Where: The 3rd party test data shows as below:

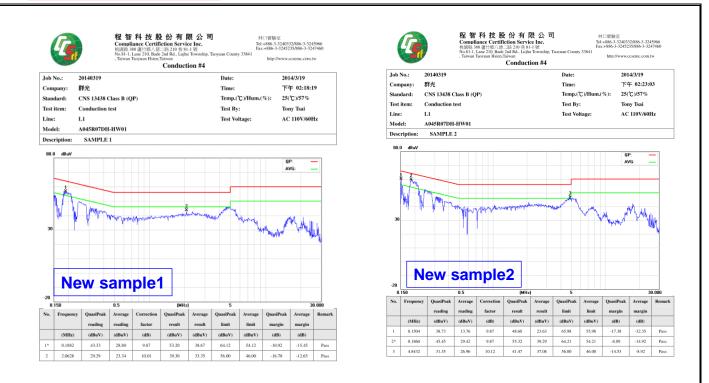
1. We provided 2pcs new sample to 3rd party lab. They can both pass the conduction test and the test margin has 8.92dB.
