Eight Discipline Report (8D Report)

To: 8D report No.: CPCQ0421

Submit date: 2015/05/11 Product description: 45W adapter

Subject: 45W adapter sample ISN failed D1.) 問題解決成員:Use Team Approach 主持者 (Team Leader): Henry_Zhang 內部成員 (Internal Team Members):

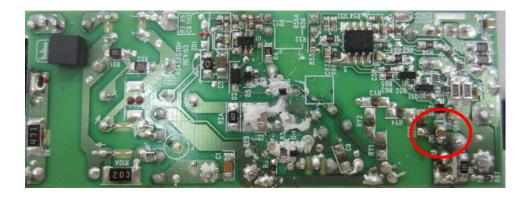
2. 拆開樣機確認,發現產品 CC 位置有補焊痕跡,且表面有微小裂痕,量測 CC 電容單體阻抗為 11kohm,阻抗偏低(正常樣品 CC 電容阻抗為開路)。

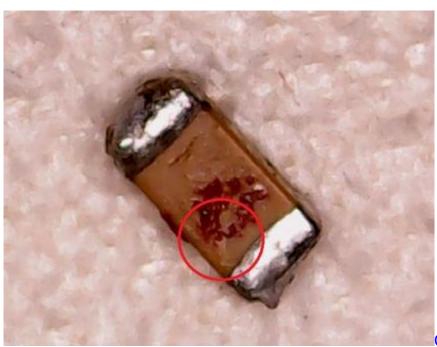
CC 零件表面有微小裂痕

綜上所述: CC 零件破損造成 CC 阻抗偏低, 導致客戶端 ISN 測試異常。 CC 破損發生原因,從 2. 實物機台觀察,應為維修員補焊作業時不熟練,補焊 CC 時間較久,造成零件受損微裂,從而 因間歇性接觸,而流入客戶導致不良發生。

針對新近維修人員必須接受焊錫培訓,人員都需焊錫理論和實際操作考核,並由 IPQC 發證后上崗.

- 2. 針對焊錫時間重點教育, 對於 MLCC 零件必須焊錫時間不得超過 5 秒, 且不得碰觸到 MLCC 本體
 - 一.名詞解釋(每題4分,共16分)
 - 1. 通孔:孔的內壁有金屬鏡層。
 - 2.短路:焊錫跨接於兩不同之電路.
 - 3.空焊焊盤與零件腳未粘到焊錫
 - 二.填空題(每空3分,共39分)
 - 1.焊點的形狀成 <u>圓錐狀</u>或 <u>內弧形</u>,可見零件腳.
 - 2.翹皮的允收標準是:焊錫銅膜上翹高度小於 或 等於__銅箔__厚度,上翹高度看不見縫隙,且不可超過焊盤的50%。.
 - 3.目標之吃錫面積與錫量標準吃錫面積須 100% 覆蓋零件腳與銅箔面(即:引腳與焊盤潤濕良好.)
 - 4.MLCC零件焊錫時間不得超過_5_秒
 - 5.允收之吃錫面積與錫量標準
 - (A). 自動插件彎腳後零件腳吃錫面積需≥_75%.
 - (B). 手插部份零件腳吃錫面積或通孔焊錫的垂直填充量≥ 75%.
 - (C). 但(B)之要求,不包含須100%吃錫的零件如:可調整零件,零件<u>引腳直徑</u>≥1.3mm,和零件<u>本體直徑</u>≥20mm。
 - (D). 任何零件之吃錫量不可接觸零件<u>本體或 封裝</u>.
 - (E). 末端焊錫寬度大於或等於零件或焊盤寬度的 75% , 其中較小者; 側面偏移小於等於零件或焊盤寬度的 25%

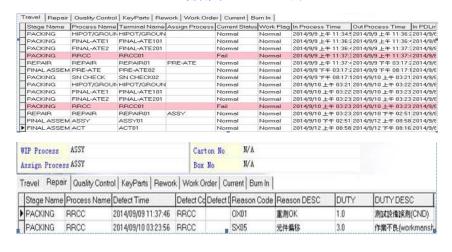
根據退回產品 S/N, 查詢廠內 SFCS 記錄,確認不良品當時有 RRCC 不良并有 repair 記錄.
