Eight Discipline Report (8D Report)

1 1 1
To: W company	8D report No.: 202403001
From: : Chicony Power Technology	RMA claim No.: N/A
CC:	Chicony Power P/N: A360A001P-DL01-A00
	Customer P/N: NN34T
Submit date: 2024/5/17	Product description: 360W Adapter
Receive date: 2024/3/19	
	•

Subject : noise issue * 2pcs

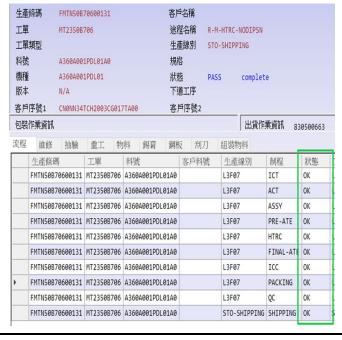
#01:

Check the SFCS record through by the PPID, both of these 2 samples have passed all test stations normally, no repaired record.
