Eight Discipline Report (8D Report)

<u> </u>	
То:	8D report No.:	
From: :	RMA claim No.:	
CC:	Chicony Power P/N: E050S040P-AZ01	
	Customer P/N:	
Submit date: 2022/07/29	Product description:	
Receive date: 2022/07/29		
	-

Subject:aux diode damage (輕載切換頻率上升加上 trr 較慢造成 diode 溫度異常升高損壞)

50W LED driver no output Issue

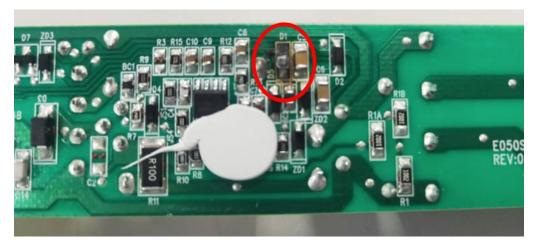
All Chicony drivers which have failed exhibit the same brown spot on the top side of the PCBA.

There are burn marks on D1 and D1 is broken.

- Measured D1 with an electric meter and replaced it with a new component, the driver works normally after replacement.
- burn-in test and check the application of load and dimming. According to the information provided by the customer, the input voltage is 277Vac.
- When dimming is switched to any state at high temperature, the driver will no output and D1 damage by analysis.
- Measure frequency with dimming:

• The reverse recovery time(Trr) of the diode is too slow or the reverse leakage current(Ir) is too high, and the switching frequency of the 20% current is too fast, causing temperature to rise rapidly, and finally causing D1 to be damaged.

- 1. Because the TSC component perform best, we will replace the TSC component (RS1ML).
- 2. In order to prevent Ir and Trr tolerance of the diode from causing the temperature to become higher, we will add thermal glue on D1 location.
- After D1 replace to the TSC component and add thermal glue, the D1 component will not cause damage.
