Tenant Safety Inspection Report
446 Hospital Street
Steinbach, MB
CANADA

June 25, 2025

Produced by Brad Taylor

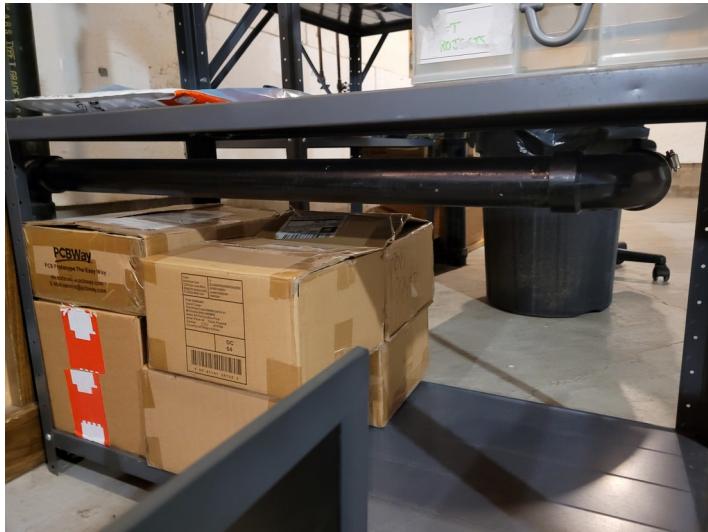
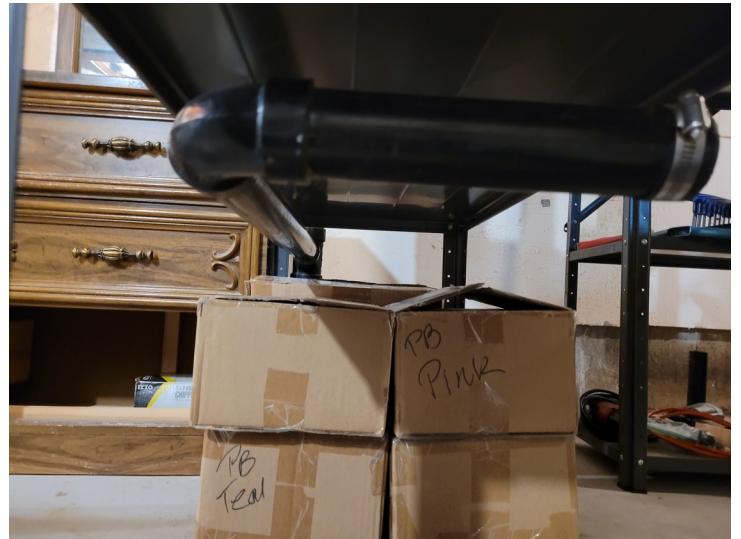
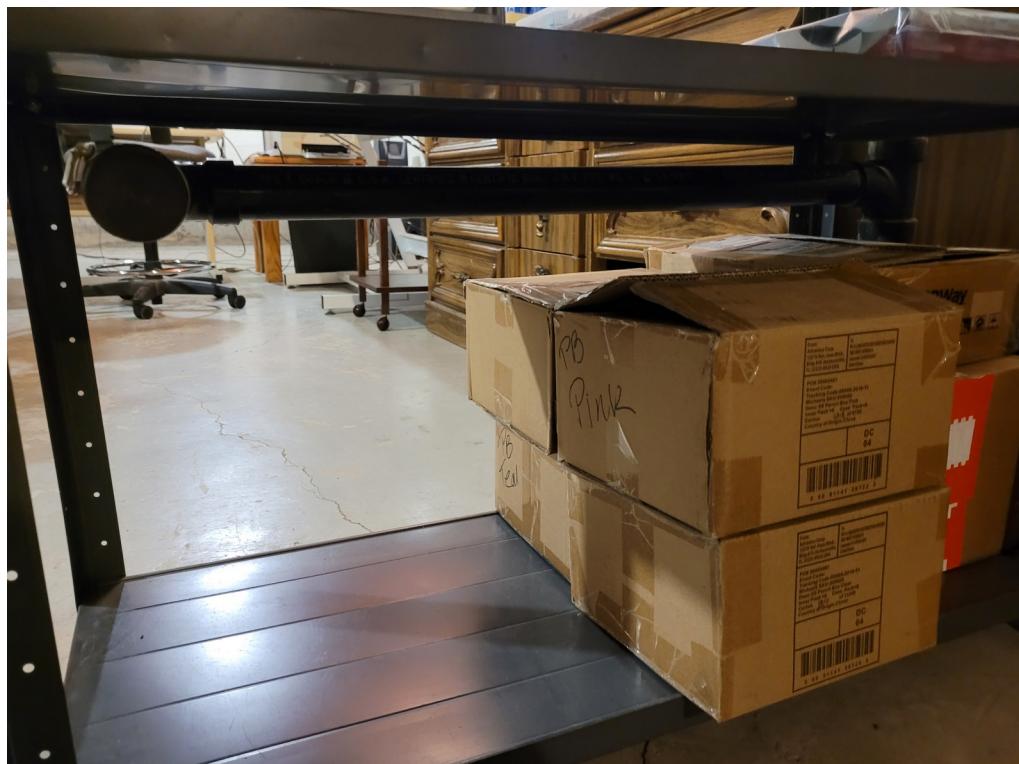
Violation #1: Floating Horizontal PVC Pipe

- A **horizontal PVC pipe**, 32 inches long
- Attached to what appears to be a **sewer vent relief stack** (which should be rigid and vertical)
- **Protruding unsupported** into living space
- **18 inches off the ground**, i.e., right at **ankle/shin level—prime tripping hazard**
- Entirely **unsupported at the free end**

This floating PVC is **100% non-compliant**.

Vent pipes must maintain alignment, not sag, and must not be installed in a way that allows movement or disconnection under normal household traffic.

While an **unsupported PVC pipe** is not as catastrophic as other violations, this hazard still creates:

- **Trip & fall risk** (especially if lighting is poor)
- **Chance of joint failure**
- **Potential gas leak** from sewer

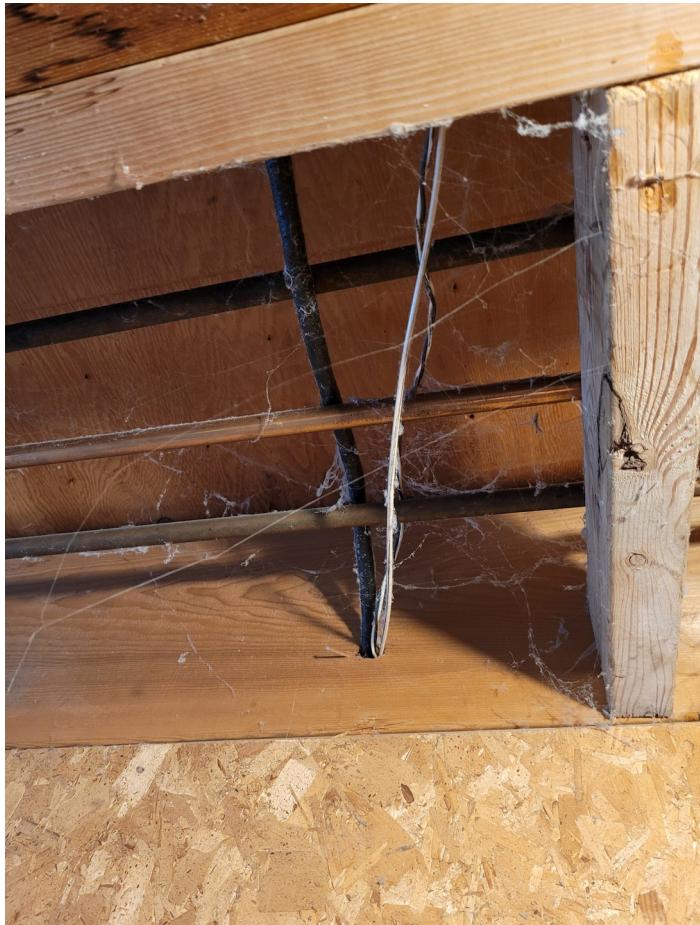
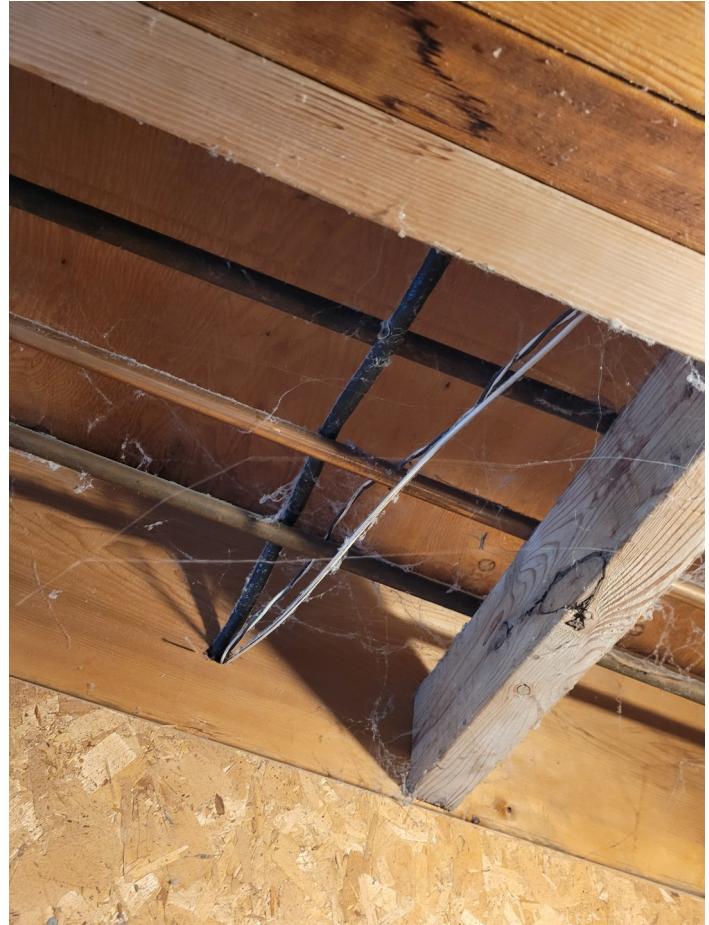
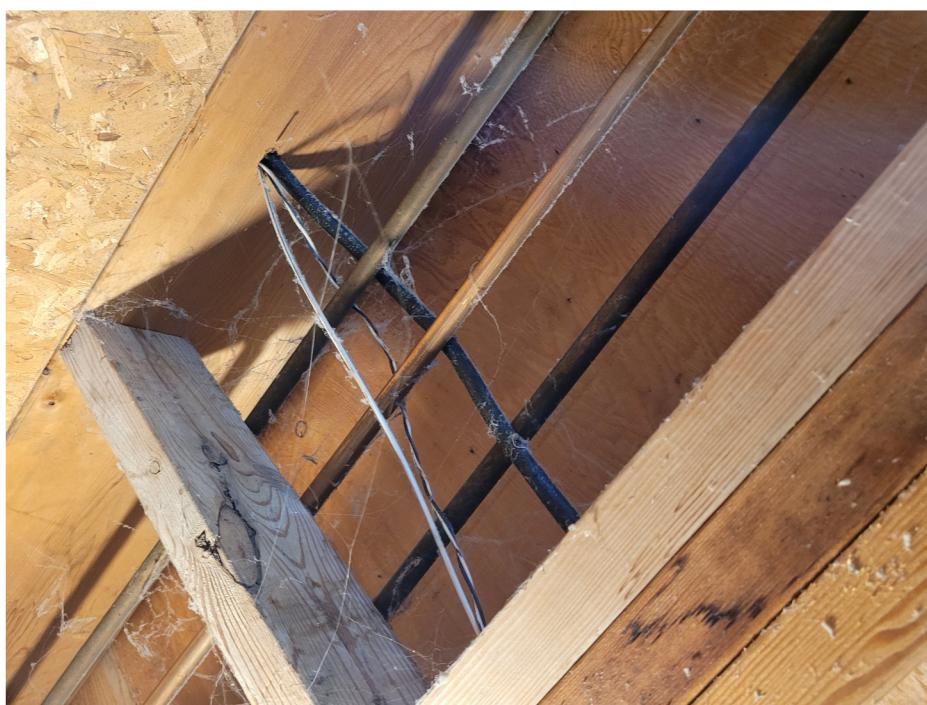
Violation #2: Electrical Wiring Weaved to Plumbing Work

Even weaving wires between **perpendicular plumbing runs** puts strain and risk of movement/vibration, especially if plumbing shifts due to temperature or water hammer. This creates:

- Chafing on insulation
 - Hidden **electrocution risks**
 - High fire hazard
-

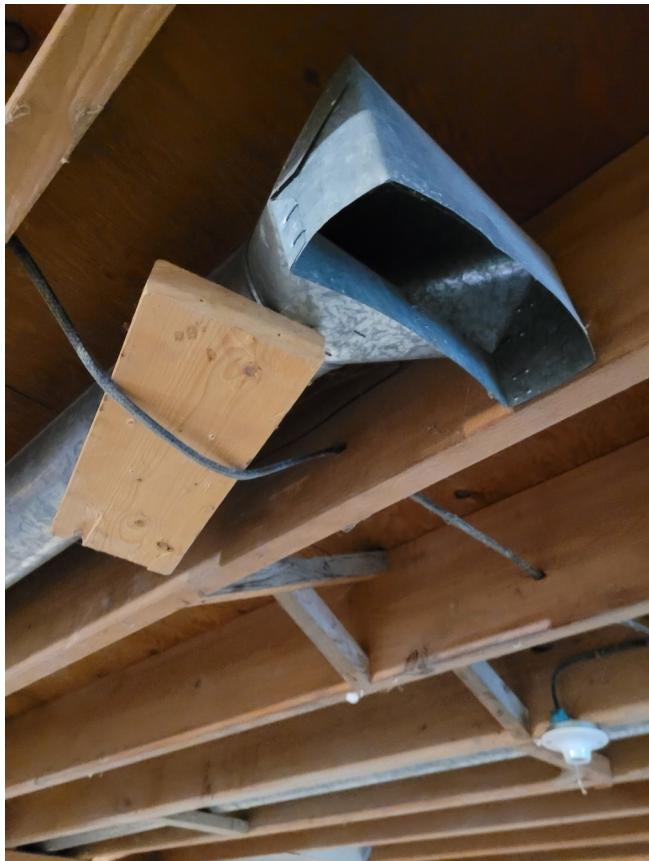
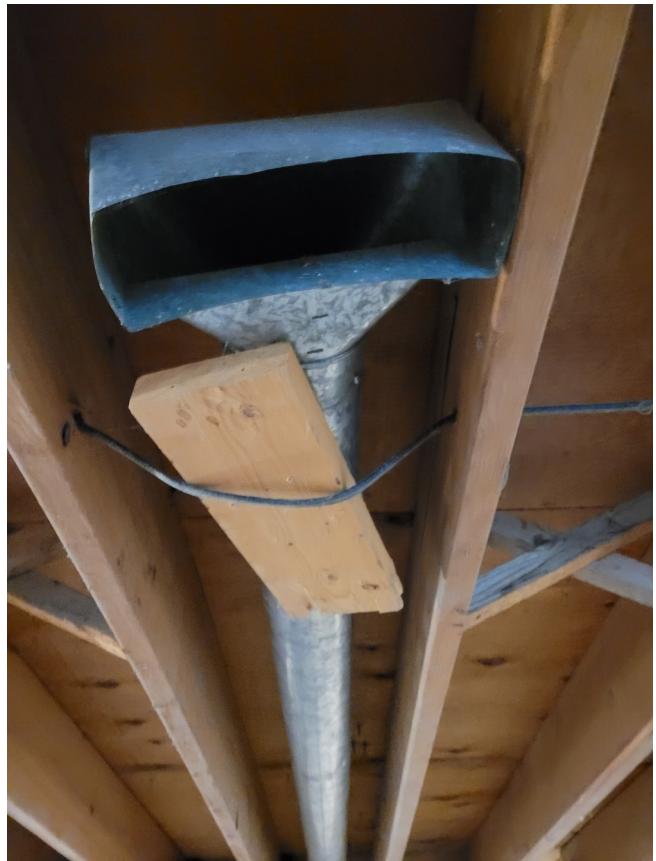
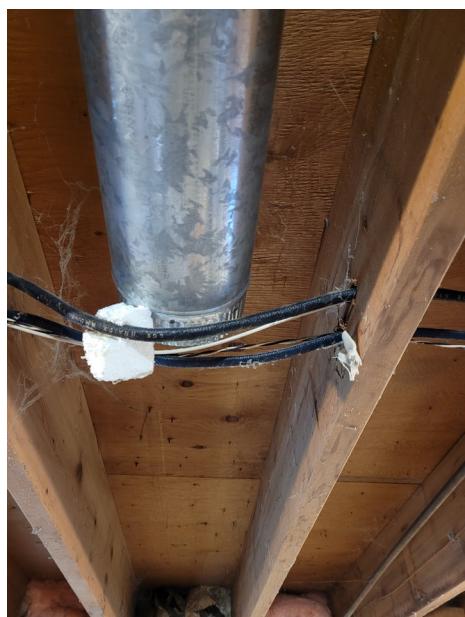
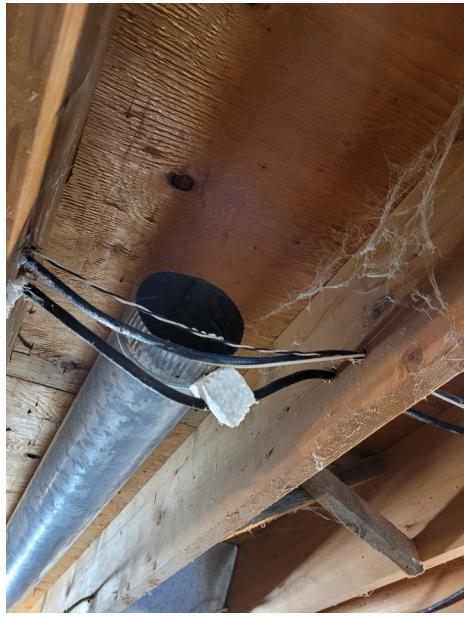
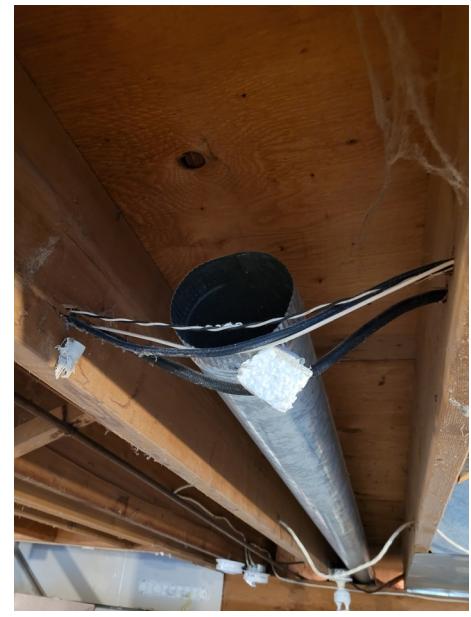
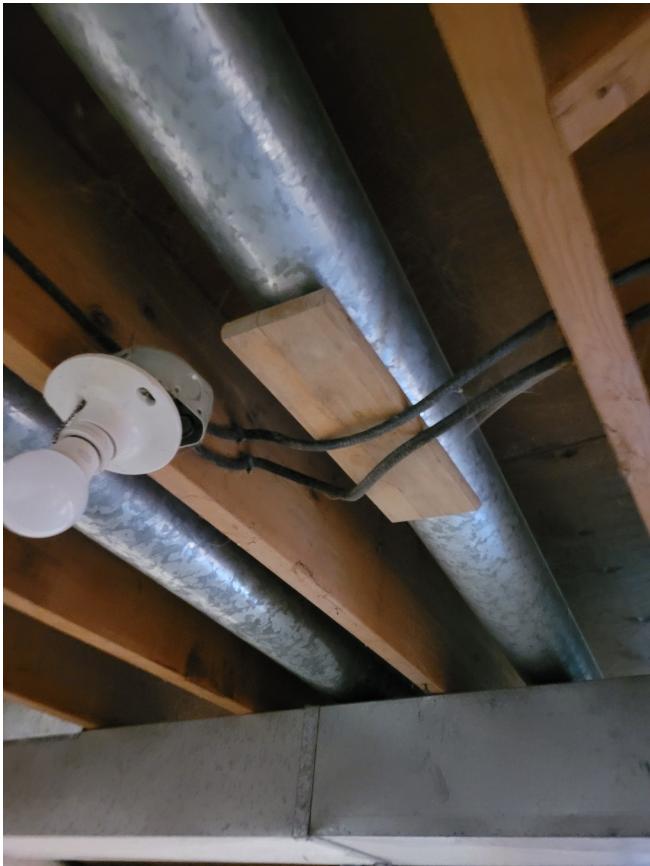
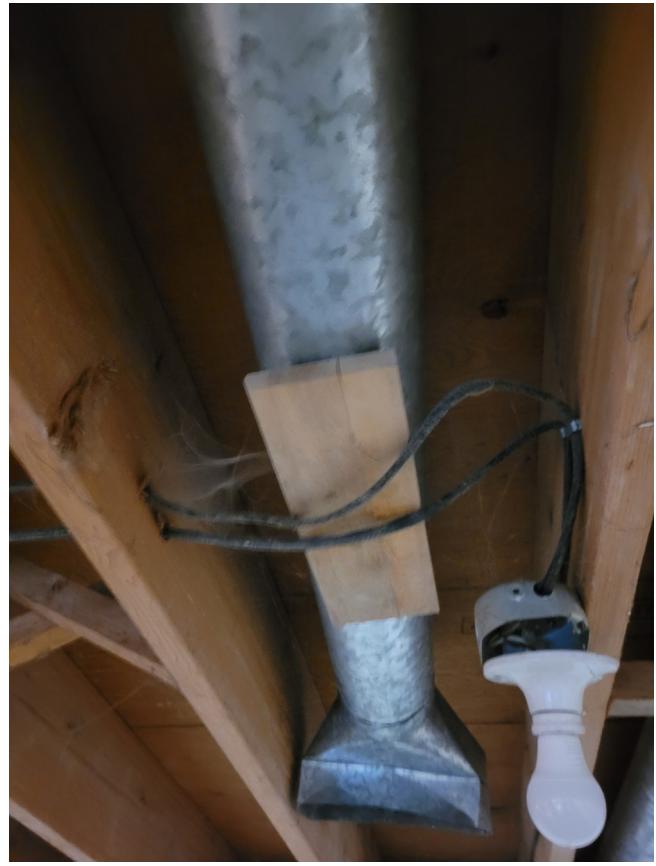
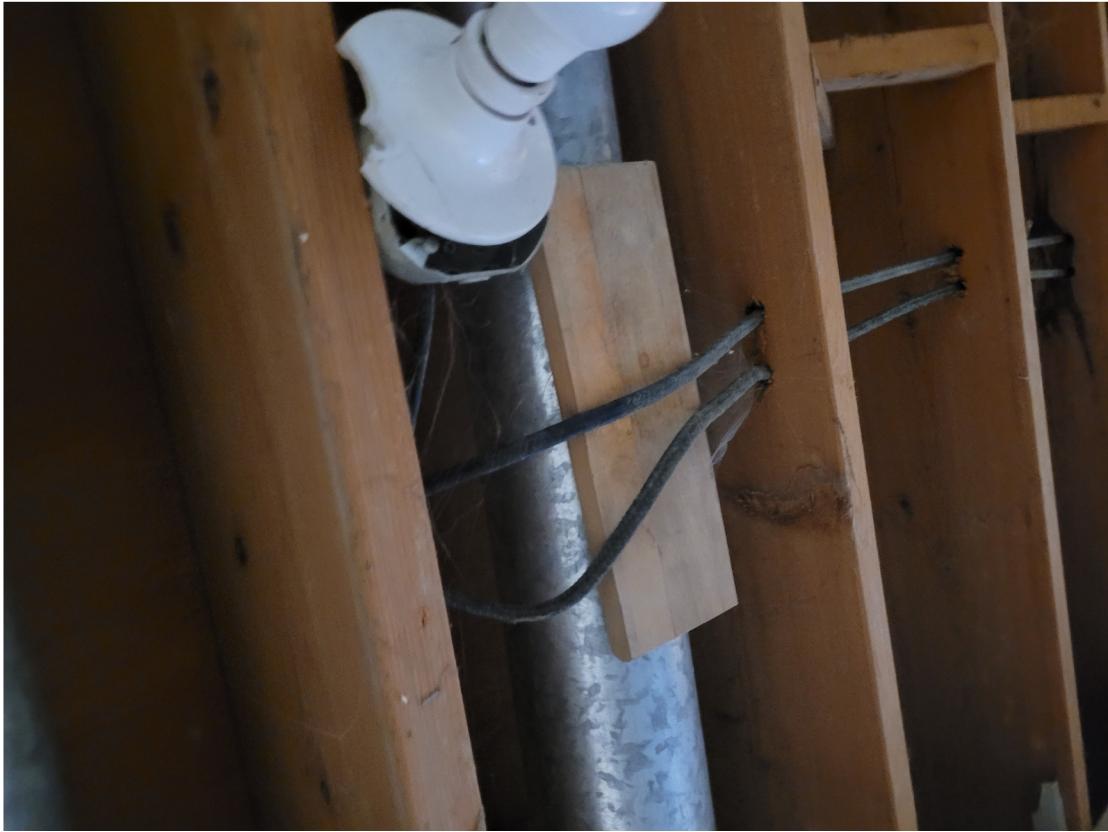
Violation #3: Electrical Wiring Supporting Duct Work

Supporting a **heavy or shifting HVAC duct** using an electrical cable is a **textbook example** of mechanical stress that could:

- Damage insulation
- Cause arcing, overheating, or fire
- Lead to failure over time

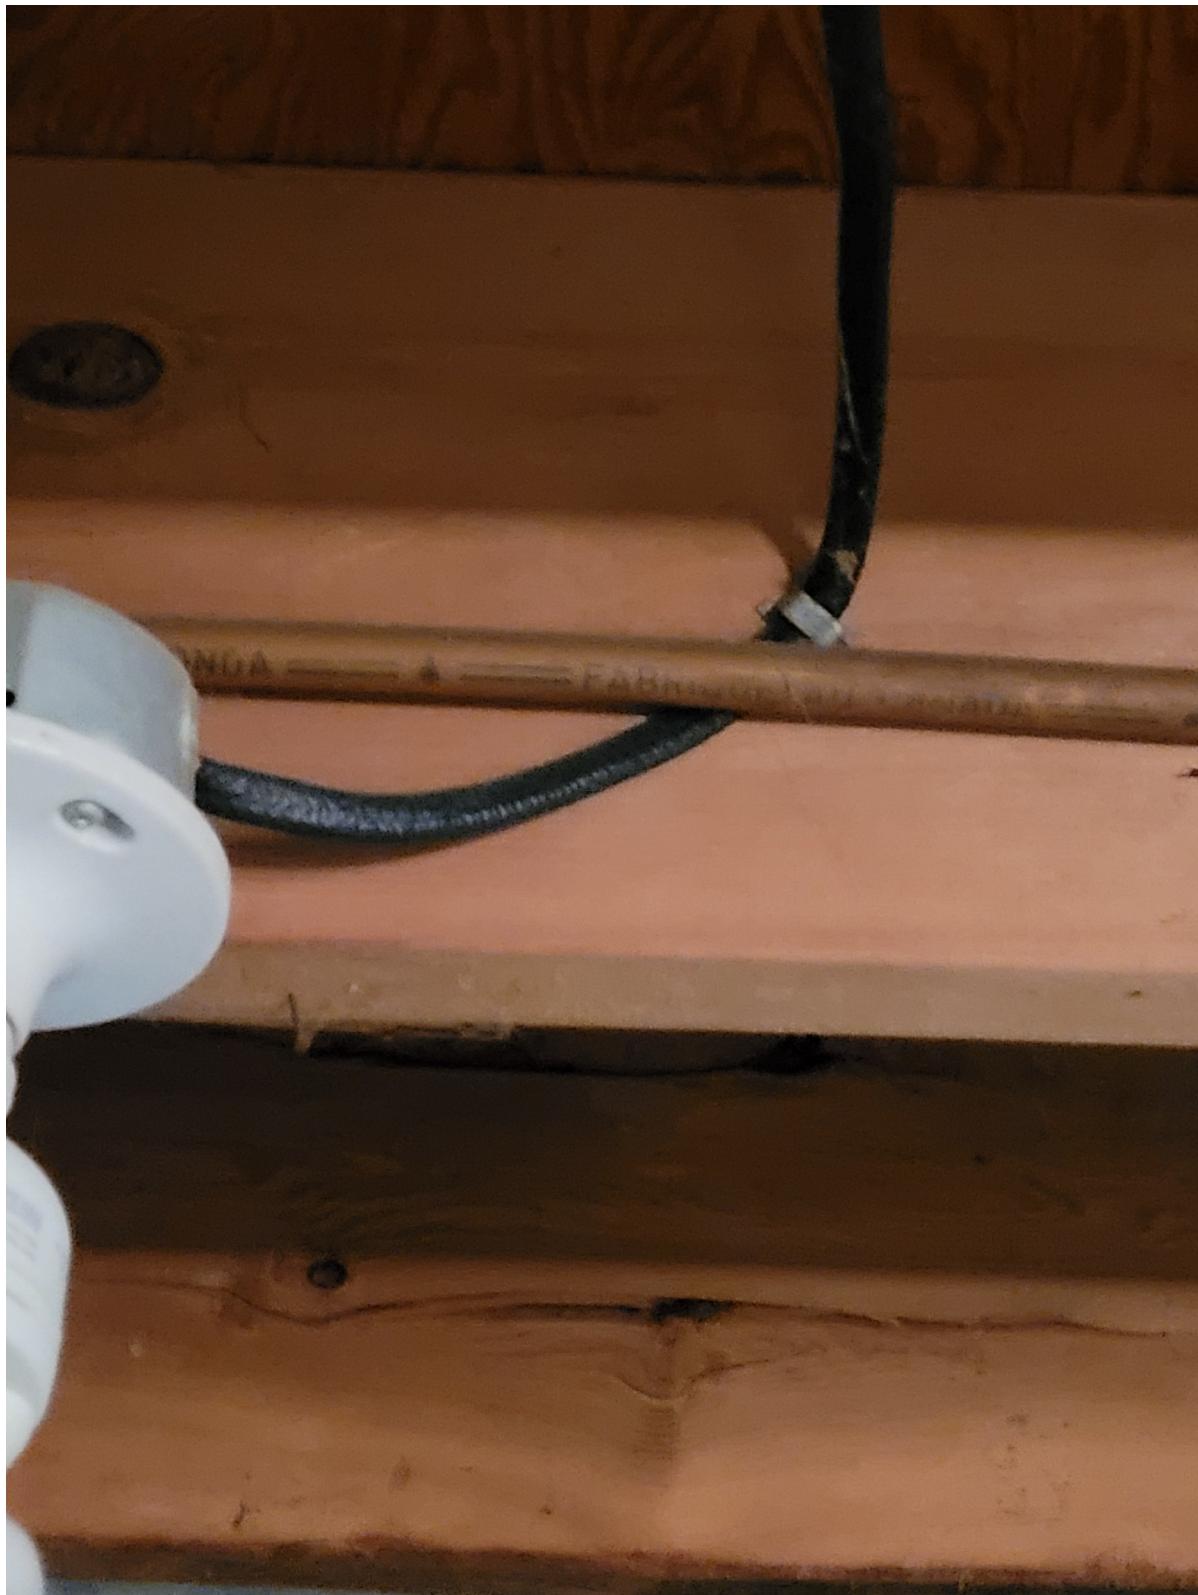
Figure 6a.

Violation #4: Pinched Electrical Wiring

Pinching wires between wooden structures or near copper plumbing is not “adequate protection”—it increases the chance of:

- Abrasion of insulation
 - Arc faults or ground faults
 - Electrocution or fire if wire insulation fails near plumbing (especially copper, which is conductive)
-

If a wire is **wedged between wood framing and a duct or plumbing line**, that's a **code violation** unless protected by **a raceway or shielding**.

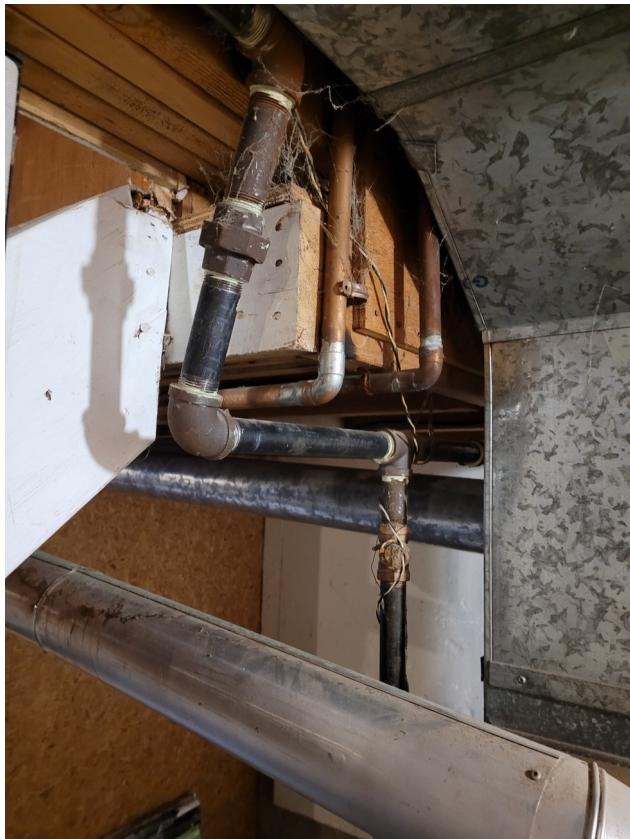
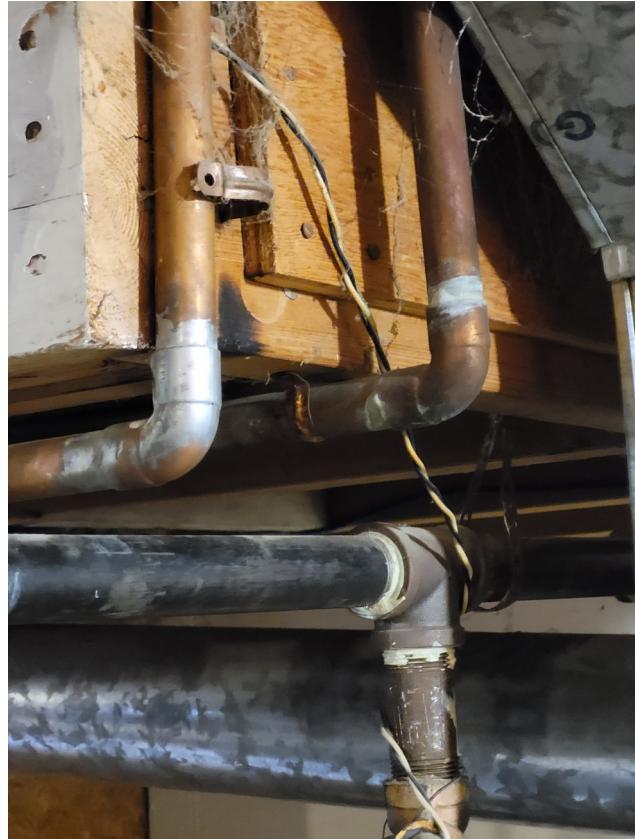
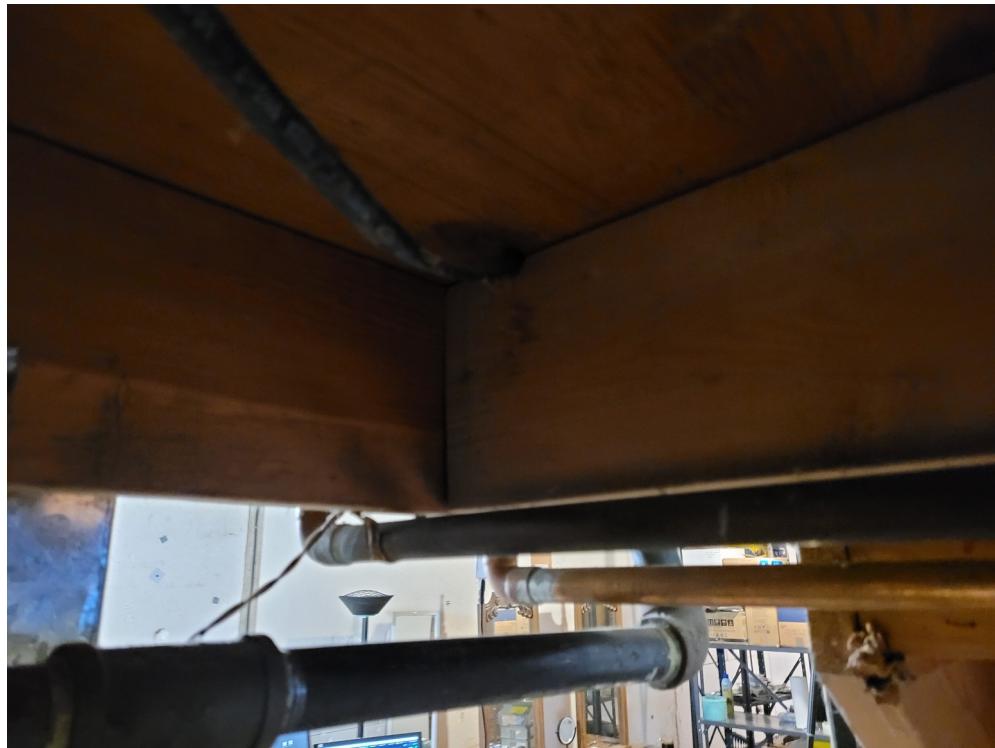
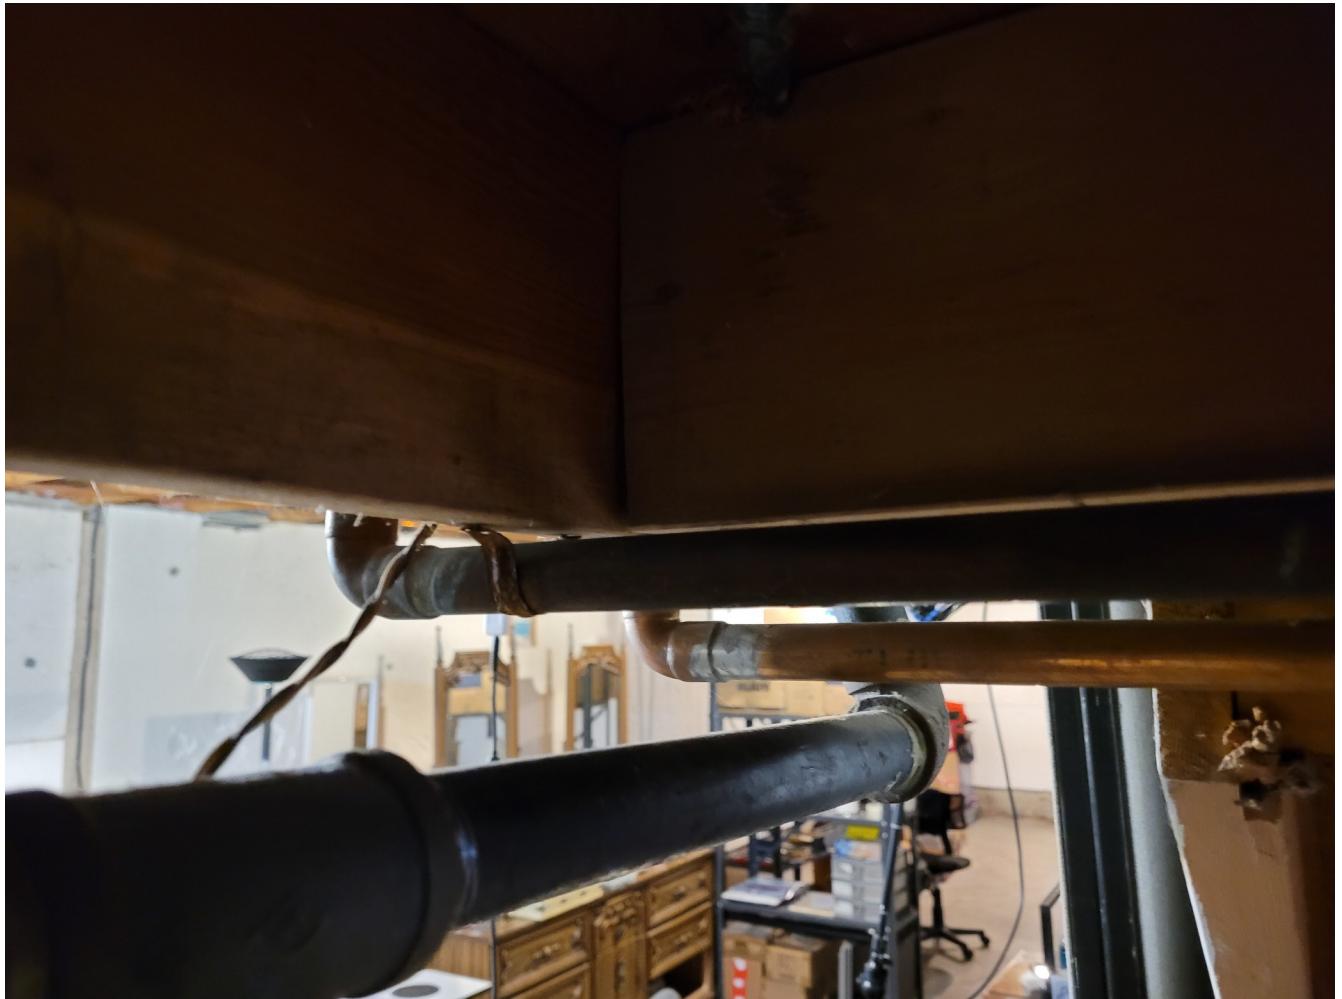
Violation #5: Plumbing Underneath Floating Entranceway

A plywood board is **not** a legal support for a primary exterior entry platform corner. This is textbook **deficient construction**.

Bolting **active plumbing pipes under the weakest load point** is not just irresponsible—it's **sabotage-level stupid**.

- **Burst the pipes** if the deck fails.
- Cause **flooding, water damage, mold, or sewage contamination**.
- Risk **personal injury** from collapse or slipping on water damage.

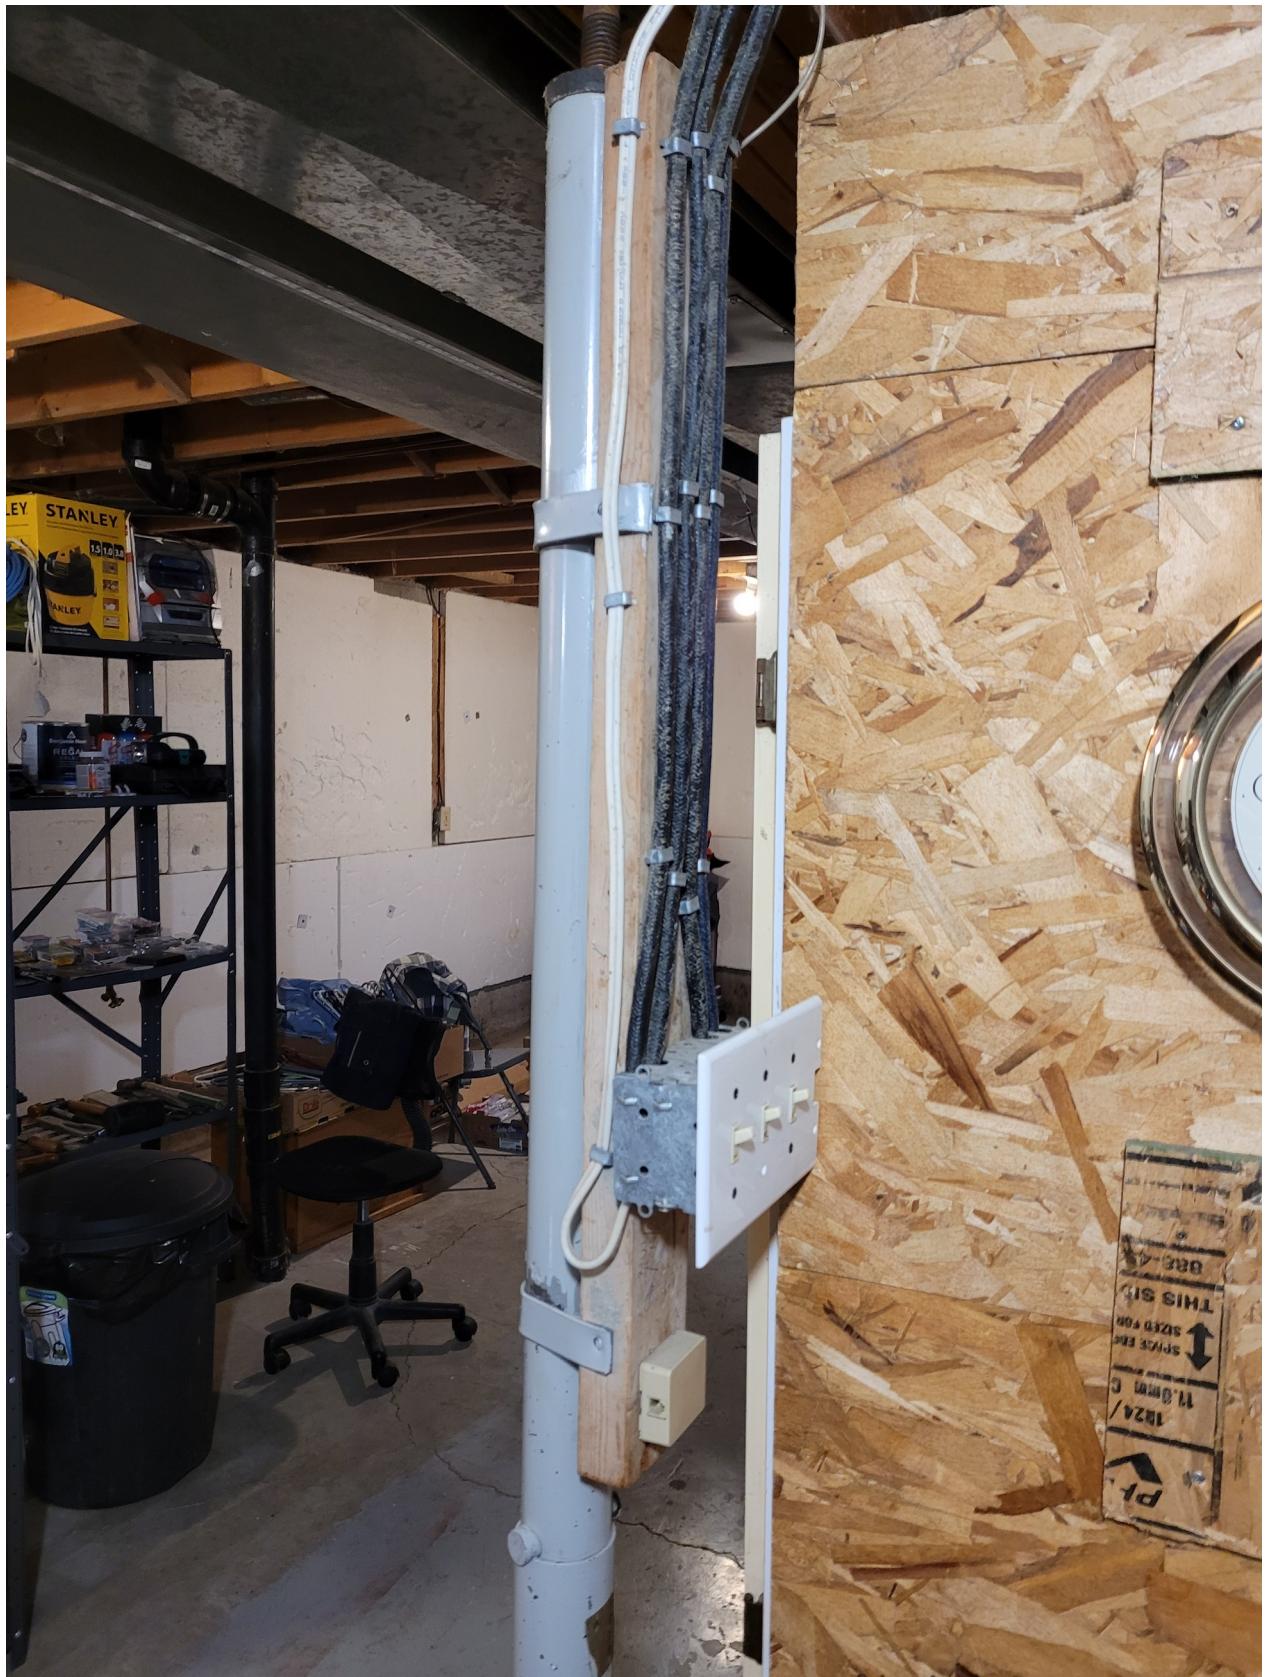
Figure 8a.

Violation #6: Floating Electrical Switch Panel

That switch box is **not allowed to just float** on the pole. If it spins, twists, or flexes, it:

- Puts strain on the wires
 - Risks **loose terminals, arcing, and shock hazard**
 - Is an obvious **fire hazard**, especially in damp or cluttered basement conditions
-

- **Shock risk** if it shorts
- **Trip hazard** if the wall shifts and someone lunges to turn it off
- **Fire risk** if the loose connections arc inside the box

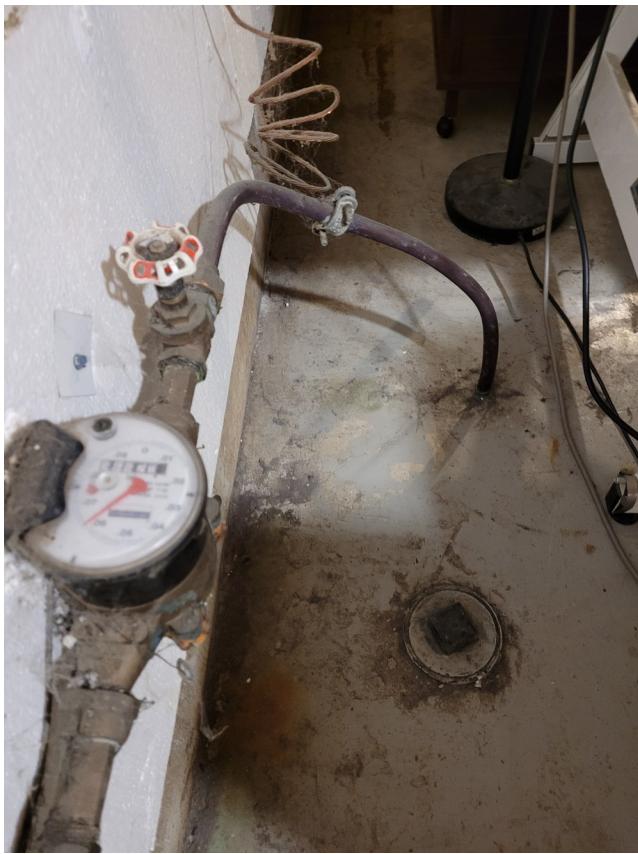
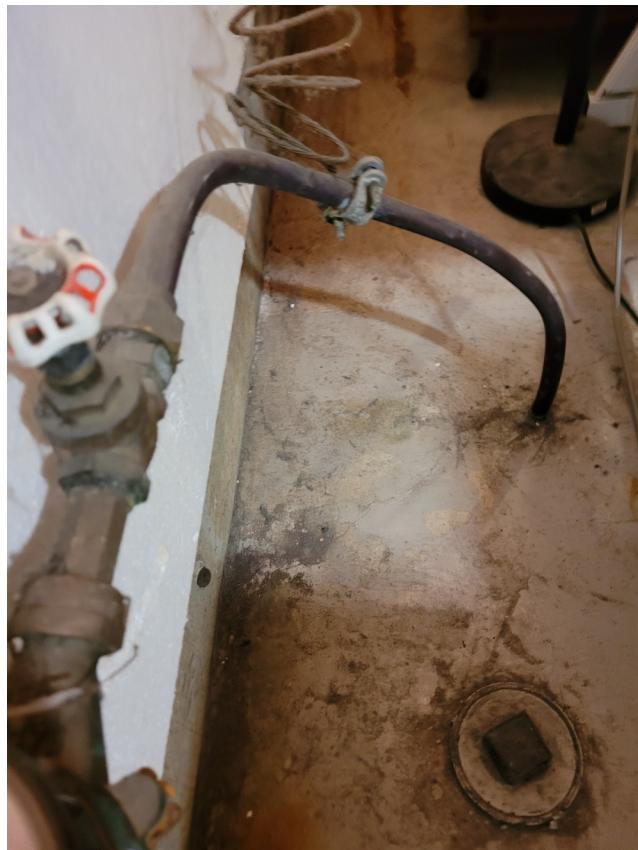
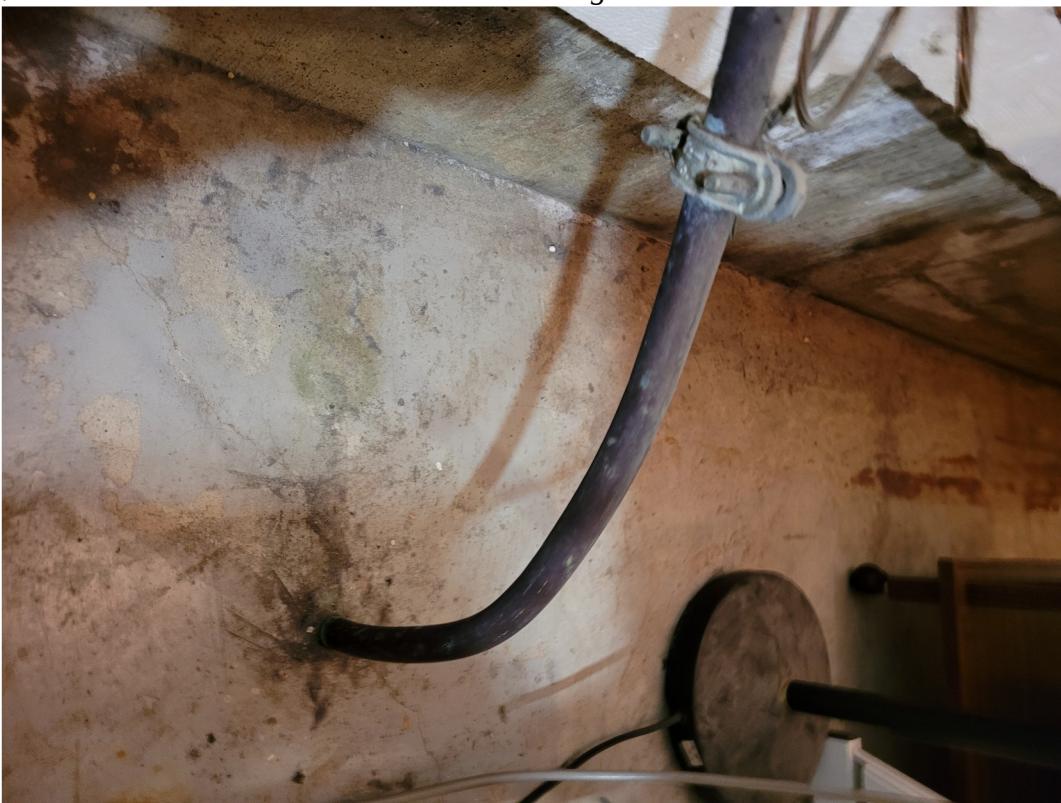
Violation #7: Unprotected Water Service Line

- If that pipe is **hit**, it can:
 - **Shear off at the base** where it enters the concrete.
 - **Release full city water pressure** into your basement.
 - **Flood the unit within seconds**—and the only shutoff is at the **city main**.
- You'd need to:
 - Call the city's **24-hour emergency utility line**
 - Hope they can get a crew out before **your home is underwater**

This is an unacceptable tenant risk, and grounds for declaring the unit **unsafe for occupancy** under the **Residential Tenancies Act** sections 7 and 76, *and the Public Health Act – Unsafe Living Conditions*.

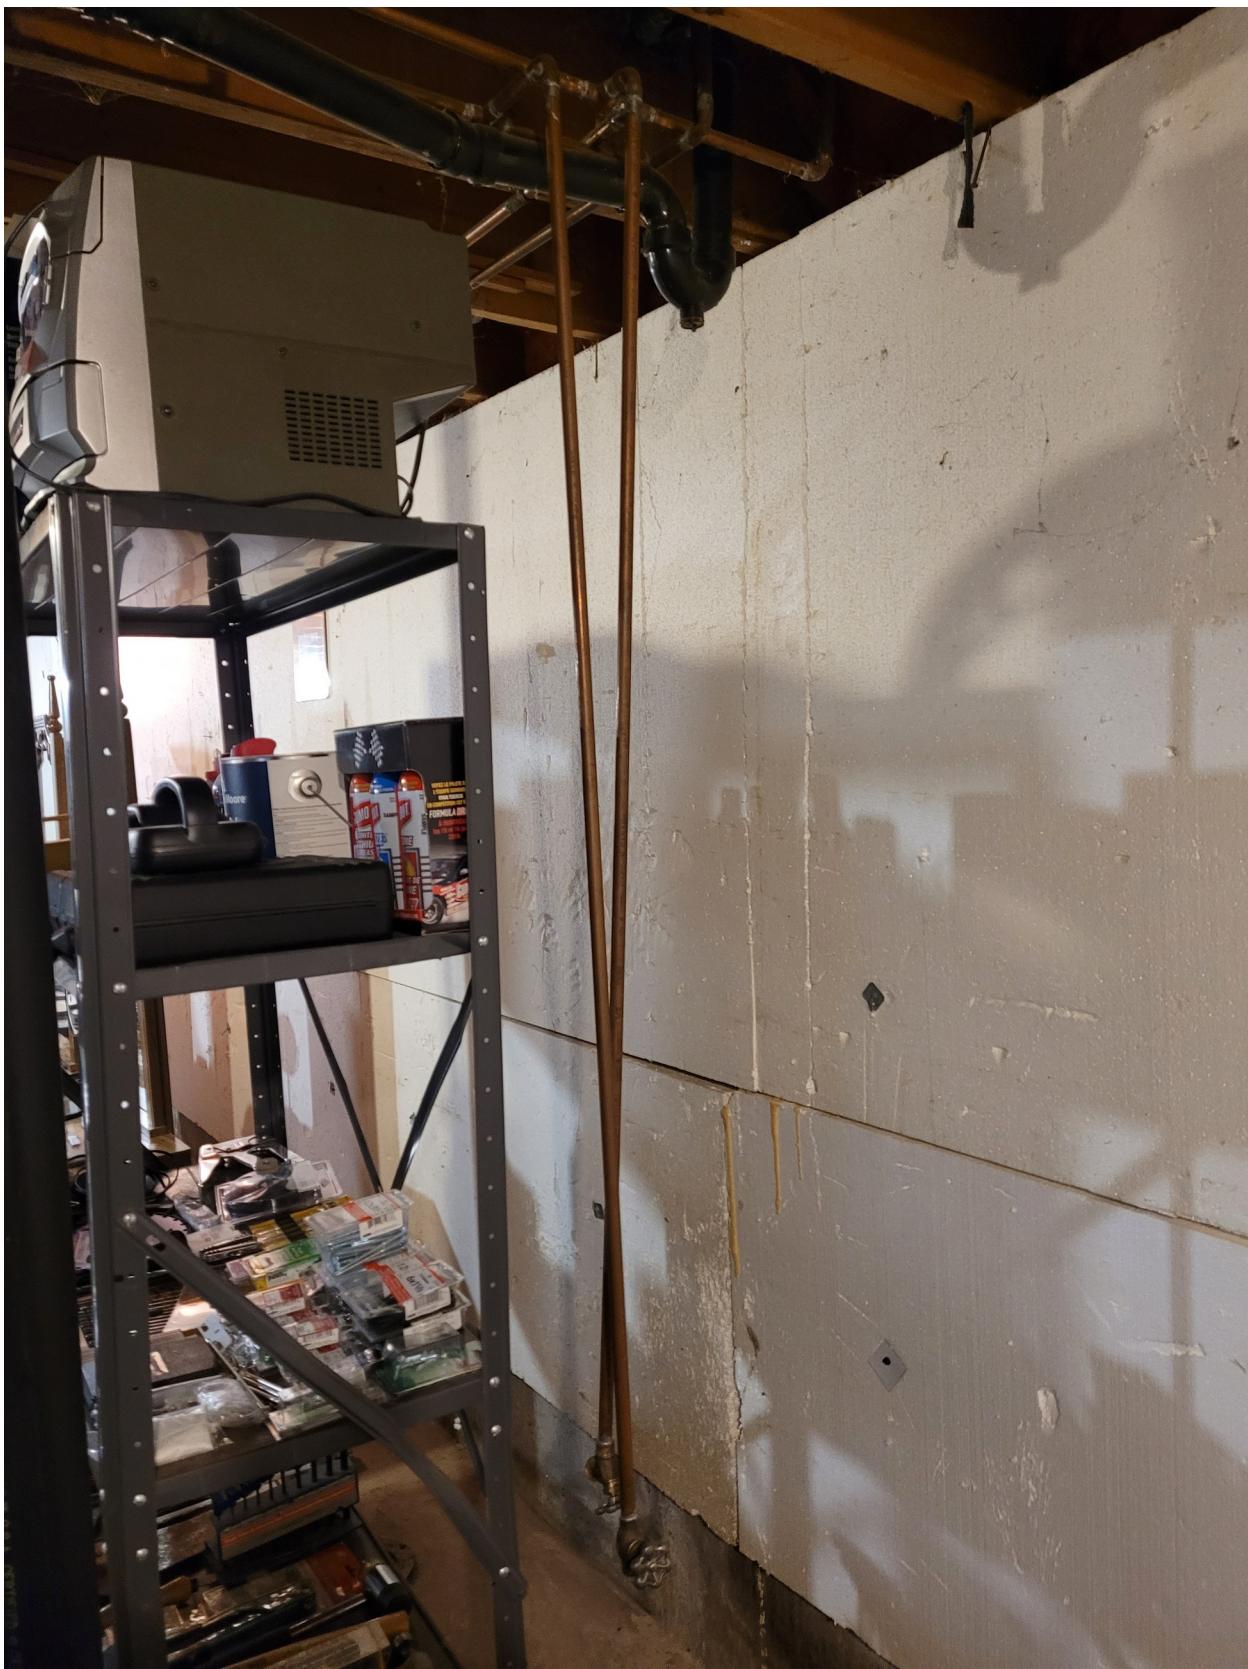
Figure 10a.

Violation #8: Long, Dangling Water Pipe Faucets

- A **jerk, twist, or trip** could **rip it out**, causing **pressurized water to spray**, potentially flooding the unit.
- The tenant could be blamed unless it's **formally documented** as a **known landlord hazard**.
- If hot water is involved, there's also a **burn/scalding risk** if it dislodges or fails.

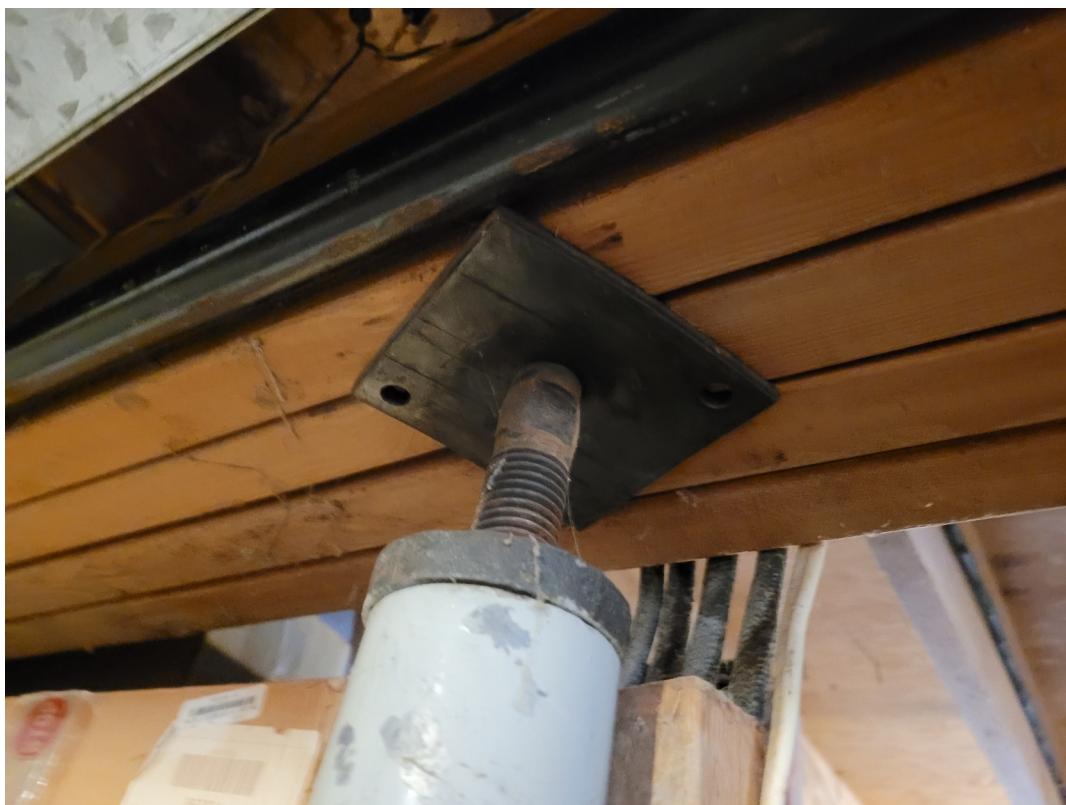
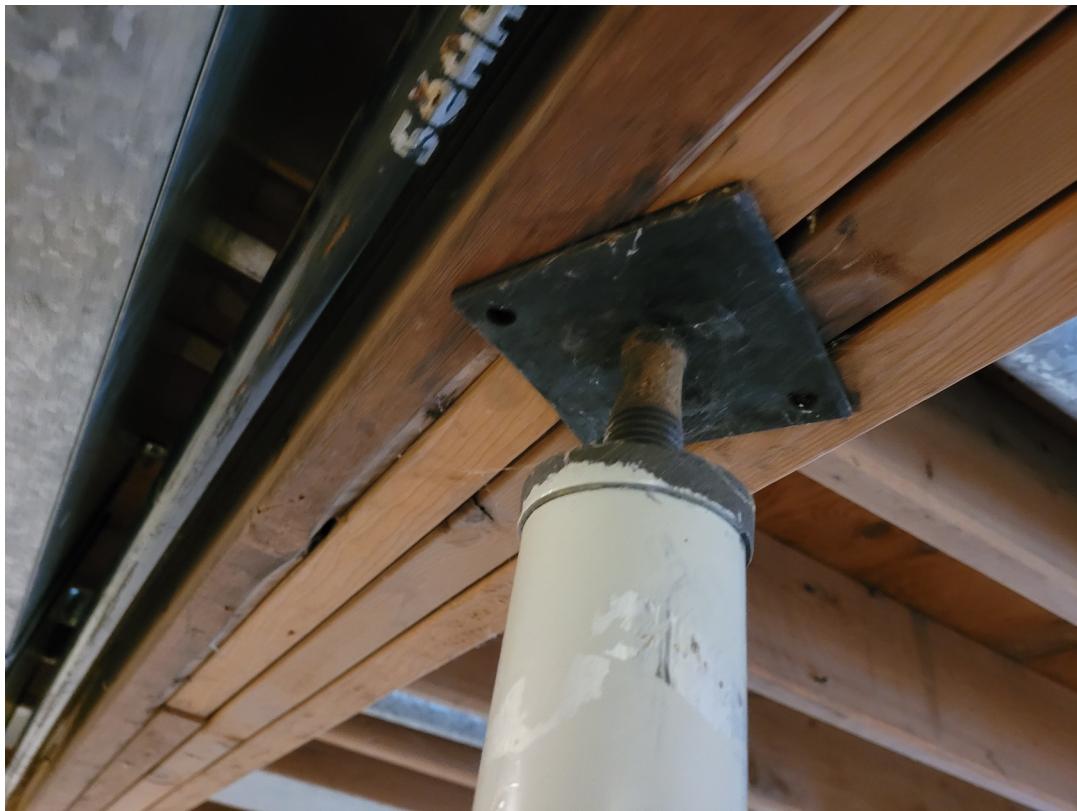
Violation #9: Support Pillars Not Anchored to Ceiling Joists

- Structural beam can slip **completely off the support** during vibration
- Load-bearing weight becomes unbalanced → wall cracking, floor sag, or **full collapse**
- If someone were to accidentally strike the pillar (e.g. moving a washer/dryer, carrying lumber), the **entire structural load path would fail**
- This is the kind of issue that, if discovered by an inspector, leads to an **immediate evacuation order**

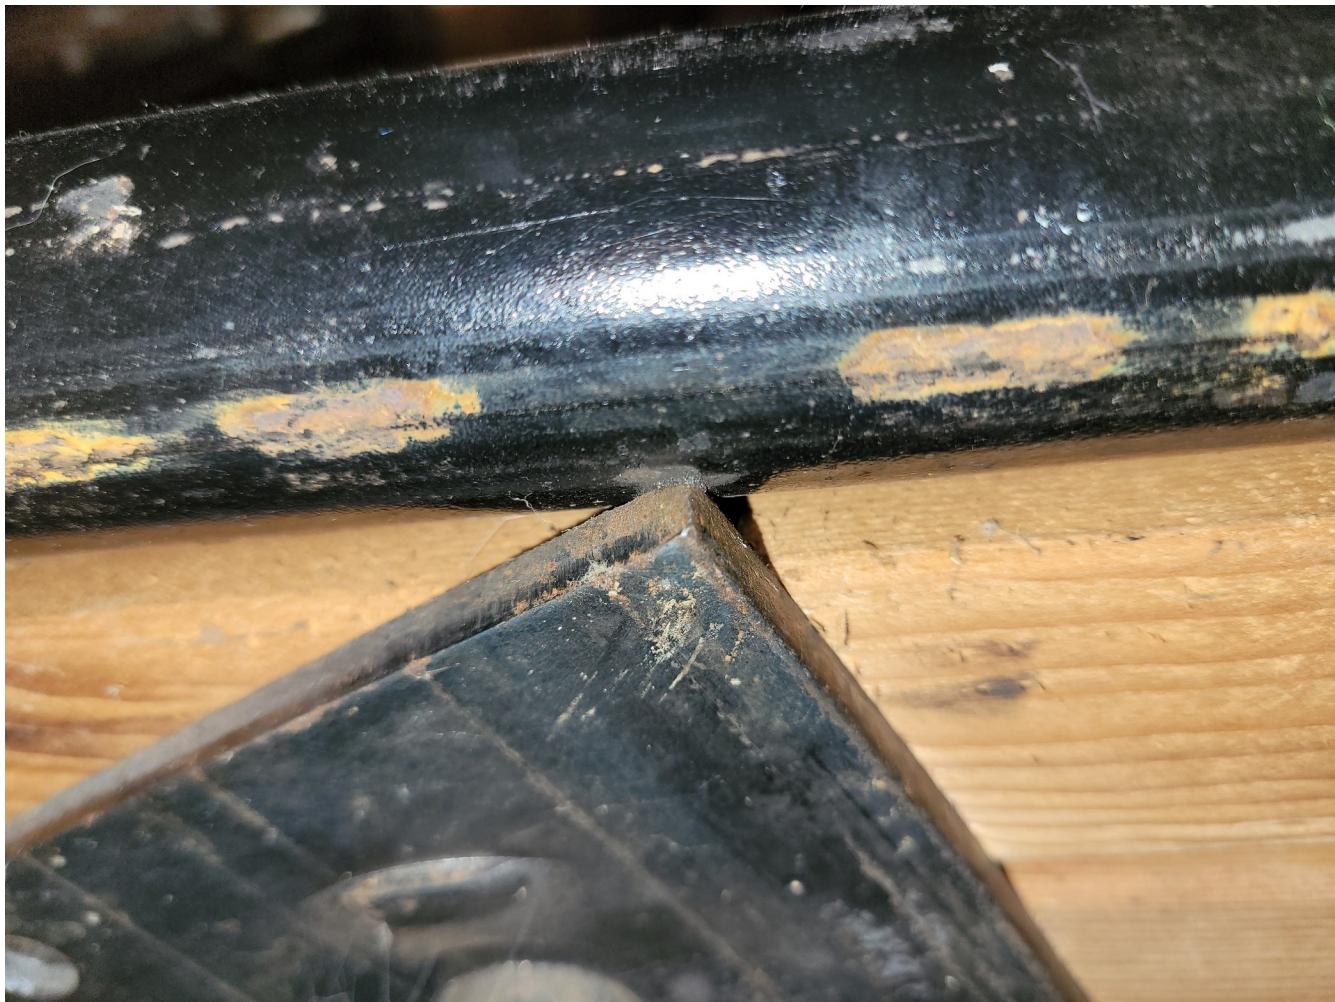
Figure 13a.

Violation #10: Jack Post Fastening Plate Striking Gas Line

- The post **isn't anchored** to the ceiling or beam
- Over time, it **drifted out of alignment**
- It is now **relying on the gas pipe to stop it from drifting further**

- The gas line is:
 - **Slightly lower than the beam**
 - Not intended to bear *any* force
 - Now a **collision buffer** for structural weight
