Tenant Safety Inspection Report
446 Hospital Street
Steinbach, MB
CANADA

June 25, 2025

Summary of Code Violations

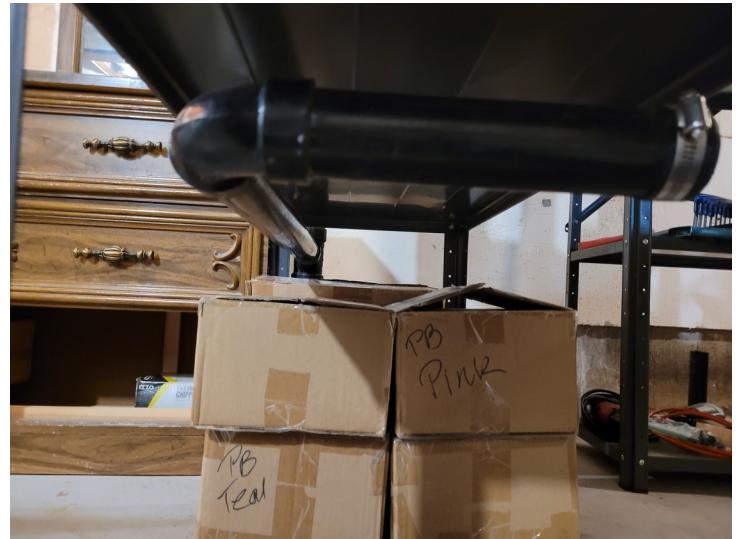
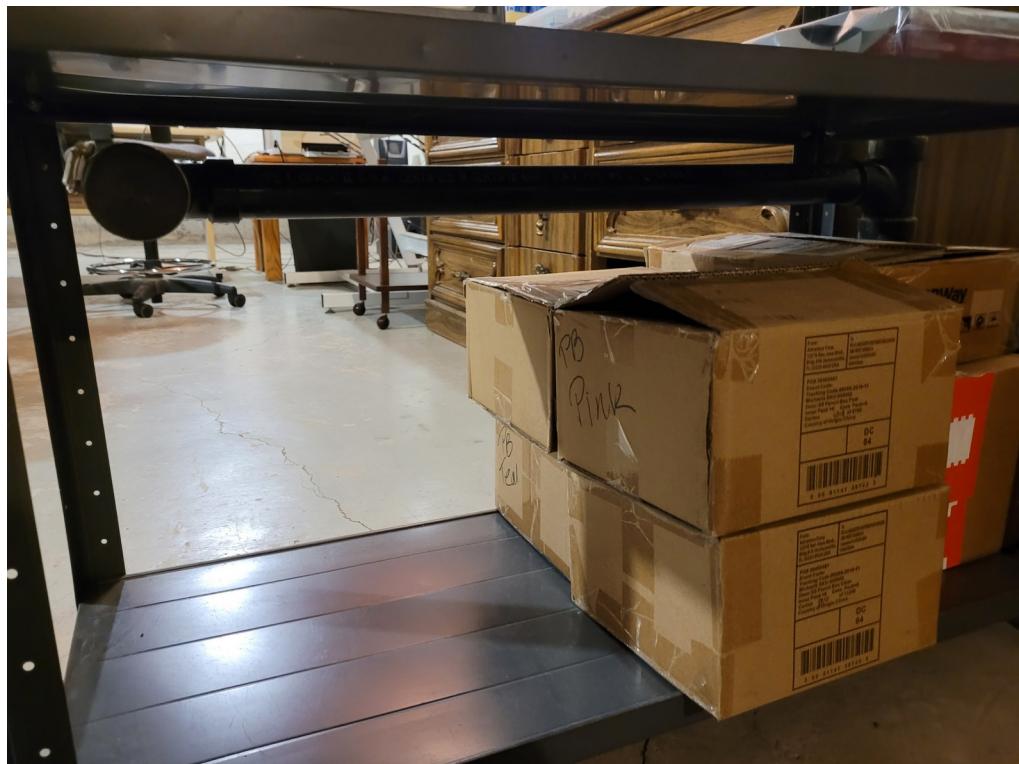
Violation #1: Floating Horizontal PVC Pipe

- A **horizontal PVC pipe**, 32 inches long
- Attached to what appears to be a **sewer vent relief stack** (which should be rigid and vertical)
- **Protruding unsupported** into living space
- **18 inches off the ground**, i.e., right at **ankle/shin level—prime tripping hazard**
- Entirely **unsupported at the free end**

Manitoba Plumbing Code / NPC Rule 2.2.10.6 — Pipe Support Requirements

"All piping shall be adequately supported to prevent movement, vibration, and mechanical damage."

This floating PVC is **100% non-compliant**.

A pipe connected to the **vent or drain system** cannot just hang in mid-air—especially not one that could:

- Detach from the vent stack
- **Leak sewer gases** into the home (if it's part of a DWV system)
- **Crack at the hub or elbow** from weight

Rule 2.4.6.2 — Vent Pipes Shall Be Rigid and Protected

Vent pipes must maintain alignment, not sag, and must not be installed in a way that allows movement or disconnection under normal household traffic.

While an **unsupported PVC pipe** is not as catastrophic as other violations, this hazard still creates:

- **Trip & fall risk** (especially if lighting is poor)
- **Chance of joint failure**
- **Potential gas leak** from sewer

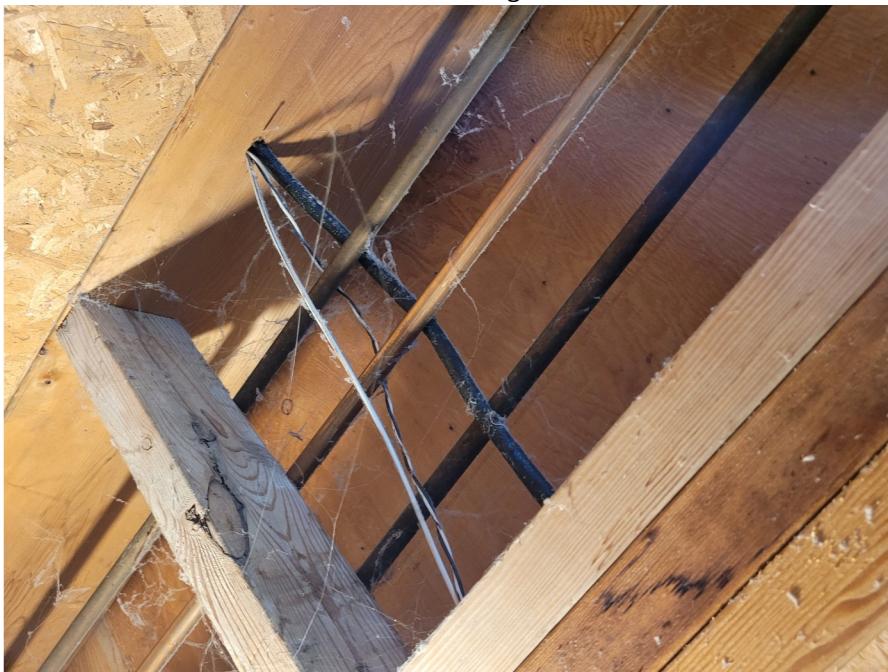
Violation #2: Electrical Wiring Weaved to Plumbing Work

CEC Rule 12-518 — Location of Conductors Relative to Pipes

"Conductors shall not be installed in contact with heating ducts, hot water or steam pipes, or other piping systems likely to cause damage to the insulation, unless suitable protection is provided."

CEC Rule 12-514 — Wires Shall Not Support or Be Entangled With Other Systems

"Cables... shall not be used to support other objects."

Even weaving wires between **perpendicular plumbing runs** puts strain and risk of movement/vibration, especially if plumbing shifts due to temperature or water hammer. This creates:

- Chafing on insulation
 - Hidden **electrocution risks**
 - High fire hazard
-

CEC Rule 12-516 — Minimum Separation Required

"A minimum **25 mm (1 inch)** separation must be maintained between electrical conductors and plumbing, unless separated by a physical barrier."

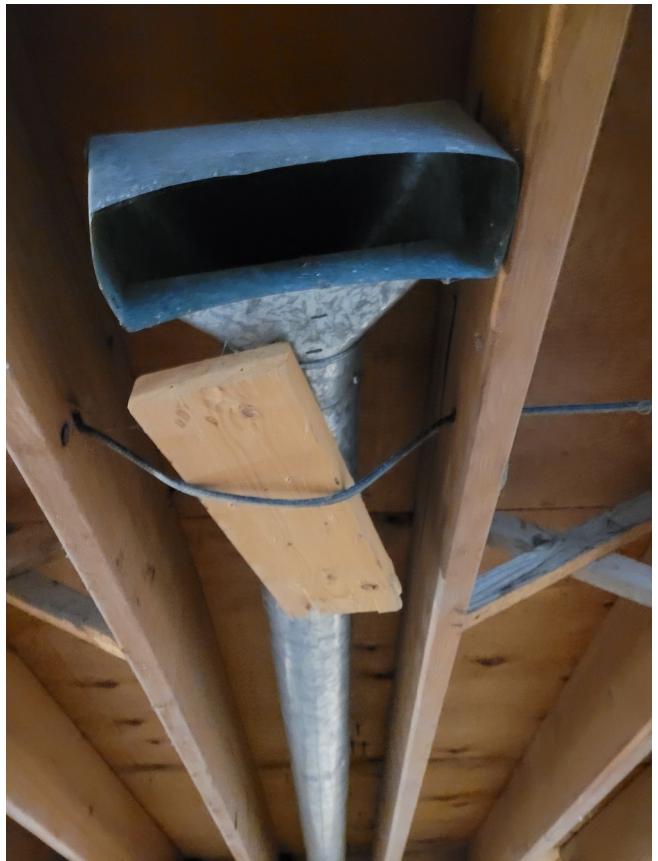
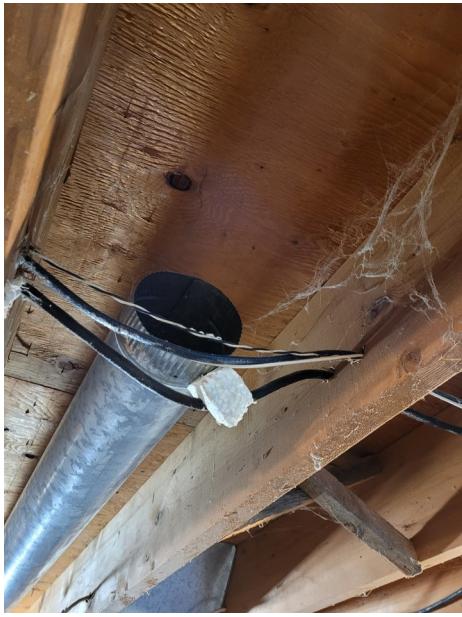
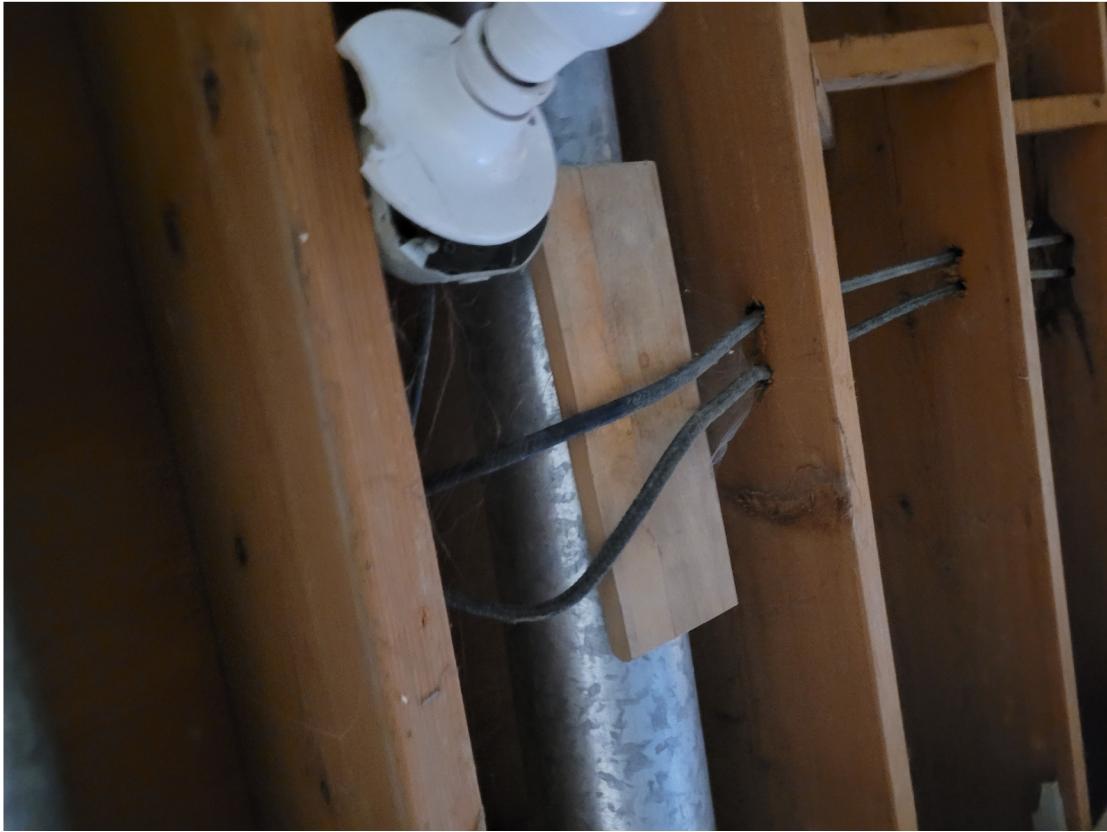
Violation #3: Electrical Wiring Supporting Duct Work

CEC Rule 12-514 — Support of Conductors

"Cables and raceways shall be supported in such a manner that they will not be damaged, and shall not be used to support other objects."

This rule is **clear and direct**:

- Electrical wires **must be supported properly** (e.g., with staples, straps, hangers—not improvised).
 - **You cannot hang other systems**, such as **ductwork**, plumbing, or building materials, **on electrical wiring**.
-

CEC Rule 12-510 — Mechanical Protection

"Cables shall be protected against mechanical damage."

Supporting a **heavy or shifting HVAC duct** using an electrical cable is a **textbook example** of mechanical stress that could:

- Damage insulation
- Cause arcing, overheating, or fire
- Lead to failure over time

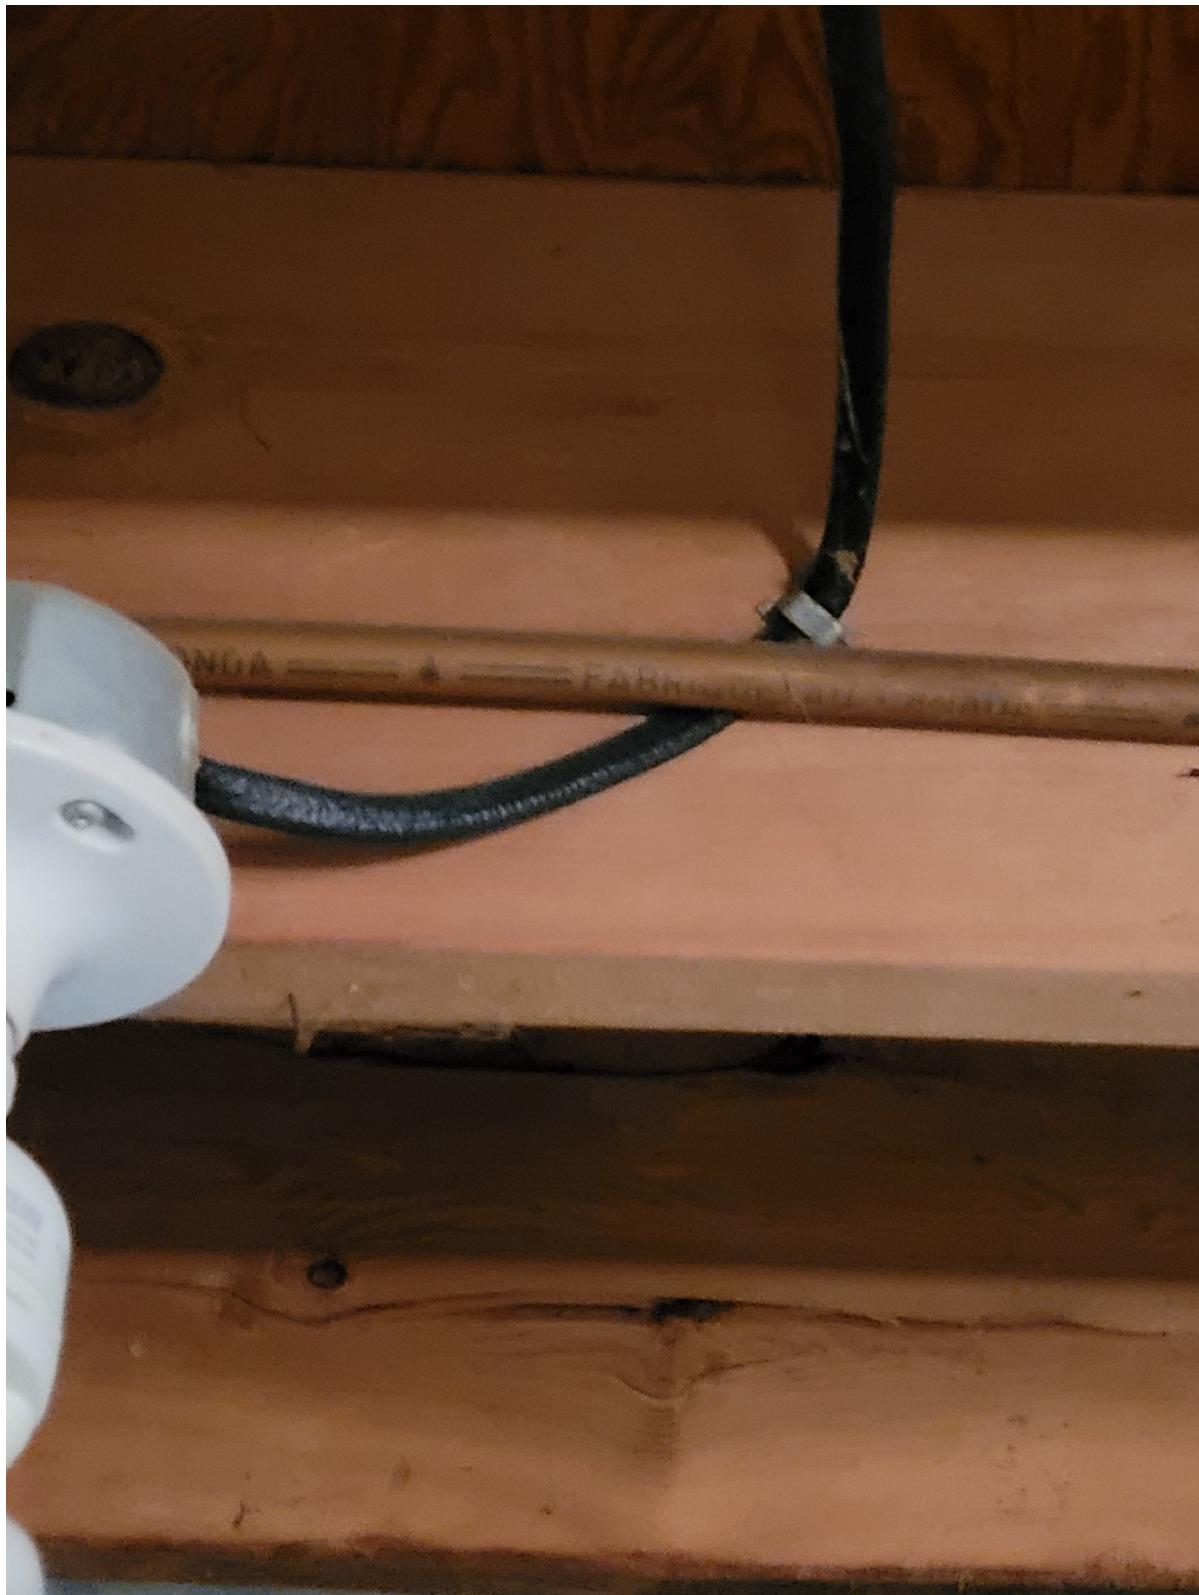
Violation #4: Pinched Electrical Wiring

CEC Rule 12-510 — Protection from Physical Damage

"Where there is a possibility of mechanical injury to a cable or conductor, it shall be adequately protected against such injury."

Pinching wires between wooden structures or near copper plumbing is not “adequate protection”—it increases the chance of:

- Abrasion of insulation
 - Arc faults or ground faults
 - Electrocution or fire if wire insulation fails near plumbing (especially copper, which is conductive)
-

- Cables must be **securely supported** and **not under strain** or **pinched**.
- Cables **must not be routed in a way that can damage the sheath** or insulation.

If a wire is **wedged between wood framing and a duct or plumbing line**, that's a **code violation** unless protected by **a raceway or shielding**.

CEC Rule 12-516 — Minimum Separation from Other Services

"Electrical conductors shall be separated by at least 25 mm (1 inch) from plumbing, gas lines, and other services unless properly protected or separated by a barrier."

Routing wires tightly against **copper plumbing** violates this rule unless:

- There's **mechanical protection**, like conduit or grommets.
 - There's a **minimum spacing**, and no pressure or contact that could damage insulation.
-

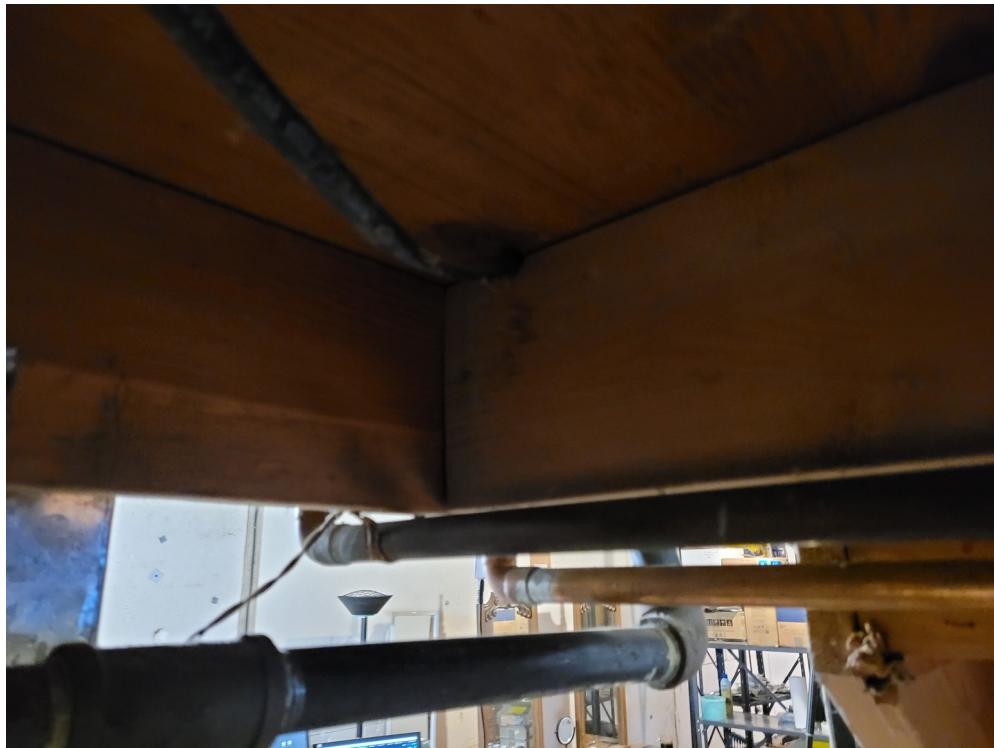
Violation #5: Plumbing Underneath Floating Entranceway

- All load-bearing structures must have **continuous vertical support to footings** or be properly cantilevered with **engineered load paths**.
- **NBC 9.23.10.1 & 9.23.10.4** – improper beam support & load transfer.

A plywood board is **not** a legal support for a primary exterior entry platform corner. This is textbook **deficient construction**.

Bolting **active plumbing pipes under the weakest load point** is not just irresponsible—it's **sabotage-level stupid**.

This could:

- **Burst the pipes** if the deck fails.
- Cause **flooding, water damage, mold, or sewage contamination**.
- Risk **personal injury** from collapse or slipping on water damage.

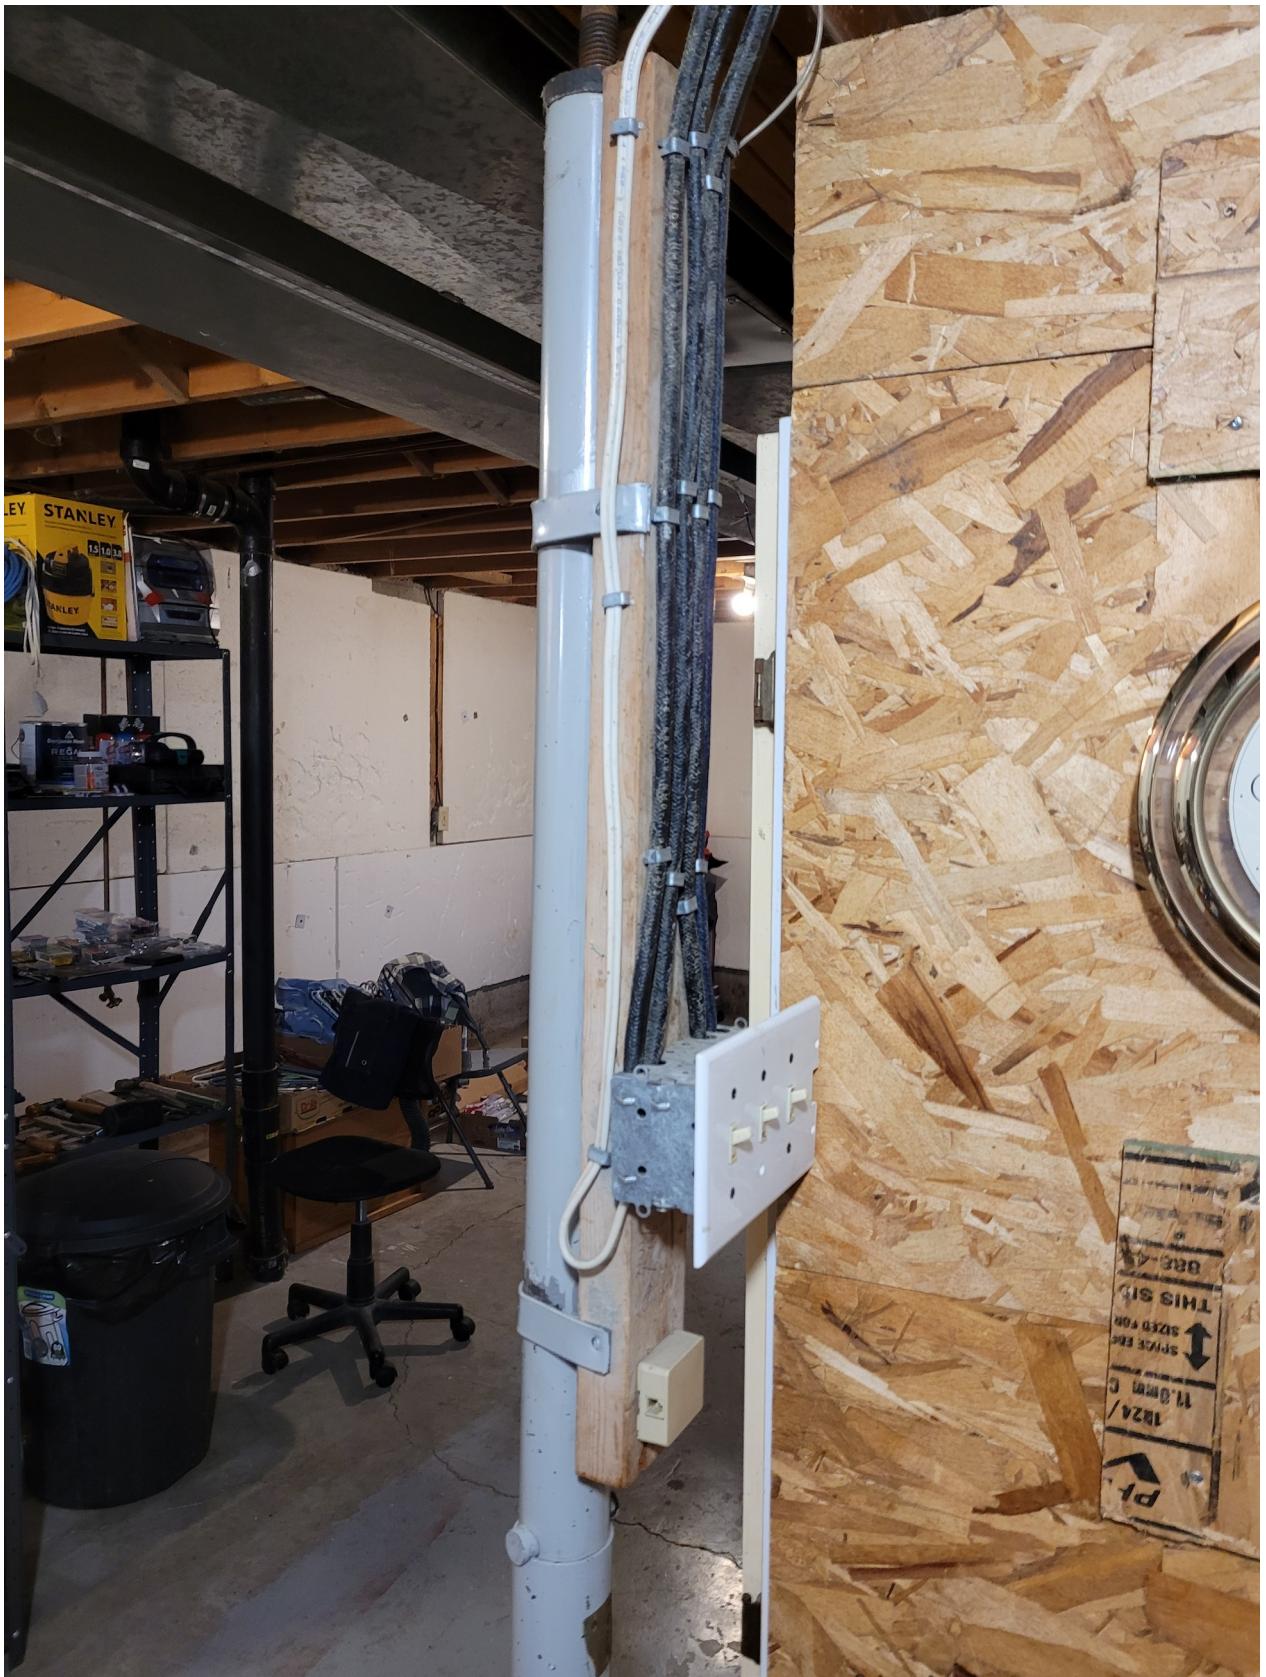
Violation #6: Floating Electrical Switch Panel

CEC Rule 12-3016 — Boxes and Fittings Shall Be Securely Fastened

“Boxes shall be securely fastened in place and supported independently of the conduit or cable connection.”

That switch box is **not allowed to just float** on the pole. If it spins, twists, or flexes, it:

- Puts strain on the wires
 - Risks **loose terminals, arcing, and shock hazard**
 - Is an obvious **fire hazard**, especially in damp or cluttered basement conditions
-

CEC Rule 12-3034 — Switches Must Be Mounted Securely and Accessibly

“A switch shall be mounted on a suitable support so as to be stable and accessible.”

- **Shock risk** if it shorts
- **Trip hazard** if the wall shifts and someone lunges to turn it off
- **Fire risk** if the loose connections arc inside the box

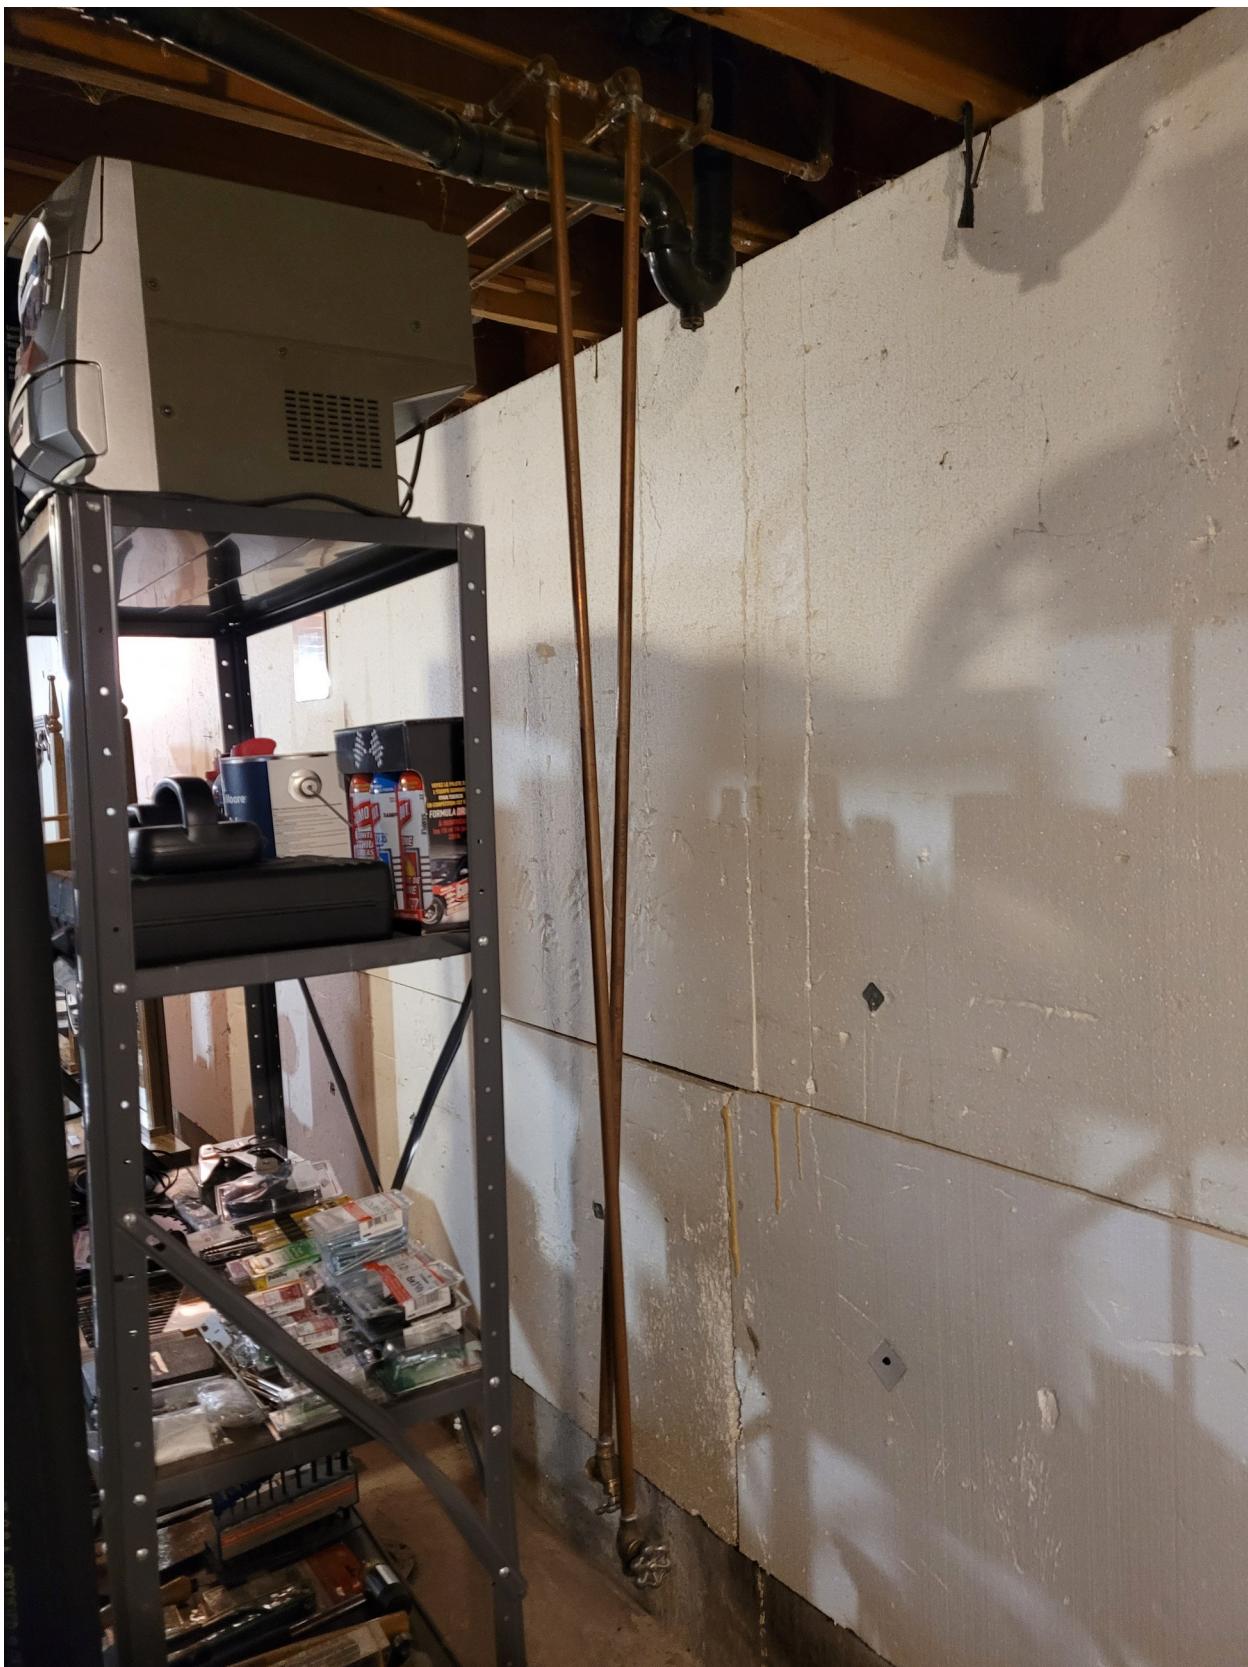
Violation #8: Long, Dangling Water Pipe Faucets

Rule 2.2.10.6 — Support of Piping:

“Every pipe shall be securely supported with appropriate hangers or supports at intervals that prevent sagging, strain, or joint failure.”

Rule 2.3.3.1 — Water Distribution Support:

Water distribution pipes shall be supported so they do not move when valves are operated.

- A **jerk, twist, or trip** could **rip it out**, causing **pressurized water to spray**, potentially flooding the unit.
- The tenant could be blamed unless it's **formally documented** as a **known landlord hazard**.
- If hot water is involved, there's also a **burn/scalding risk** if it dislodges or fails.
