Inline Inspection- Finishing

Inspection #: 1528971, 1528972, 1528973,
 1528974, 1528975, 1528976, 1528977, 1528978,
 1528979, 1528980, 1528981, 1528982 | Group #:
 144087

Style	NOMB 03-01-49772-SP26	Color	ADMIRAL/ FLASHING RD [QTY : 1, 014], ADMIRAL/ FLASHING RD [QTY : 1, 687], ADMIRAL/ FLASHING RD

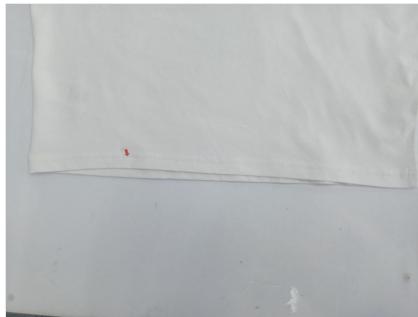
7-Pressing-Pressing: Poor (C-23)

Defect Severity	Quantity	Comment
Major	1

Poor Shape at Bottom hem

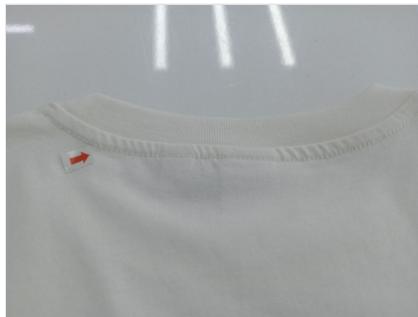
1-Seam-Seam puckering (E-1)

Defect Severity	Quantity	Comment
Major	1

Puckering at banding
