Baystate Roads Program Local Technical Assistance Program (LTAP) **Tech Notes**

Tech Note #34 -- 2004

Tack Coat

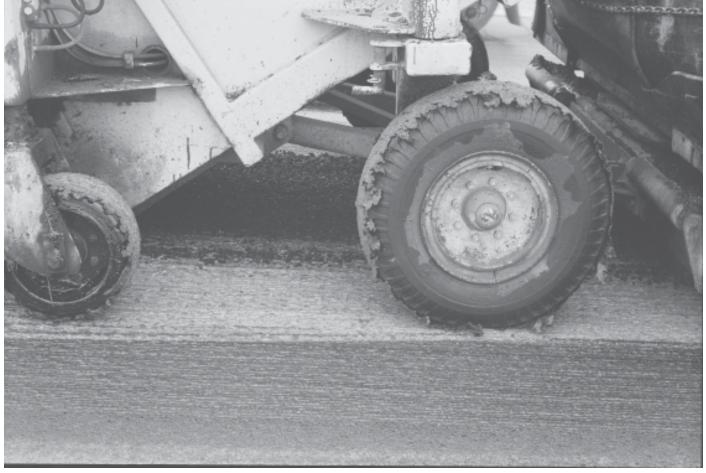
Image 3 - Material transfer device tracking.

can occur. Pick up is the term used to describe when the tires of the paving and delivery equipment pick up the tack coat. If the existing surface is not thoroughly cleaned, absorption into the surface does not occur (the excess fines on the roadway absorb the emulsion). In this case, the emulsion does not bond to the existing surface and when delivery or placement equipment is driven over the tack coat, the tack sticks to the equipment's tires instead of the roadway. Of course, tire pick up typically occurs in each of the wheelpaths, which is the most critical location for the new surface to bond to the existing surface (Images 2 and 3).

This problem happens more often with a milled surface because of the large amount of debris created during the milling process. Brooming the surface typically does not adequately remove the debris. A broom and vacuum system may be necessary to completely clean the roadway prior to the application of the tack coat.

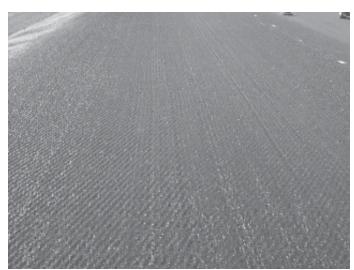
Image 9 - Proper coverage on a milled surface.

Image 9 shows a correct tack coat application. There is a uniform coverage with no excess tack, which will allow the emulsion to cure in the minimum amount of time and perform well over the intended period of time.
