# U.S. Department of Energy Office of Environmental Management

## Accident Investigation Report

**Phase 2  
Radiological Release Event at the  
Waste Isolation Pilot Plant,  
February 14, 2014**

**April 2015**

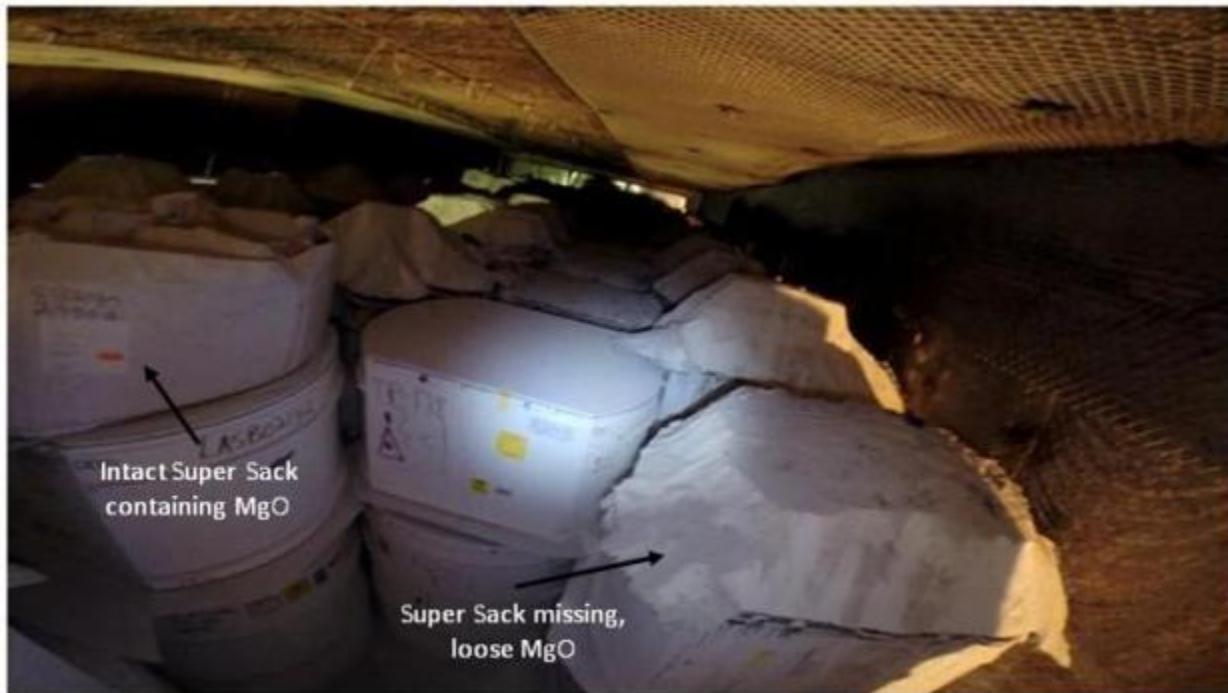
**Figure 2-2: Missing Super Sacks Leaving Loose Piles of MgO on Waste Stacks**

Photographic evidence of Panel 7 Room 7 from re-entries shows that 17 of the MgO super sacks were damaged. The super sack fabric and stiffener material (cardboard) was damaged or missing as illustrated in Figure 2-2, which allowed MgO to fall between waste stacks and left partial sloped piles of material on top of and between the waste stacks.

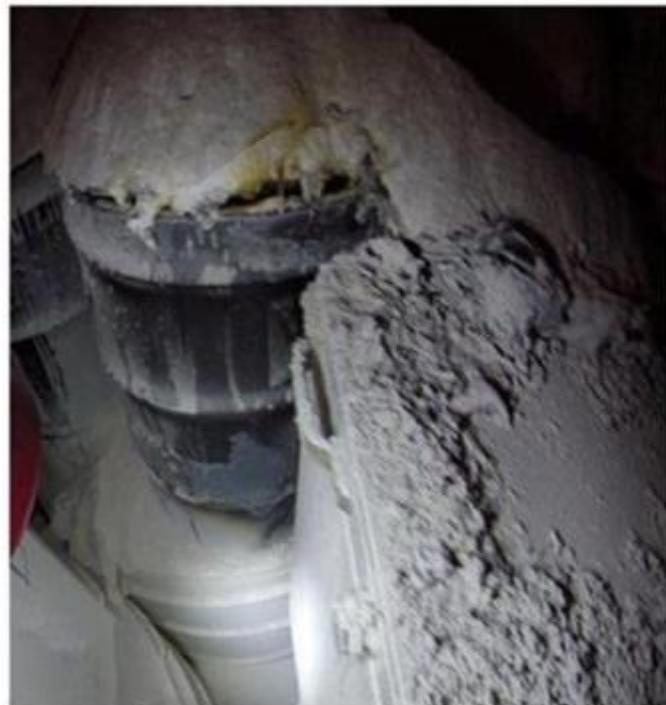
**Figure 2-3: Drum 68860 Lid Failure**

On February 19, 2014, CBFO requested that the LANL Carlsbad Office (LANL-CO) develop a list of potential source containers for the release. On February 20, 2014, LANL-CO provided the list based on a comparison of isotopic ratios calculated from the Waste Data System (WDS) radionuclide data for each emplaced container in Room 7 of Panel 7 and isotopic ratios calculated from data obtained from WIPP Station A air filter samples. The list included containers from an Idaho - Rocky Flats waste stream and several drums containing nitrate salts from LANL. Of note, the isotopic ratios for the LANL drums were later determined to be in error. Subsequently, on May 1, 2014, NWP declared a Potential Inadequacy in the Safety Analysis (PISA) regarding the potential for untreated nitrate salt bearing waste being emplaced which subsequently prompted LANL to declare a PISA as well. On May 15, 2014, photographic evidence confirmed that a LANL - LA-MIN02-V.001 waste stream container (68660) was in fact breached.

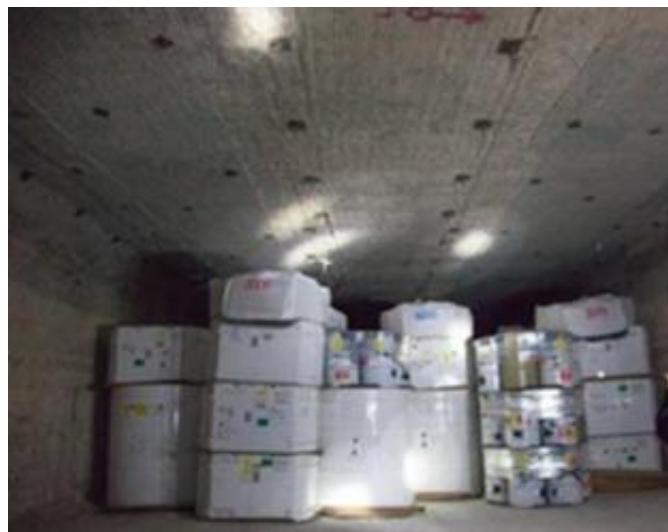
**Figure 2-5: Panel 7 Room 7 Waste Face**

On January 31, 2014, drum 68660 was emplaced at Panel 7 Room 7, Row 16, Column 4 (R16: C4) in the WIPP underground (Figure 2-5).

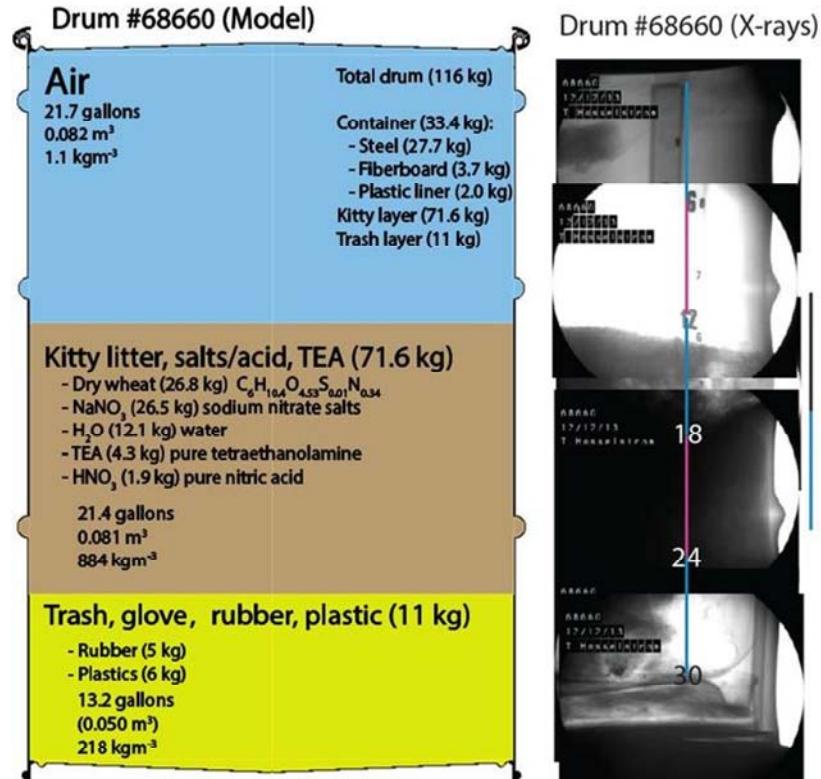
**Figure 5-1: Drum 68660 Model Contents**

On December 4, 2013, ES remediated parent drum S855793 in accordance with the glovebox procedure, producing daughter drums LA00000068660 (68660) and LA00000068685 (68685). Drum 68660 was repackaged by first adding some secondary waste including a tungsten-lined glovebox glove. Approximately two gallons of free liquid were decanted from the parent drum. The pH was measured and recorded to be 0 (zero). The pH was adjusted using KOLORSAFE® to an unspecified final pH. Swheat Scoop® organic kitty litter was added as the absorbent and was placed in the drum. Additional bags of nitrate salt were absorbed and placed in the drum. See Figure 5-1 for a drum contents model.

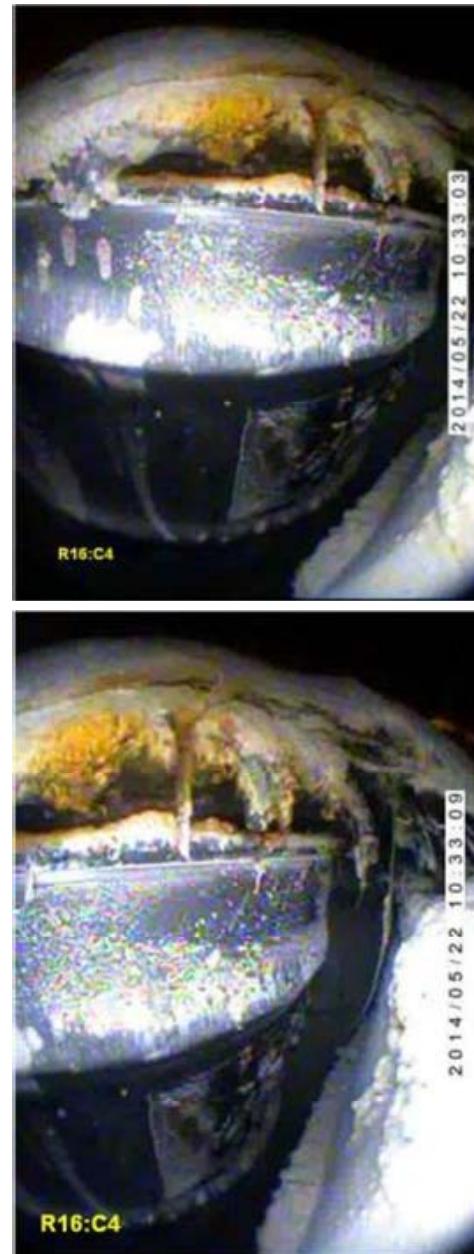
**Figure 6-1: Drum 68660**

The visual inspections found evidence of slight localized discoloration of the Panel 7 Room 7 south rib (wall) that was the result of fire exposure. There were no such discolorations of the north rib, back (overhead), or bulkhead and no significant accumulations of soot on these three surfaces. This evidence indicates that flashover in Room 7 did not occur. The inspection demonstrated that the primary fire damage was intermittently dispersed in the array between Rows 8 through 18 (Figure 6-2). No physical damage was evident for waste containers in Rows 2 through 7 (yellow box in Figure 6-2), or Rows 19 through 24 (red box in Figure 6-2). The most significant damage occurred in the regions marked in blue on Figure 6-2.

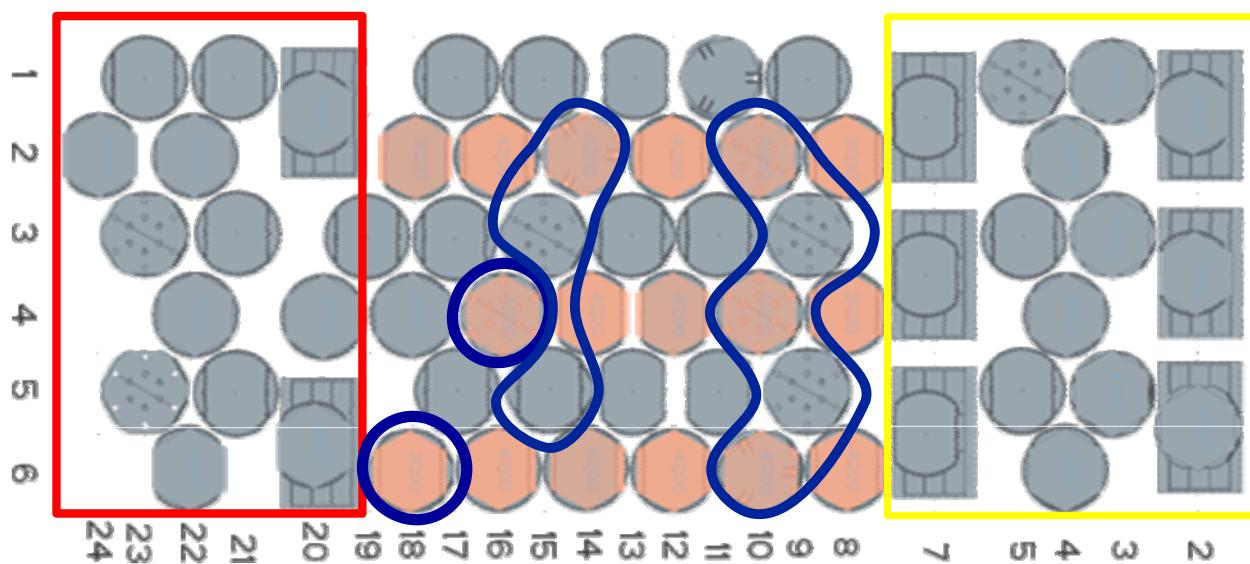
**NOTE:** Significantly damaged MgO Super Sacks shown in peach.

The MgO super sacks from Rows 8 through 18 were damaged. The polypropylene fabric that formed the sacks was severely damaged or missing from most of these locations. The fabric damage could have been caused by melting or ignition (Figure 6-4). Polypropylene is categorized as an easy-to-ignite material with a melting temperature in the range of 160°-176°C. Evidence of both mechanisms was identified during the array inspections. When the fabric was damaged, the cardboard stiffeners collapsed, the MgO flowed and formed piles of loose material at the damaged MgO super sack locations. At most of these locations the angle of repose (e.g., slope) was very steep, almost 60°, indicating gravity was the dominant force acting on the MgO after the super sacks were consumed by the fire.

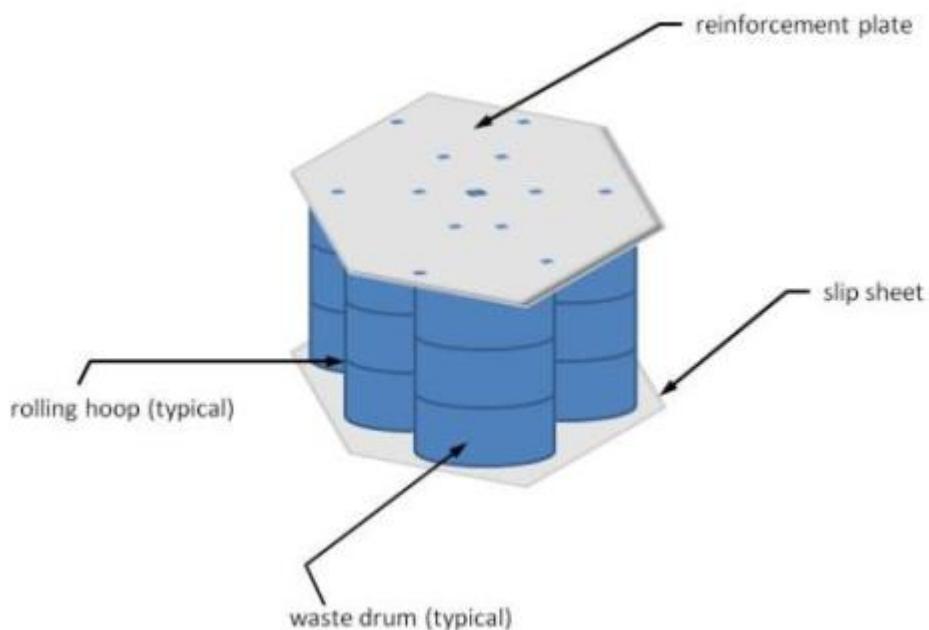
**Figure 6-3: Drum Waste Assembly with Slip Sheet and Reinforcement Plate**

Visual damage within the waste array was most severe at, or near, locations with 55GD and 100GD. These were locations with higher quantities of combustibles external to the waste containers such as fiberboard and polyethylene slip sheets, reinforcement plates, stretch wrap, cardboard stiffeners and polypropylene super sack fabric (Figure 6-3). Evidence of both melting and ignition were identified at these locations. Polyethylene is categorized as an easy-to-ignite material and has a melting temperature range of 122 – 135°C (NFPA 921, pp 51) and the observed damage was consistent with this information.

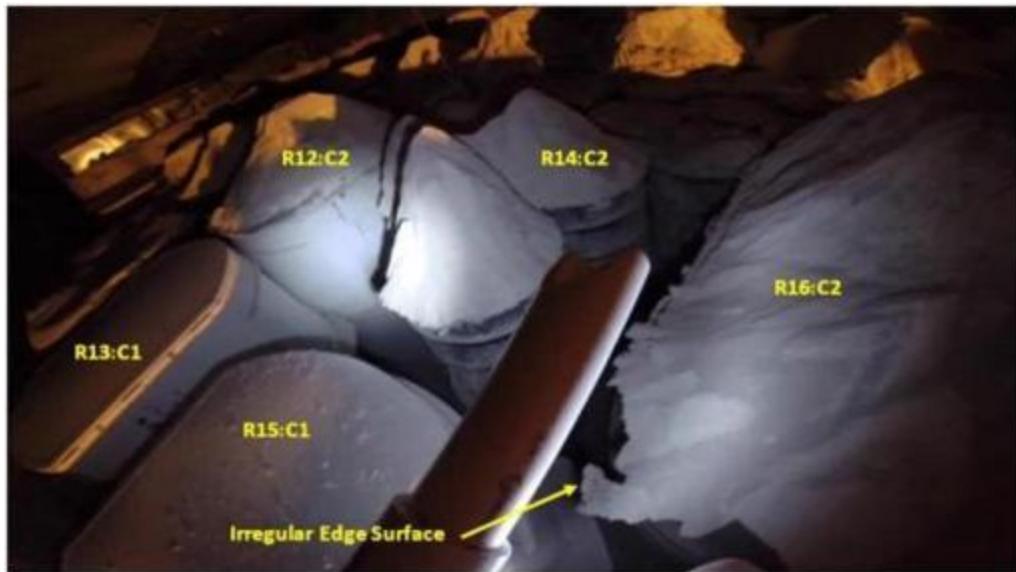
Figure 6-5: Evidence of Irregular Edge Surfaces at R16:C2

The cardboard stiffeners collapsed into multiple final orientations: hanging from a stack edge, cantilevered over the edge of a waste package, bridging between two stacks, or resting on the floor. Some of the locations where the stiffeners were cantilevered or bridging exhibited irregular edge surfaces (Figure 6-5). At R15:C5 there was a concave burn pattern in the portion of the cardboard that was cantilevered over the edge of the lid of a standard waste box (SWB) (Figure 6-6). The burn-pattern is typical of horizontal material exposed to a flame from below. Similar materials may burn as long as exposed to an external flame, but will likely self-extinguish once the flame is removed. There were also smaller cardboard remnants lying on the lid. These remnants display striations of the corrugated layer within the original cardboard matrix.

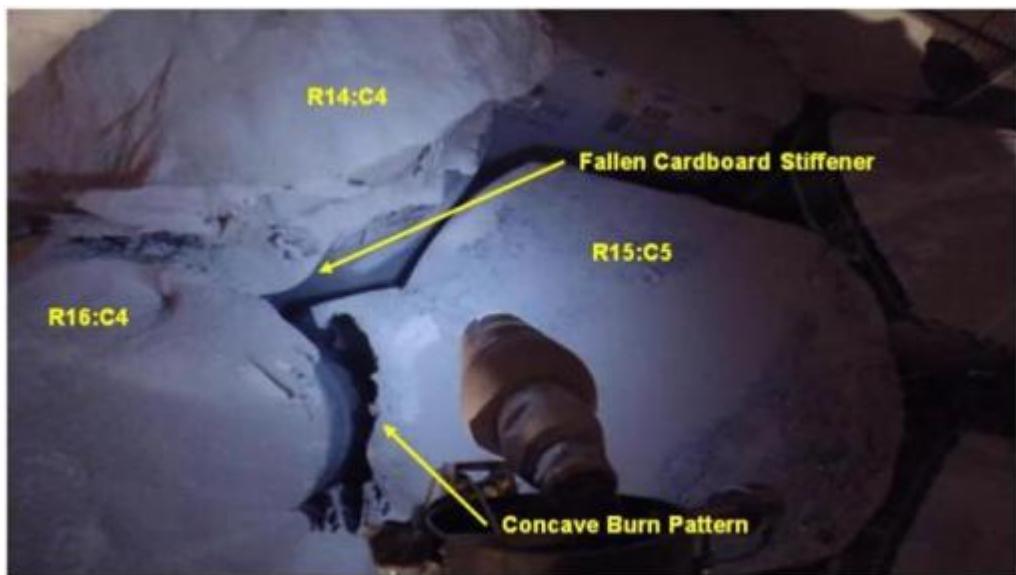
Figure 6-6: Evidence of Flaming Combustion Irregular Edge Surfaces at R15:C5

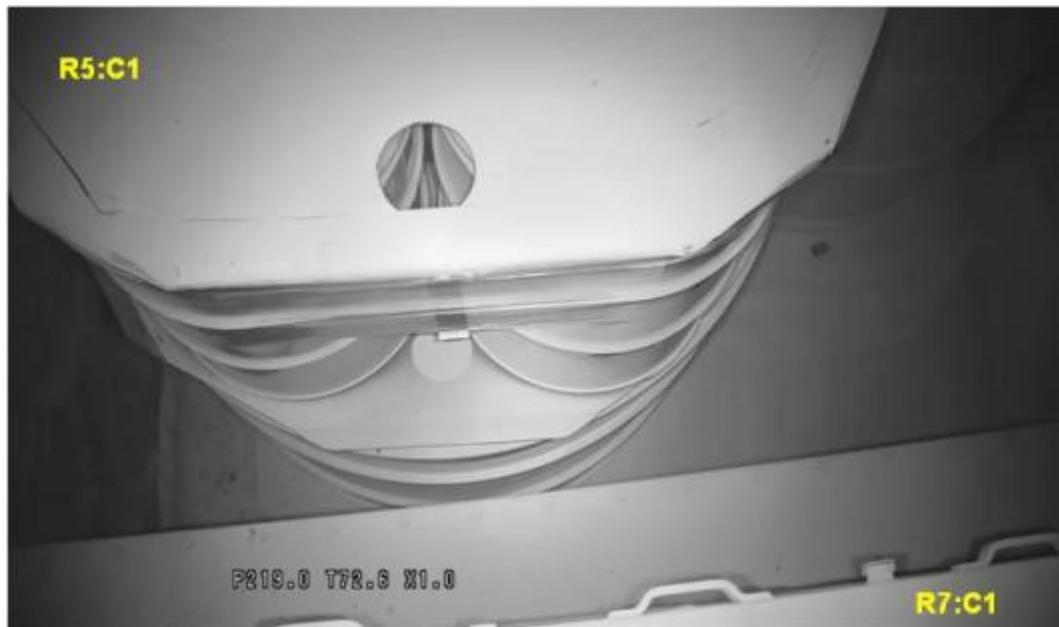
**Figure 6-7: Undamaged Stretch Wrap at R5:C1**

Rows 2 through 7 contained a mix of TDOPs, SWBs, 55GD assemblies, 100GD assemblies, and Standard Large Box Type 2s. These rows were closest to the bulkhead. The inspection identified no fire-related damage to the polyethylene stretch wrap or the polypropylene super sacks in these rows. The lack of damage to the polyethylene stretch wrap in these rows establishes that the bulk air temperature passing over the array was low, nominally below 135°C, which is the upper value of the melting temperature range of the polyethylene stretch wrap<sup>12</sup> (Figure 6-7, Figure 6-8 and Figure 6-9).

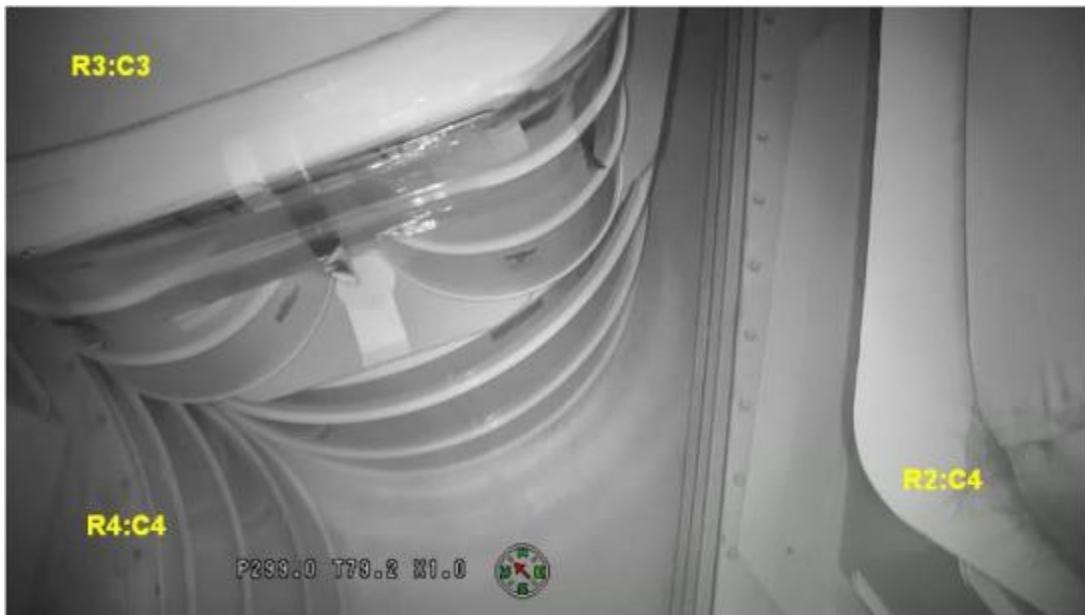
**Figure 6-8: Undamaged Stretch Wrap at R3:C5**

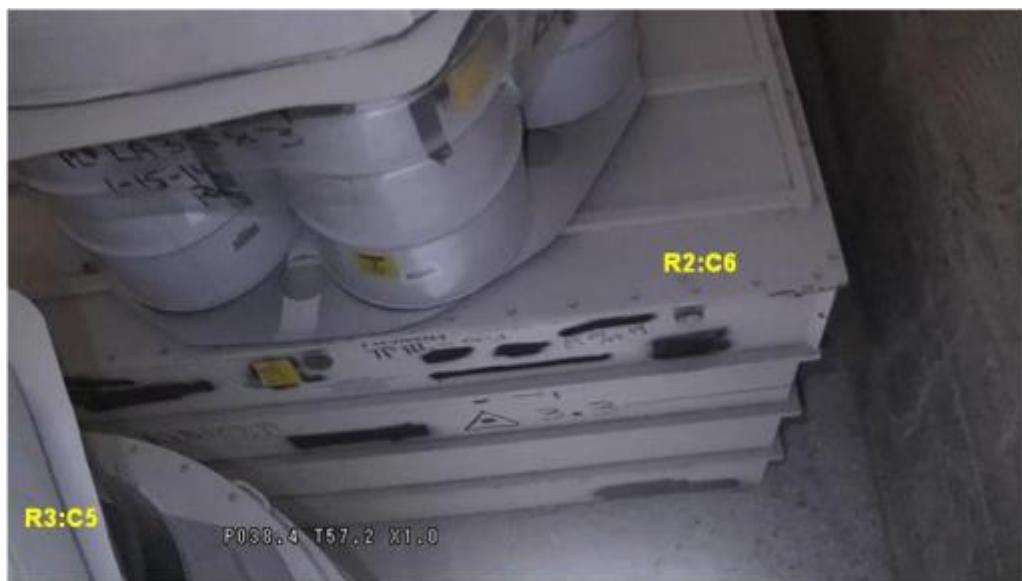
**Figure 6-9: Undamaged Stretch Wrap at R2:C6**

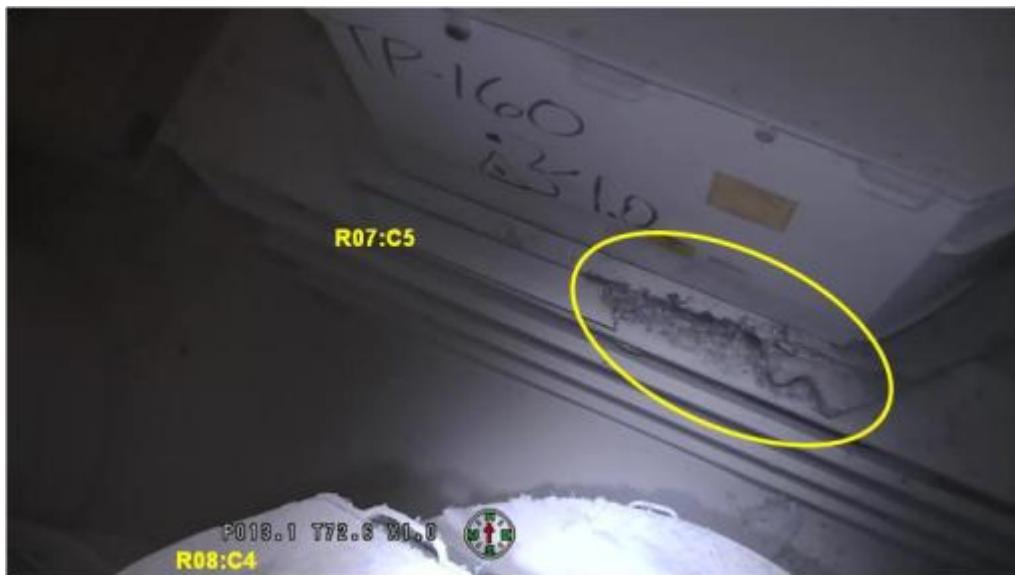
**Figure 6-10: Fiberboard Slip Sheet Damage at R7:C5**

Ignition of a fiberboard slip sheet did occur at R7:C5. The fiberboard charred over a short region and self-extinguished (Figure 6-10). This region is adjacent to R8:C4, which had a fire-damaged MgO super sack, so ignition could have occurred by direct thermal heat transfer from the fire at R8:C4, from impact by burning material (cardboard or fabric) falling from R8:C4, or by embers generated elsewhere in the array. Damage to this fiberboard was identified as fire damage closest to the bulkhead.

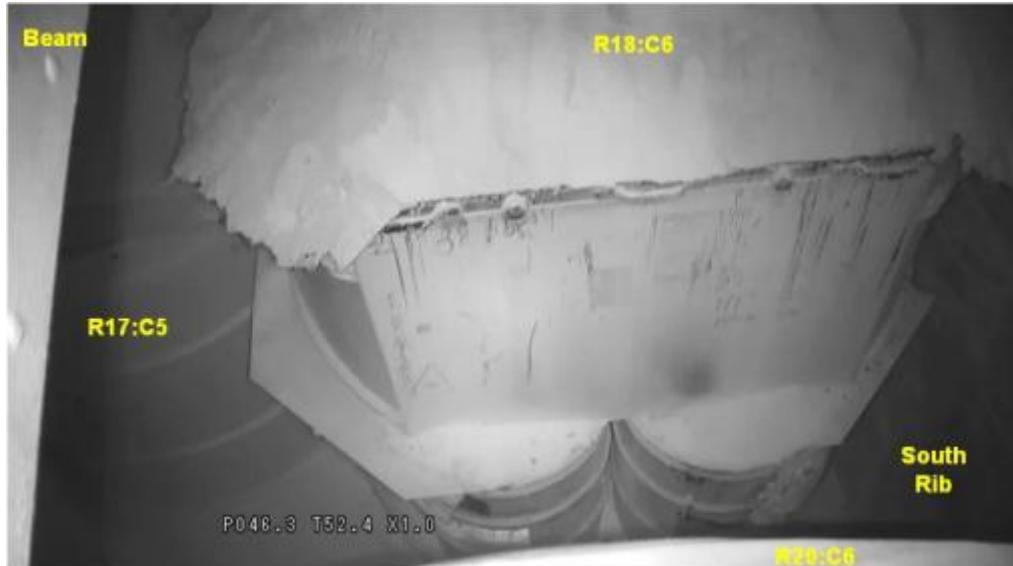
**Figure 6-11: Face Side (west) of R18:C6**

the middle and bottom 55GD assemblies appears to be intact although a variety of debris have accumulated on the top of the reinforcement plate. In some locations fallen material has combusted resulting in discoloration of a waste container. In one location sufficient flame exposure occurred to leave a clean burn pattern where all of the dirt, paint, and soot has burned away leaving a bright metal surface (Figure 6-13). The stretch wrap on the north-west corner of the lower tier was also damaged by flames (Figure 6-14). Except as noted, no other damage to the stretch wrap was identified in this stack.

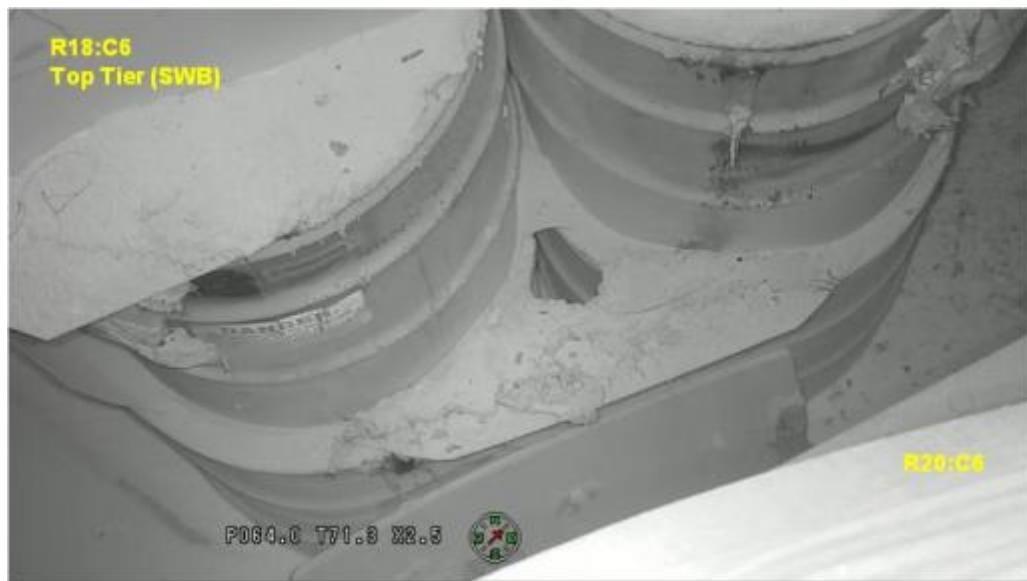
**Figure 6-12: Face Side (west) of R18:C6 Middle Tier**

Based on the orientation of the stack, the stack damage, and the ventilation direction, a hot or flaming ember is considered a plausible means of fire propagation to R18:C6. This ember landed on the fiberboard slip sheet that was below this SWB and caused ignition of the fiberboard. The fire consumed the exposed fiberboard above the two west drums (the drums on the face-side of the array, Figure 6-11). The reinforcement plate below the fiberboard burned and melted with the remaining material following the contour of the two west drums (Figure 6-12). The middle-tier stretch wrap on the west side was also damaged. There are streaks of polyethylene on the sides of the waste drums. The slip sheet and reinforcement plate between

This fire-propagation mechanism likely occurred at R18:C6, where the exposed MgO super sack fabric or a slip sheet ignited when the ventilation perturbation occurred following the failure of waste drum 68660 (Figure 6-12).

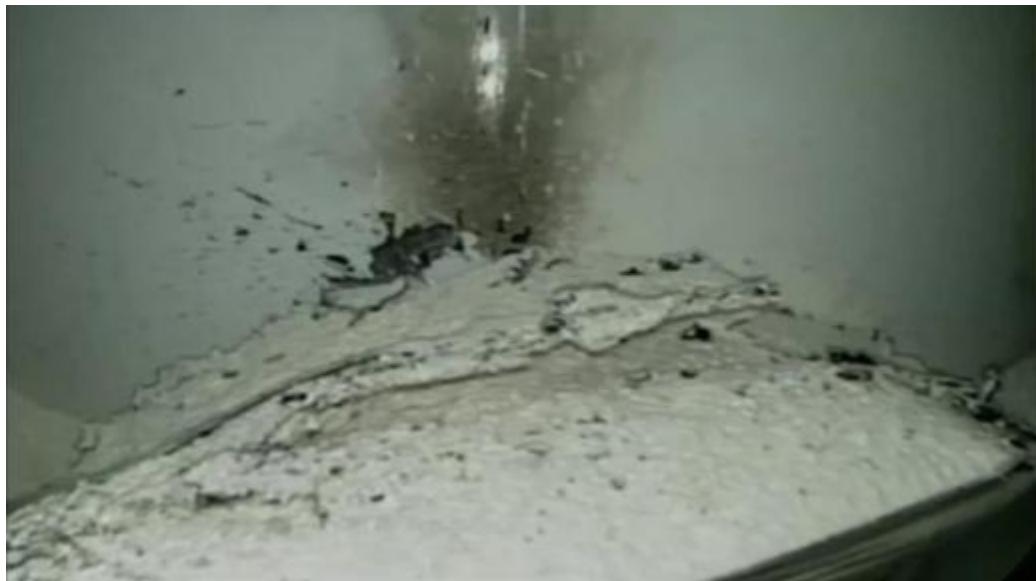
**Figure 6-13: Face View (west) Base of Middle Tier Drum at R18:C6**

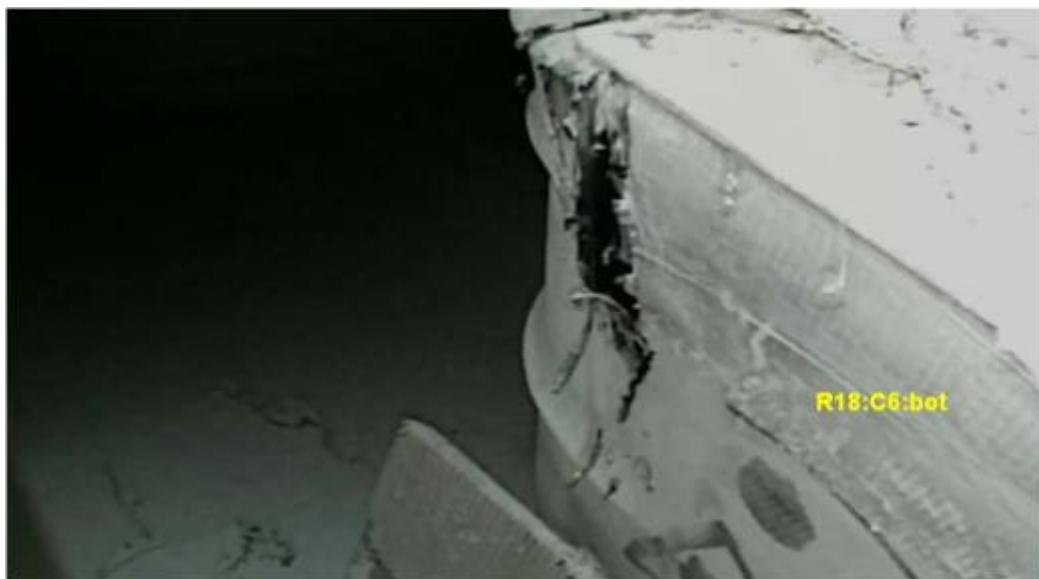
**Figure 6-14: Face View (west) Stretch Wrap at Bottom Tier**

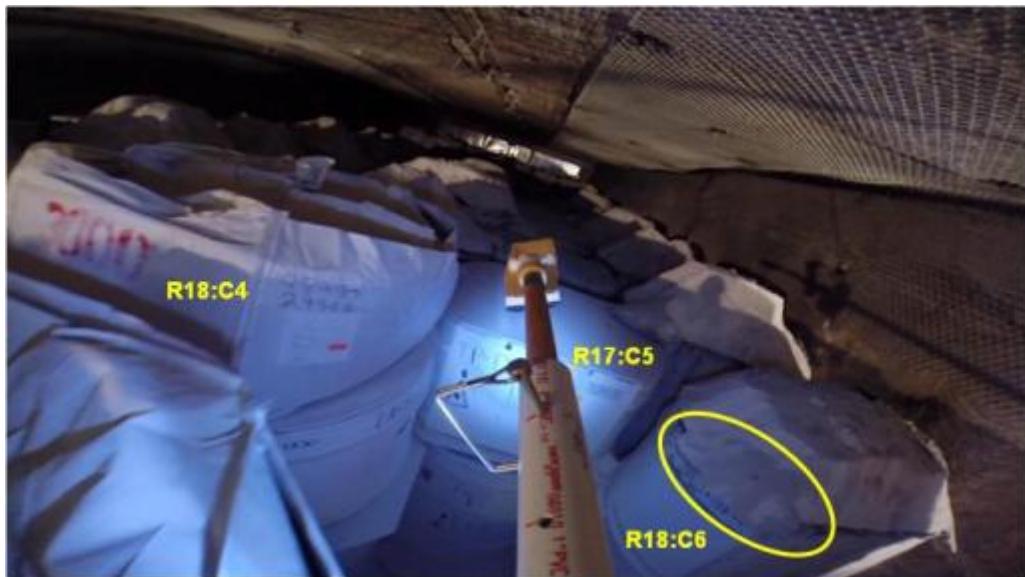
Figure 6-15: Cantilevered Bridge at R18:C6

stiffener were partially burned along with a hole through the stiffener. A stiffener on the south side bridges between the SWB and the rib. There was also evidence of flame impingement on the rib (Figure 6-17). The east (bulkhead side) stiffener fell and was not located. The SWB had vertical streaks created by melted polyethylene from the MgO super sack slip sheet flowing down the side and freezing (Figure 6-18). There was no evidence suggesting that any of the waste containers in this stack had an unfiltered release.

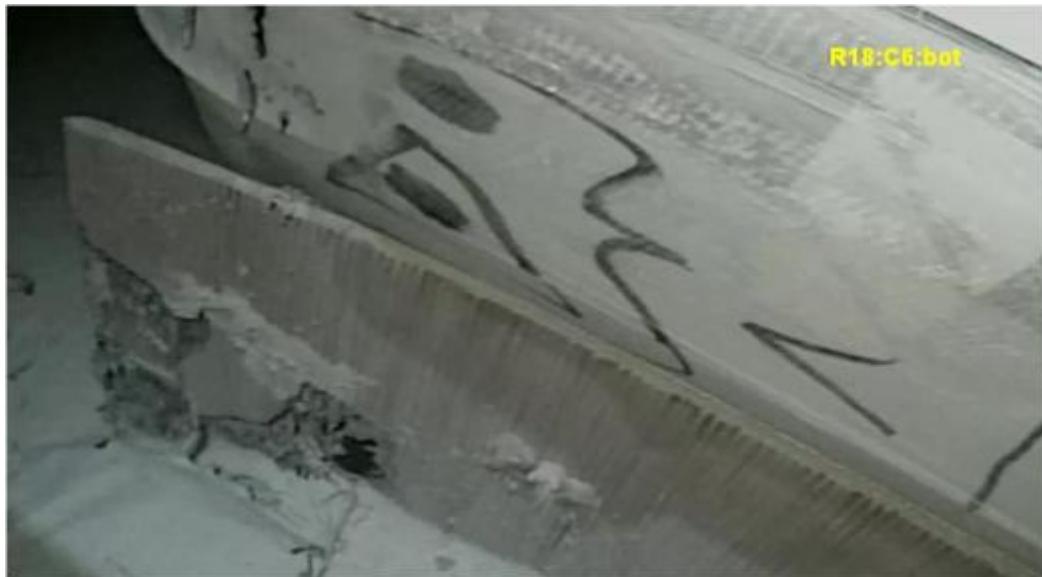
The MgO super sack was damaged by the fire. The polypropylene fabric melted, burned or fell from all sides of the super sack. On the north side the cardboard stiffeners and fabric were trapped between the MgO and the SWB lid. The stiffener and fabric formed a cantilevered bridge that supported a pile of displaced MgO (Figure 6-15). On the west side, a stiffener fell to the floor where it was partially covered by MgO (Figure 6-16). The vertical edges of this

Figure 6-16: Face View (west) – Debris at Base of R18:C6

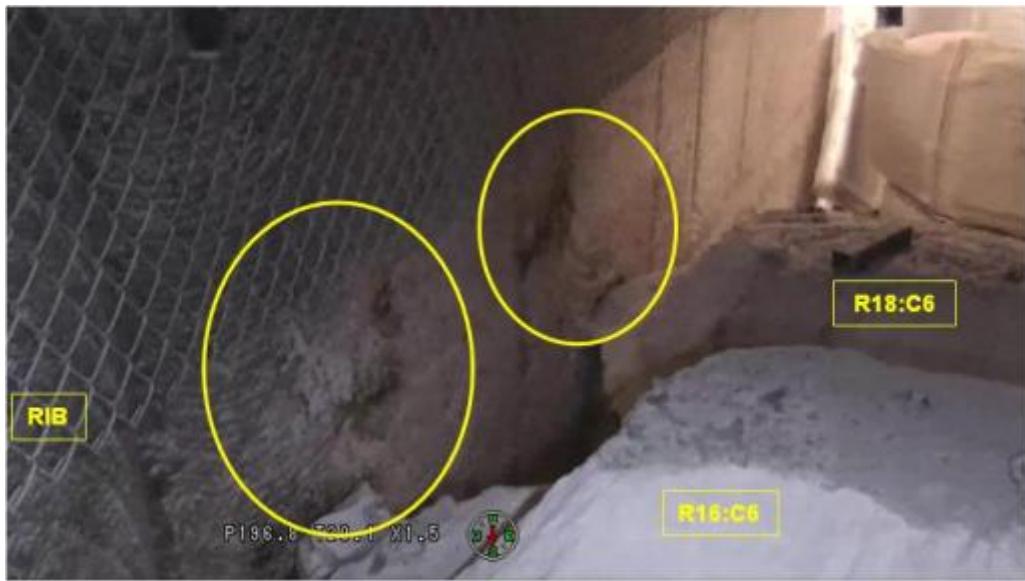
Figure 6-17: Rib Damage near Rows 16 and 18

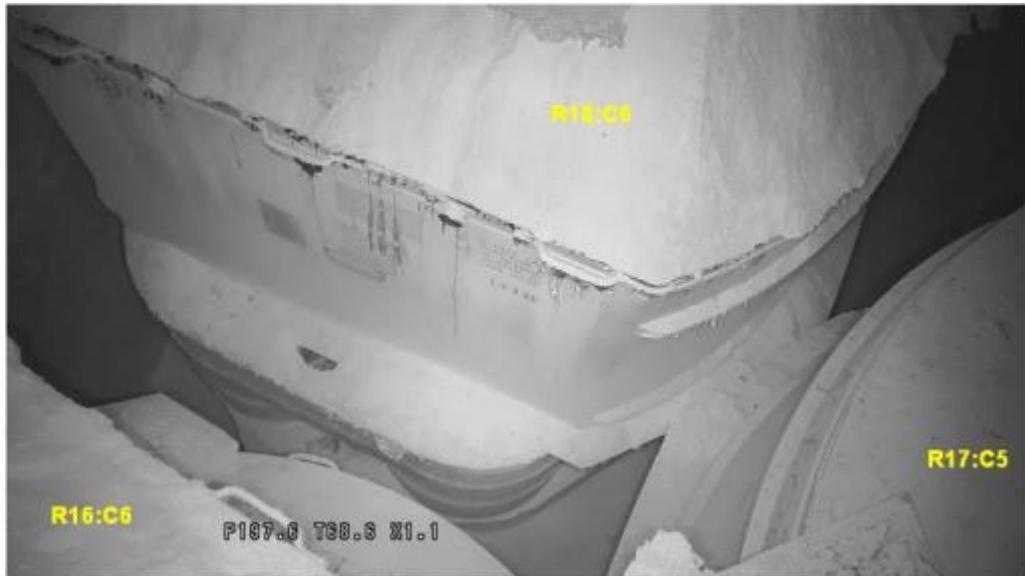
Figure 6-18: Bulkhead Side of R18:C6

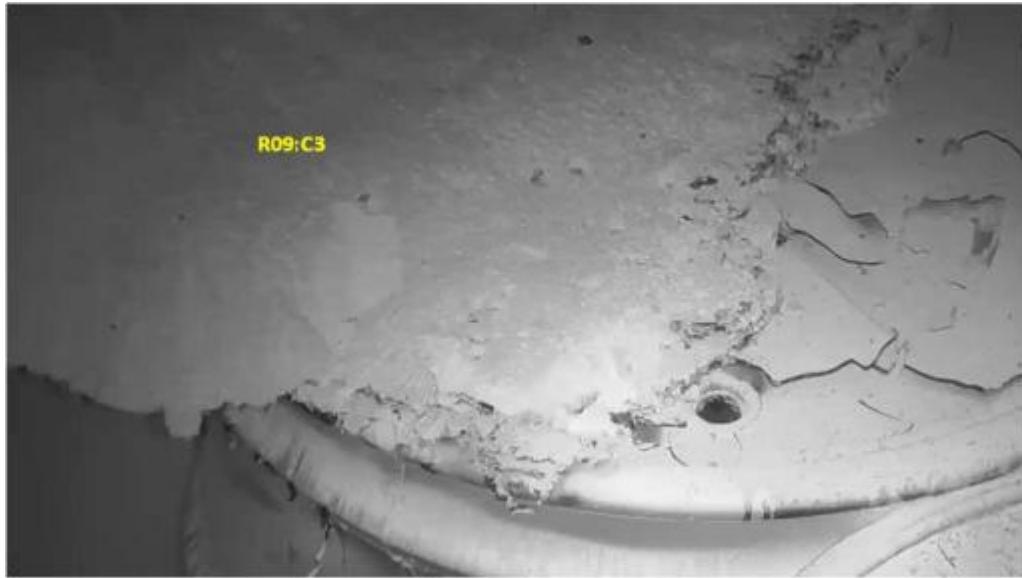
had no observable fire damage, stretch wrap at each of the other five stacks was damaged or missing. The 55GD assembly reinforcement plates at R9:C3 and R9:C5 melted, mixed with MgO, solidified on the drum lids, and cracked into pieces (Figure 6-19, Figure 6-20, Figure 6-21, Figure 6-22, Figure 6-23 and Figure 6-24). There was no evidence of reinforcement plate remaining between the drums. In some instances melting polyethylene formed streaks on the on the side of these drums. In addition, MgO slumped onto some of the drums in both locations.

**Figure 6-19: Residual Polyethylene on Dunnage Drum at R09:C3**

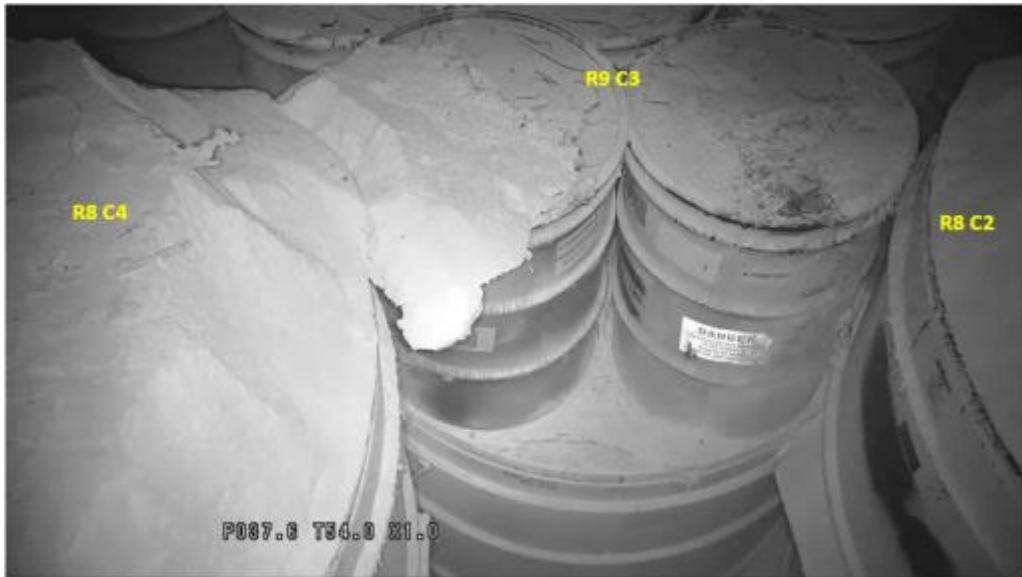
**Figure 6-20: R9:C3 Bulkhead View (east)**

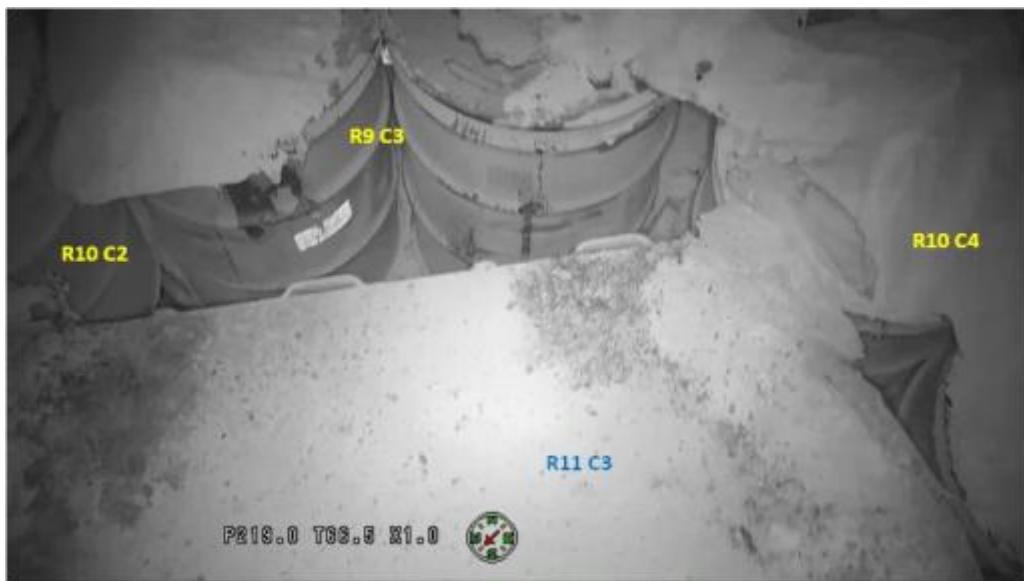
Figure 6-21: R9:C3 West Side

The MgO super sacks in Row 10 were damaged, with most of the fabric melted or gone (Figure 6-21, Figure 6-22, Figure 6-24, Figure 6-25, and Figure 6-26). The residual MgO formed conical piles consistent with the outline of the waste containers on the top tier at each stack. At R10:C6 the 100GD assembly slip sheet, the middle tier reinforcement plate and slip sheet, were partially damaged and conformed to the outline of the drums (Figure 6-27). Many locations had

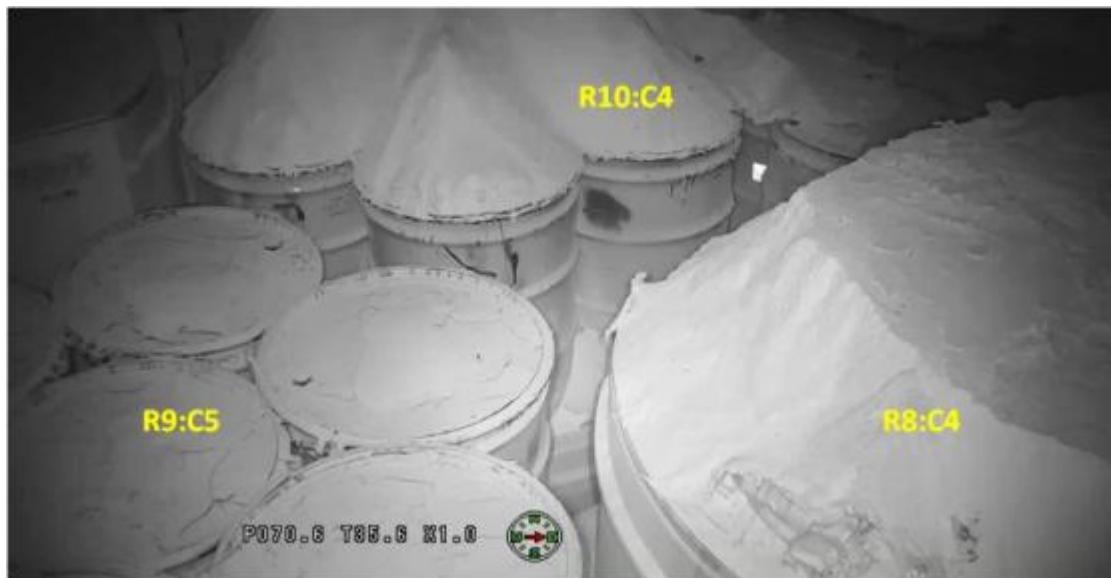
Figure 6-22: Damage at R9:C5 and R10:C4

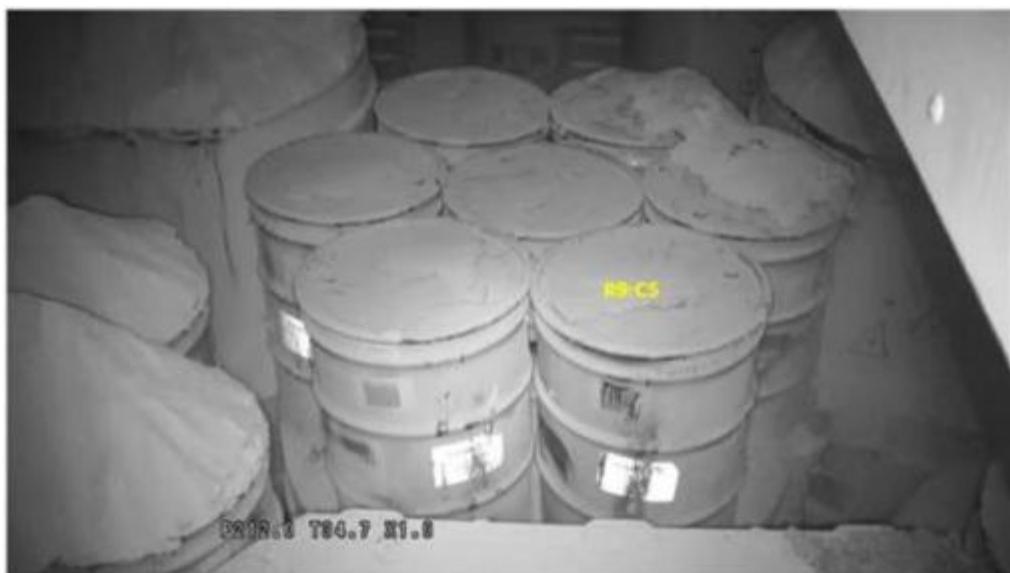
**Figure 6-23: Damage at R9:C5**

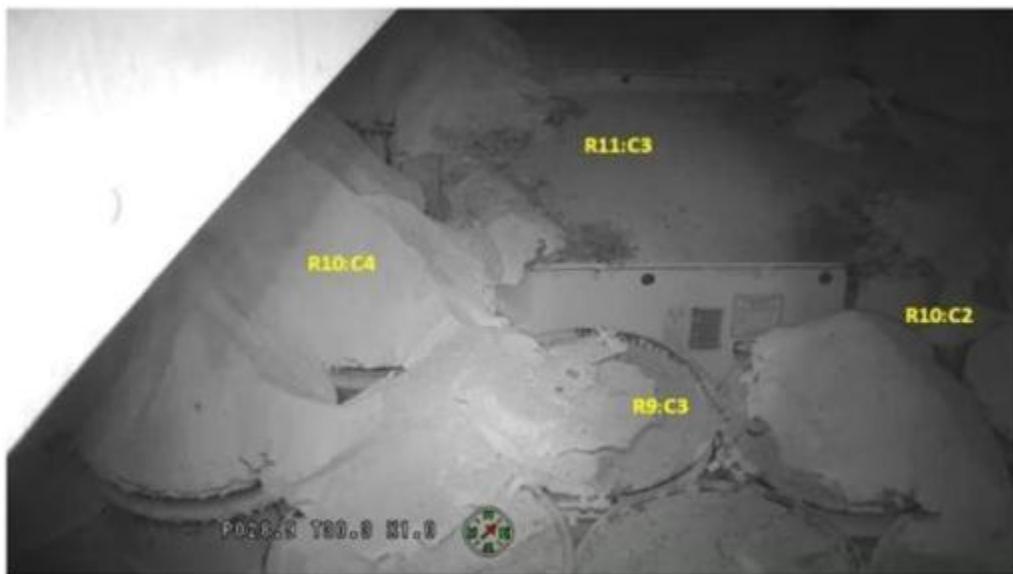
**Figure 6-24: R10:C2, R9:C3 and R10:C4 East (Bulkhead) View**

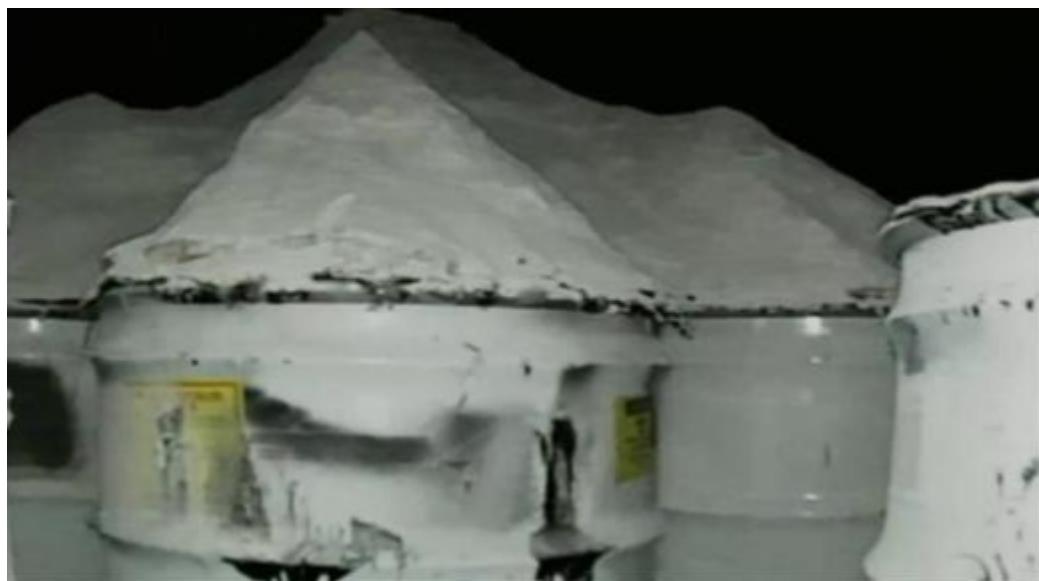
While some of the TDOPs in Rows 9 and 10 exhibited streaks of melted plastic, none had substantive damage. In some instances the depth of the MgO at the floor was so deep that it obscured a substantial portion of the lower stack tier or the lower half of a TDOP.

**Figure 6-25: Discoloration and Residual MgO at R10:C4**

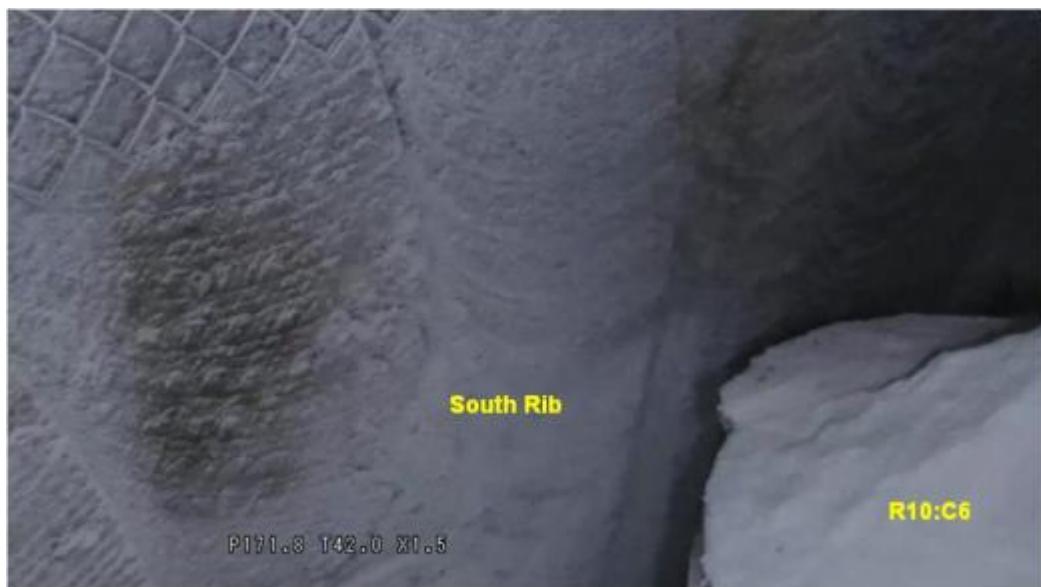
evidences of black discolorations on the sides of the waste drums. There was also evidence of flame impingement on the south rib (Figure 6-28).

Figure 6-28: Flame Impingement Evidence on South Rib near Row 10

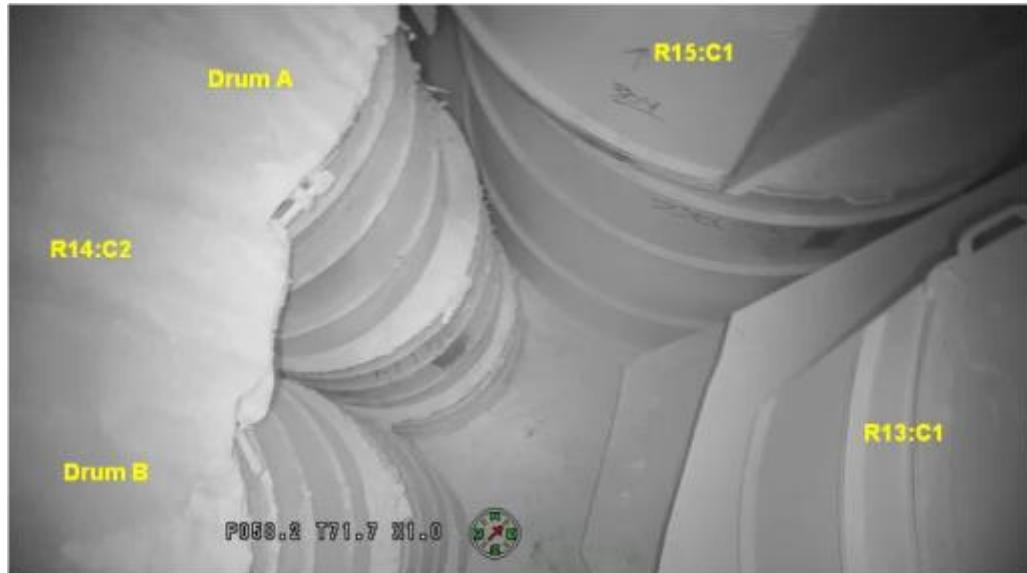
The exposed plastics (fiberboard and polyethylene slip sheets, reinforcement plates, stretch wrap, cardboard stiffeners and polypropylene super sack fabric) in stack R14:C2 were severely damaged. The polyethylene plastic burned and melted to the outline of the waste drums (Figure 6-29 and Figure 6-30). The MgO formed three conical piles on the three top-tier drums (Figure 6-31). The 100GDs were originally a glossy black, but were covered with a coating of fine white powder (Figure 6-32).

**Figure 6-29: North View**

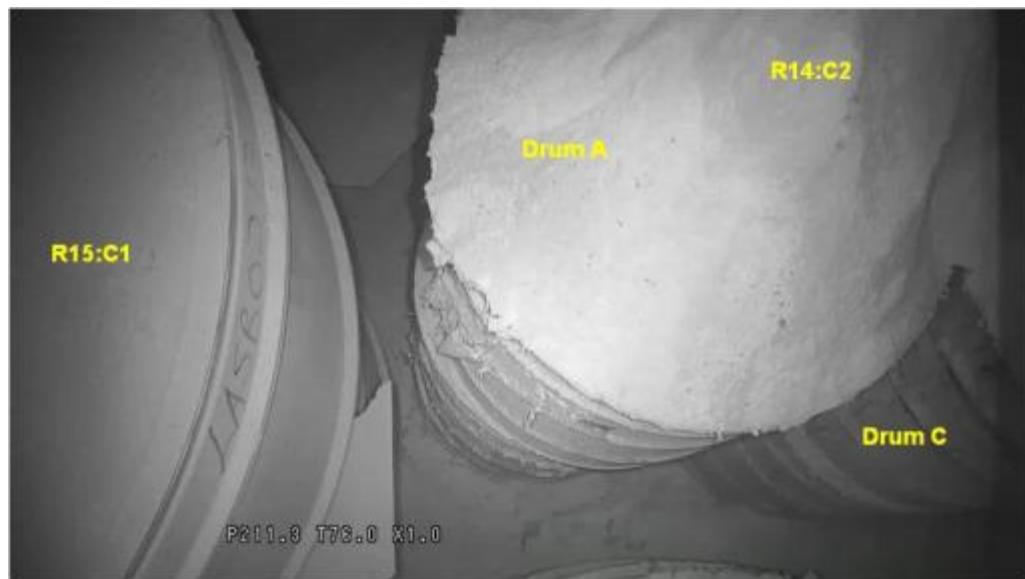
**Figure 6-30: West (face) View**

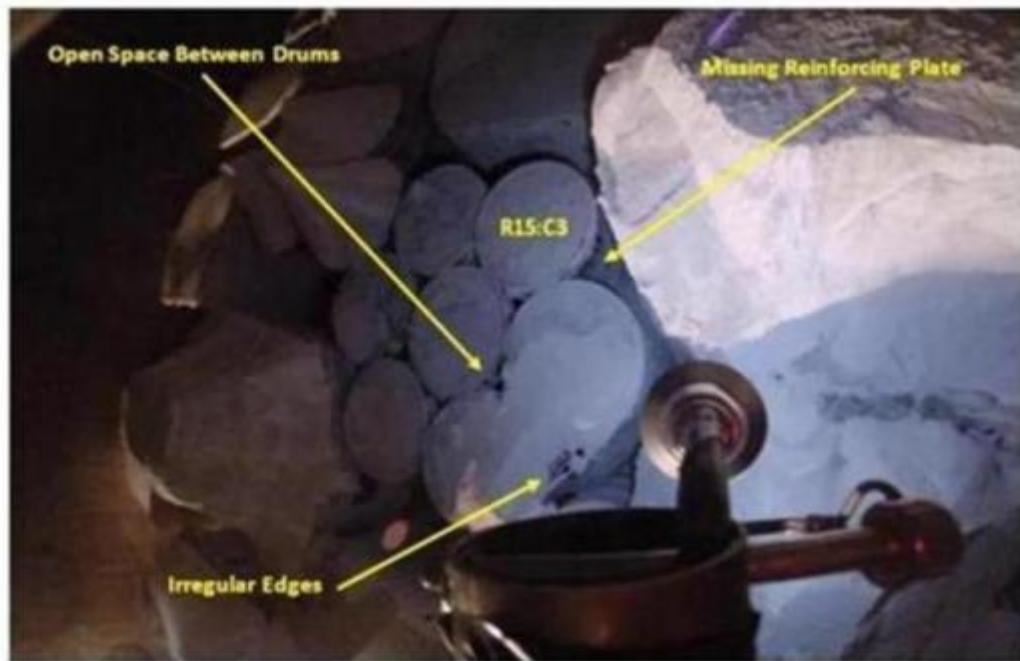
The reinforcement plate at R15:C3 was damaged. The missing plate material conformed to the outline of the seven drums, including the spaces between the drums (Figure 6-33). There was residual stretch wrap visible on some portions of the assembly and some of the drum labels were undamaged (Figure 6-34). The TDOP below the 55GD assembly was undamaged.

Figure 6-33: Missing Reinforcement Plate at R15:C3
