# U.S. Department of Energy Office of Environmental Management

## Accident Investigation Report

**Phase 2  
Radiological Release Event at the  
Waste Isolation Pilot Plant,  
February 14, 2014**

**April 2015**

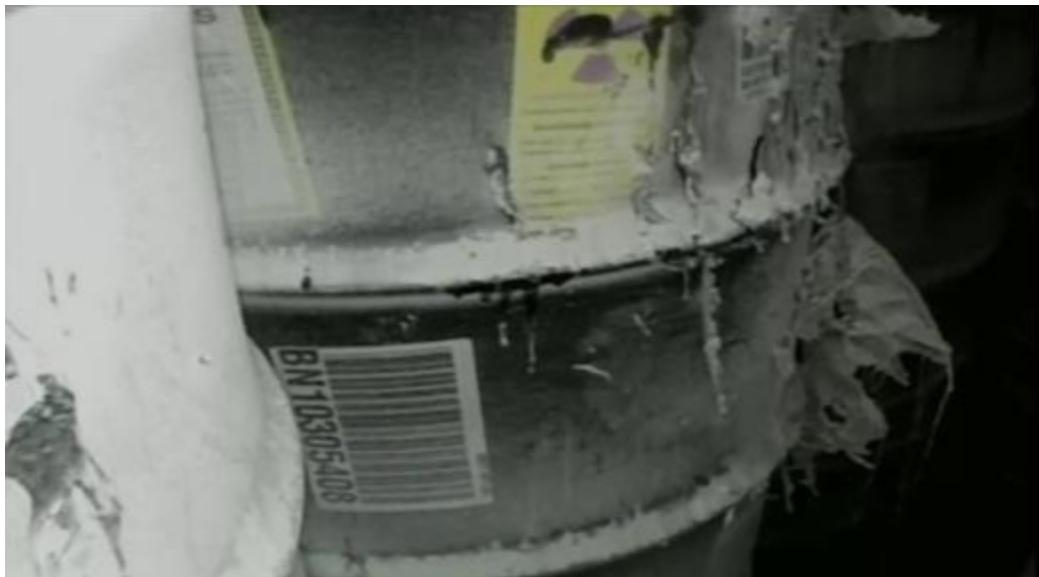
**Figure 6-34: Drum in R15:C3 on Bulkhead Side Looking Southeast**

The reinforcement plate at R15:C3 was damaged. The missing plate material conformed to the outline of the seven drums, including the spaces between the drums (Figure 6-33). There was residual stretch wrap visible on some portions of the assembly and some of the drum labels were undamaged (Figure 6-34). The TDOP below the 55GD assembly was undamaged.

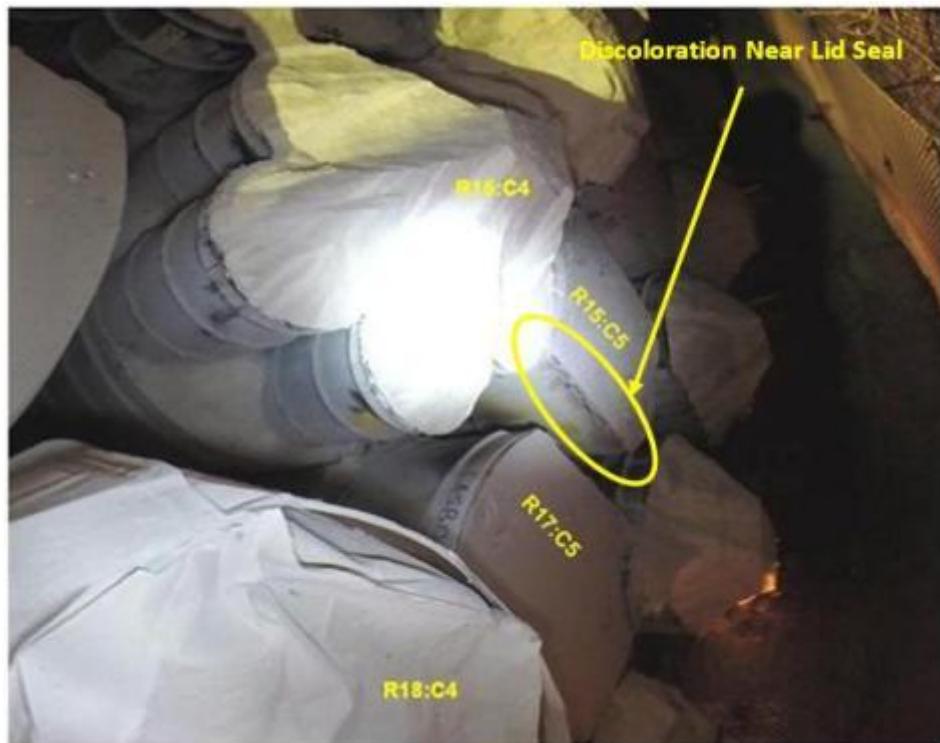
Figure 6-35: Discoloration of SWB at R15:C5

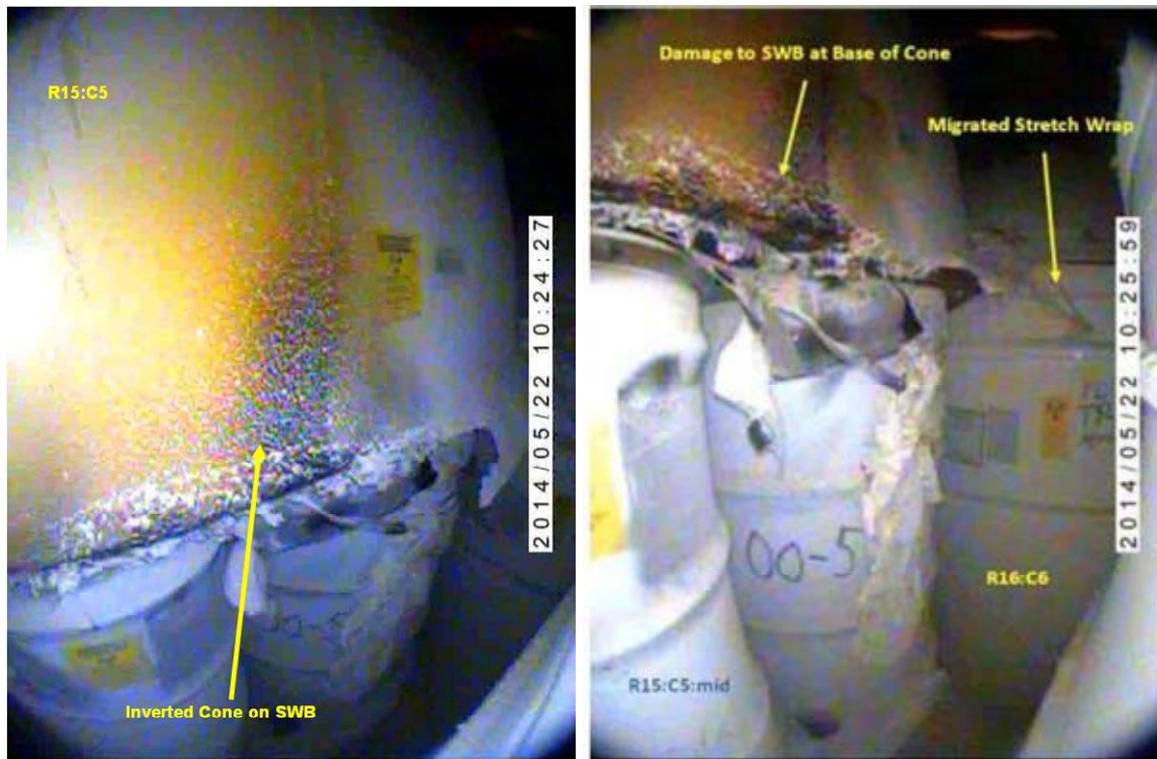
The reinforcement plate and fiberboard slip sheet between the middle and top tiers of R15:C5 was severely damaged and partly burned on the west (face) and north sides. Much of the polyethylene stretch wrap was missing from these locations. There was discoloration indicative of overheating on the west side of the SWB near the seal (Figure 6-35). There was an inverted-cone pattern on the SWB centered between the two west-most middle-tier drums (Figure 6-36). The fiberboard slip sheet had a U-shaped damage pattern (Figure 6-37). This is indicative of flame exposure to the fiberboard from below. When the flame exposure ceased, combustion of the horizontal fiberboard likely stopped. The fiberboard slip sheet and reinforcement plate were badly damaged below the north end of the SWB (Figure 6-38). Char from the slip sheet conformed to the middle tier 55GDs.

Figure 6-36: Side of SWB at R15:C5:top

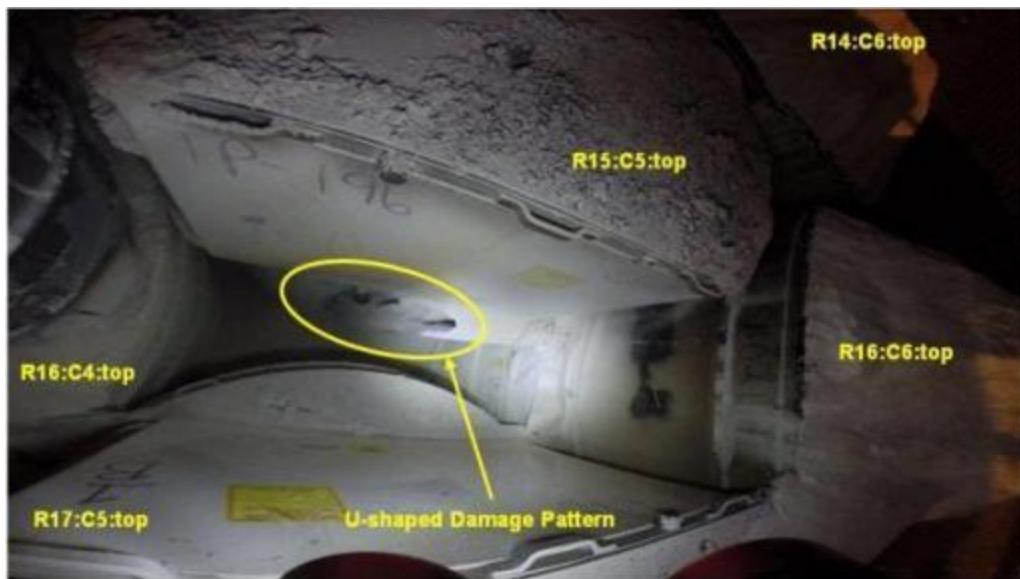
Figure 6-37: Damage to Slip Sheet at R15:C5

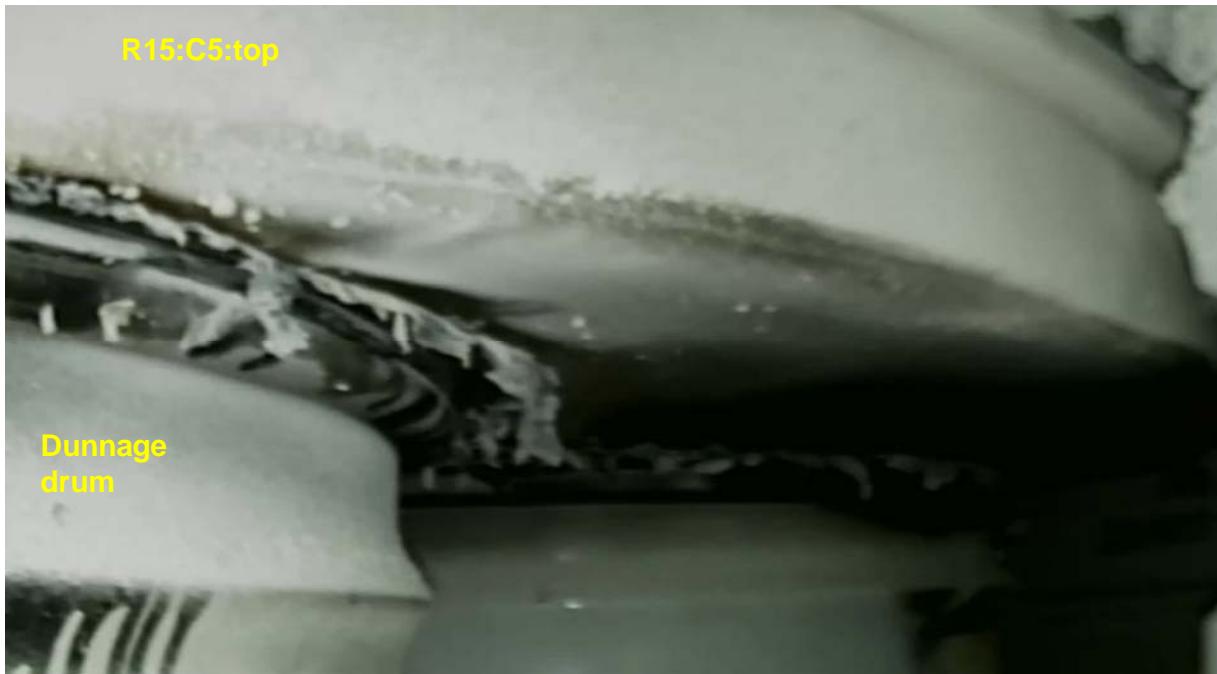
Figure 6-38: North View of R15:C5, Bottom of SWB on Top Tier

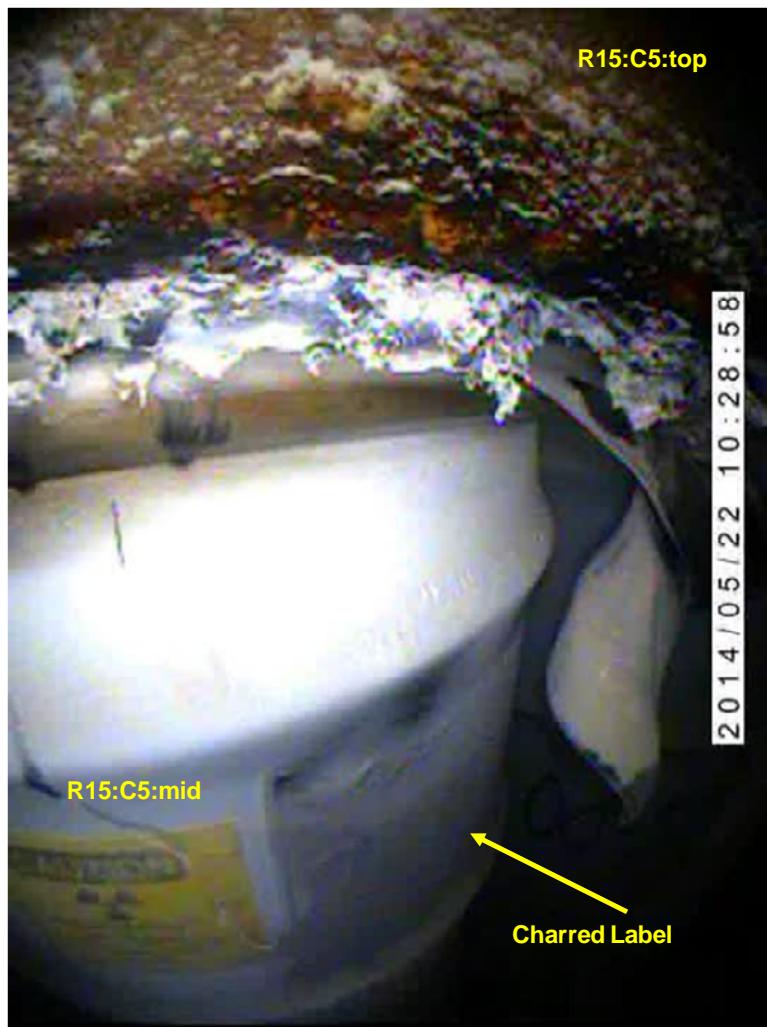
One 55GD on the middle tier of R15:C5 exhibited evidence of localized heat or flame exposure. Between the middle and upper rolling hoop there was one label that had charred, while a second label that showed no damage (Figure 6-39). In addition, there was a dark inverted-cone shaped pattern starting at the base of the drum that extended up the side of the drum about 12 inches. Around this region there was clumped MgO resting on the middle-tier slip sheet. While there was severe flame damage evidence on the west side of the SWB and the middle tier 55GD assembly, the lower tier stretch wrap appeared undamaged on the outer surface as viewed from the west side of the stack.

**Figure 6-39: Charred Label at R15:C5**

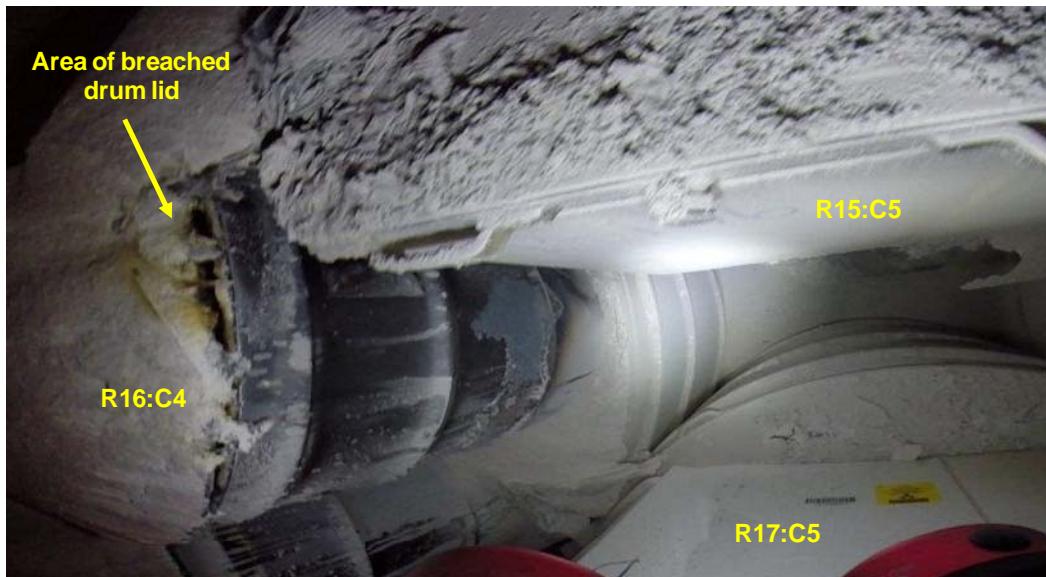
**Figure 6-40: Drum 68660 at R16:C4**

A drum on the top tier of R16:C4 breached (Figure 6-40). This is waste container 68660; it is on the south side of the stack. The MgO super sack fabric on the top of the 55GD assembly is substantially gone. The MgO piles on 68660 and the neighboring drum to the west are short with a low angle of repose. This was potentially caused by movement of the lid. The cones on the other drums are similar to other stacks where the MgO super sacks have been damaged.

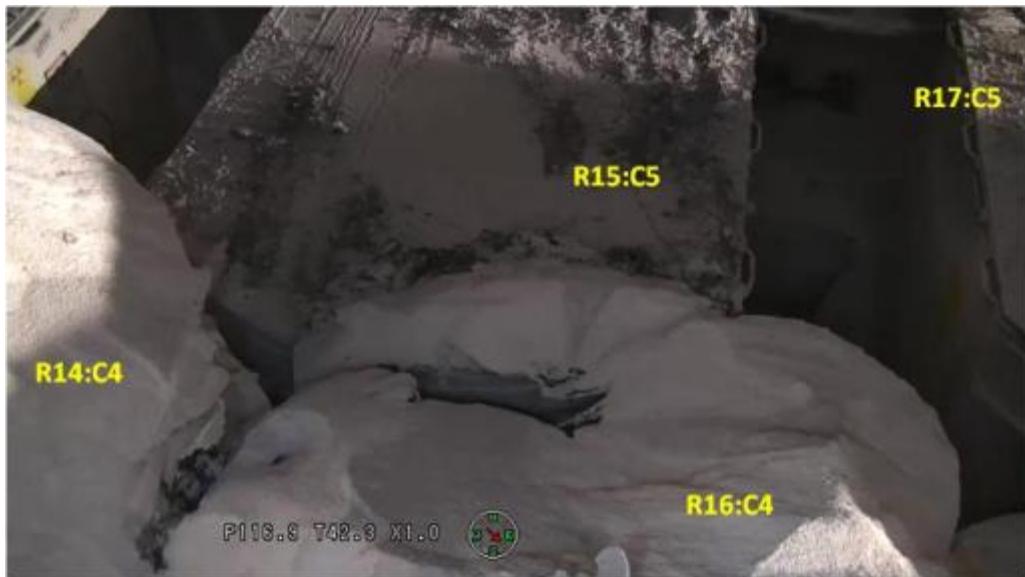
**Figure 6-41: R15:C5 SWB Lid from North Looking South**

There was a moderate quantity of clumped material and MgO spillover on the SWB lid at R15:C5 (Figure 6-41). The depth of this material was greatest on the northwest corner where the stack is in close proximity to R16:C4 (Figure 6-42). The north end of the lid had evidence of combusted cardboard stiffener material from the MgO bag that was placed on top of R16:C4. Additionally, there was a fallen cardboard stiffener lying on the north end of the lid. There were two spots on the southeast and southwest corners of the lid where white MgO was seen on top of the discolored material spread across the remainder of the lid. This suggests that the MgO sacks on R16:C6 and R14:C6 spilled their contents sometime after the clumped material dispersed across the lid surface.

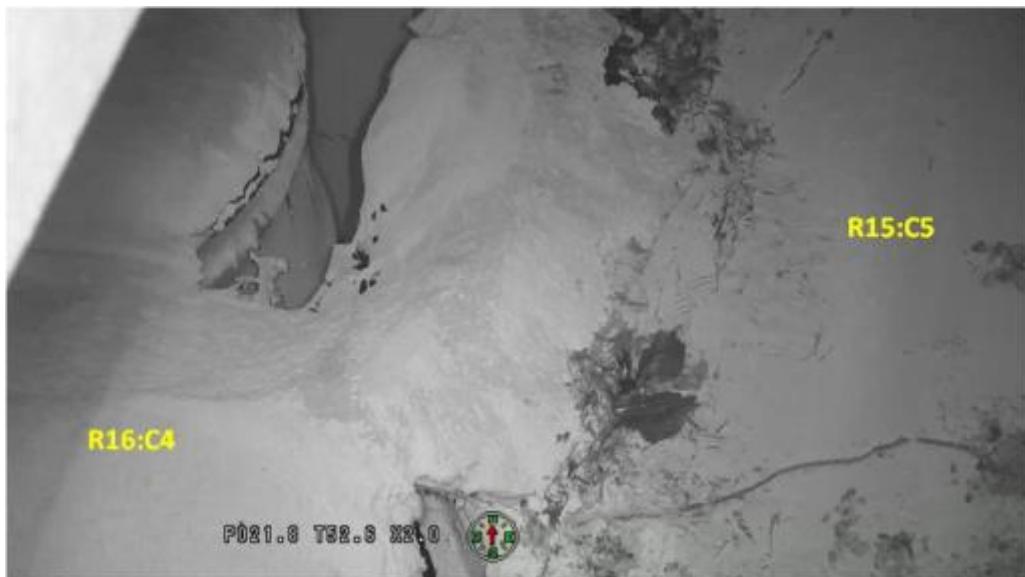
**Figure 6-42: Bridge between the R15:C5 SWB Lid and R16:C4**

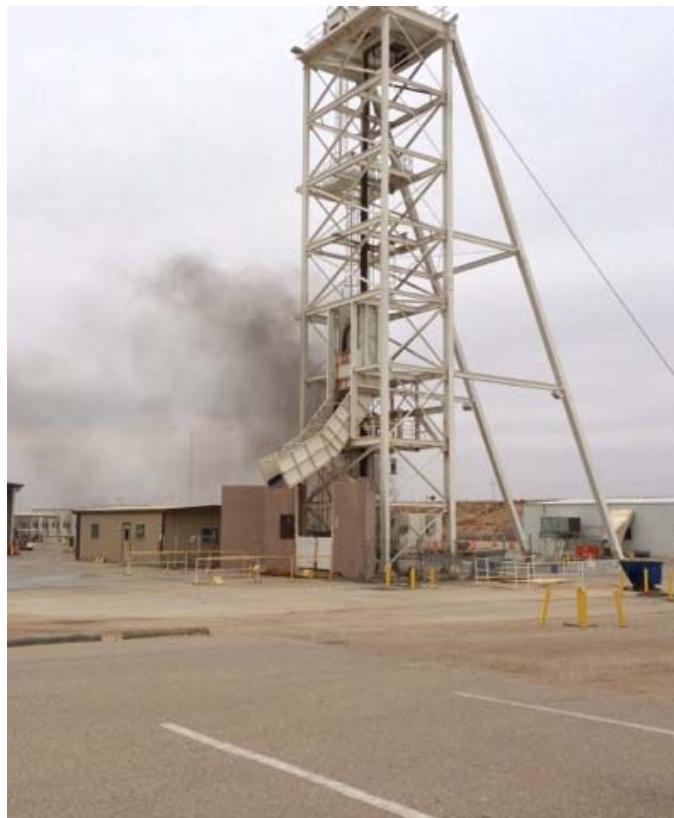
**Figure 6-43: Upcasting Observed at the Salt Shaft on February 5, 2014**

Upcasting in the Salt Handling Shaft did occur following the change to filtered mode (Figure 6-43). This upcasting increased the airflow moving past the salt haul truck fire. The flow behavior in the Salt Handling Shaft was modeled by a Bernoulli's fluid equation, recognizing that the volumetric flow up the shaft was induced by the thermal gradient, and would create a friction flow resistance. Simultaneous solution of the flow equation, and the energy balance equation, as discussed for the early portion of the fire, demonstrated that the temperature at the based of the Salt Handling Shaft was about  $82^\circ\text{C}$  when the energy release rate was 15 megawatts.

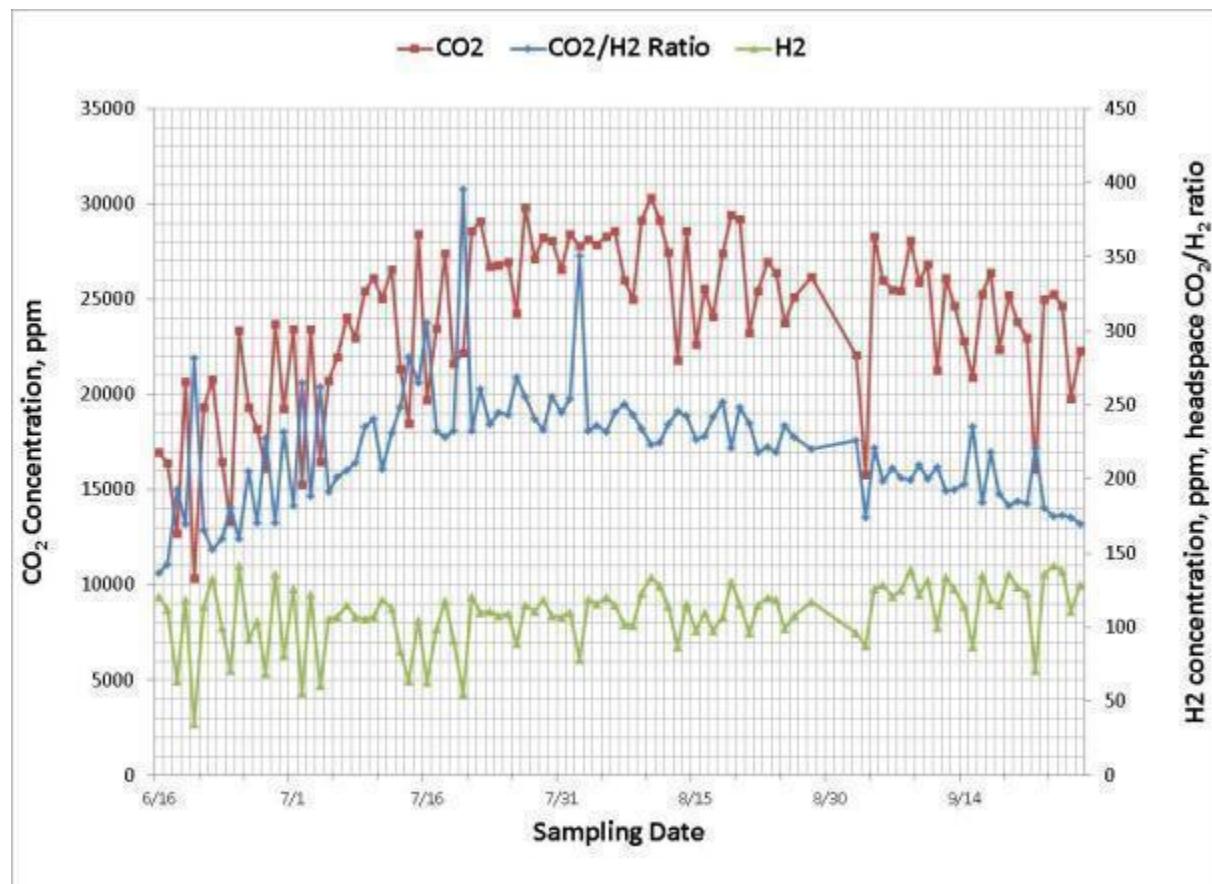
LANL conducted headspace gas sampling and thermography monitoring for the SWB containing drum 68685, the sibling drum of drum 68660. In addition, headspace gas sampling and thermography was performed for other remediated waste drums at LANL. The purpose of the gas sample analysis is to determine the presence and/or concentration of potential reaction products. The sampling was conducted via the vent port on the waste box, and thus is not able to directly sample the gases within the suspect drum, nor within any waste bags within the drum. The gases detected in the headspace gas sampling are consistent with oxidation. The headspace gas monitoring results are shown in Figure 6-46. The trend suggests that there is a chemical oxidation reaction occurring.

**Figure 6-46: Headspace Sampling Results of CO<sub>2</sub> and H<sub>2</sub>**

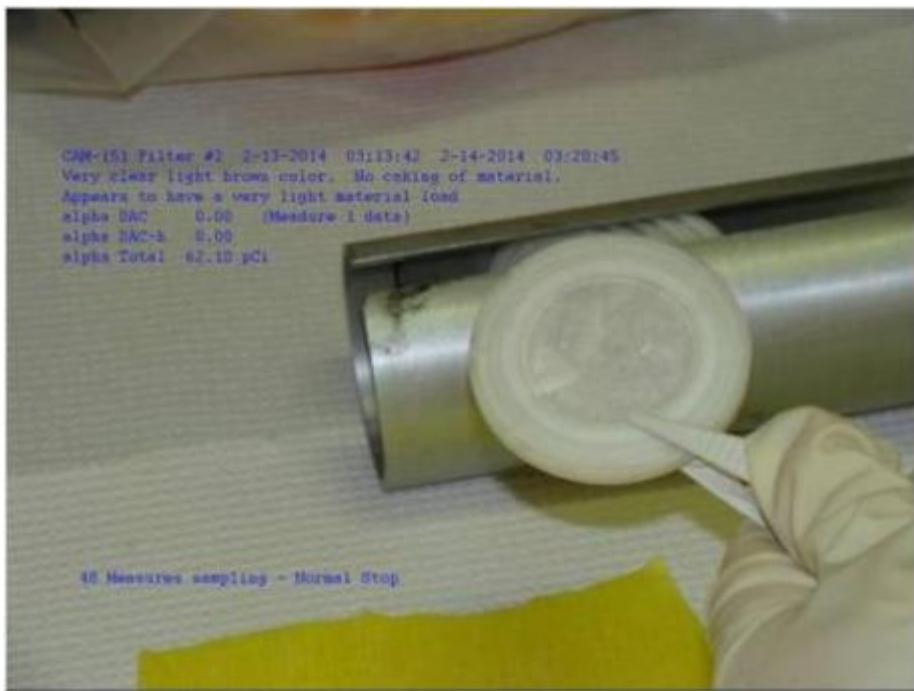
**Figure 6-48: CAM 151 Filter #2**

Following the event, the CAM (Figure 6-47) filter housing was disassembled at SRNL. Each filter was assigned a specific number based on the order in which the filters were removed from the CAM cartridge, visually examined, and recorded. Each CAM filter was then screened by gamma pulse height analysis. The first six CAM filters were white and had low levels of activity; three of these are from routine monitoring before the event took place. The following 10 sample filters had various shades of black and brown, and had high levels of activity. Table 6-5 summarizes sampling start and stop time for each CAM filter and the DAC-hr value as recorded by the CAM, as well as total gamma emitting activity as measured by gamma pulse height analysis. CAM 151 filter papers are numbered and described in the order in which the filter paper was removed from the cartridge. The CAM 151 cartridge is loaded with filter papers with the earliest filters first. This means that the first filter used by the cartridge is the last filter paper to be removed. The CAM cache records indicate filter labeling as December 27, 2013 - 6 Filter 01 (Figure 6-48) through December 27, 2013 - 6 Filter 13 (Figure 6-49) during the period starting from February 12, 2014, 0304:43 through February 15, 2014, 0005:34 when the CAM shut down after the radiological event.

CAM airborne radioactivity data correlates with the timeline for the event initiation, progression, and termination. The data indicated rapid increases/decreases in airborne radioactivity concentration over the duration. Three CAM filters (2, 7, and 11) were selected for extended gamma assays and chemical analyses. Extended gamma assays on those three CAM filters measured an actinide signature similar to what was found on the FAS. Table 6-6 is summary of the results of the three selected CAM filters.

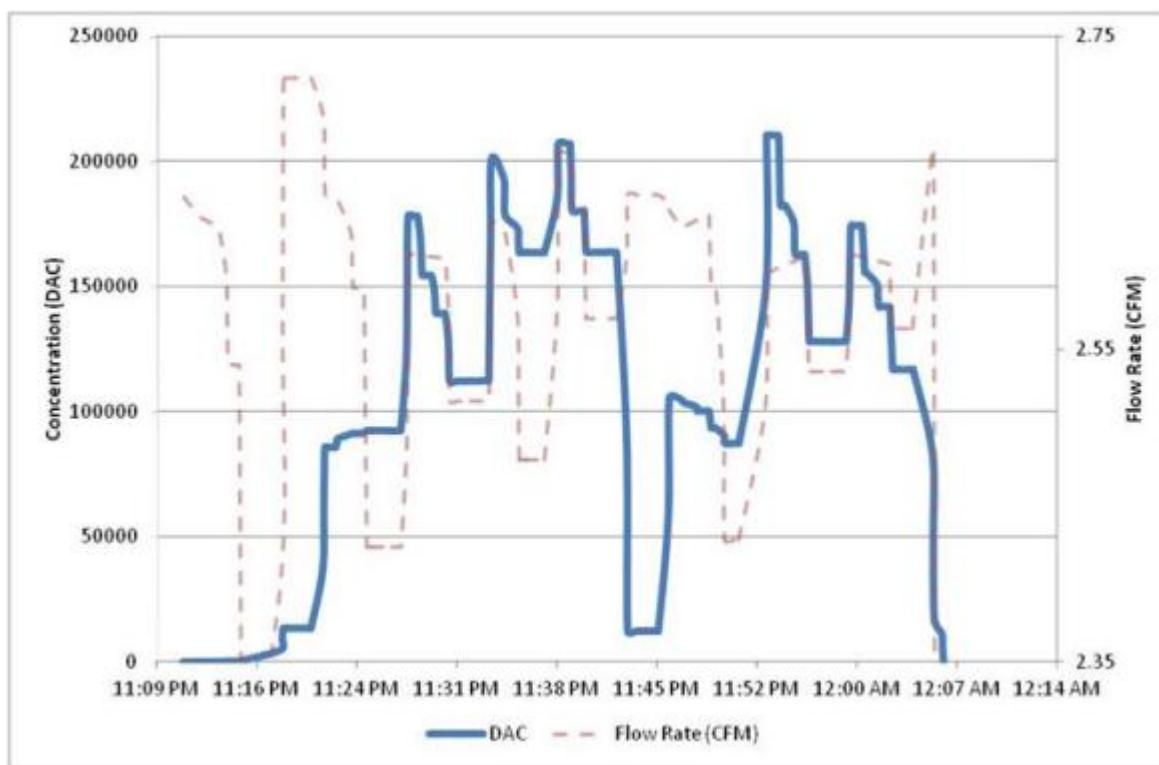
The total activity on each filter, expressed as DAC-hours, is related to the average air concentration over the entire period the filter was in use, and does not provide information about the fluctuation of real-time airborne concentrations during the time each filter is in use. As indicated in CAM log messages, the filter was rapidly clogging during the event, and required frequent filter changes at irregular intervals. However, as a filter is in use, the CAM is measuring the radioactivity on the filter at approximately 4-second intervals, and reporting the corresponding real-time concentration, which is then relayed to the CMS. The real-time DAC results are limited in their accuracy for quantitative results as the event progressed to later stages due to filter loading with ash/soot and potential alpha particle burial loss introducing measurement uncertainties; however the data are still appropriate for evaluating changes, trends, patterns, and timelines of the progression of airborne radioactivity concentrations. These real-time air concentrations as measured by CAM 151, along with the CAM flow rate, are presented in Figure 6-50.

**Figure 6-50: Real-Time Air Concentrations Measured By CAM 151 with the CAM Flow Rate**

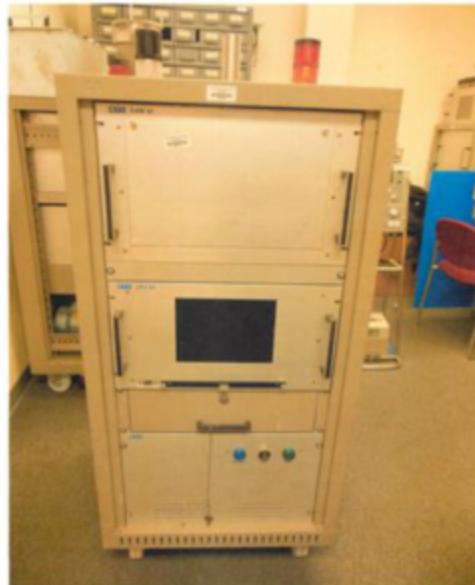
**Figure ES-1: RADOS Continuous Air Monitor**

On Friday, February 14, 2014, at approximately 2314, a "HI HI" radiation alarm was received in the Central Monitoring Room (CMR) at the DOE WIPP facility approximately 27 miles east of Carlsbad, New Mexico. The alarm was triggered from a CAM (Figure ES-1) in the U/G which was monitoring airborne radioactivity levels in air exhausting from Panel 7, an active waste panel where TRU waste was being emplaced for disposal.

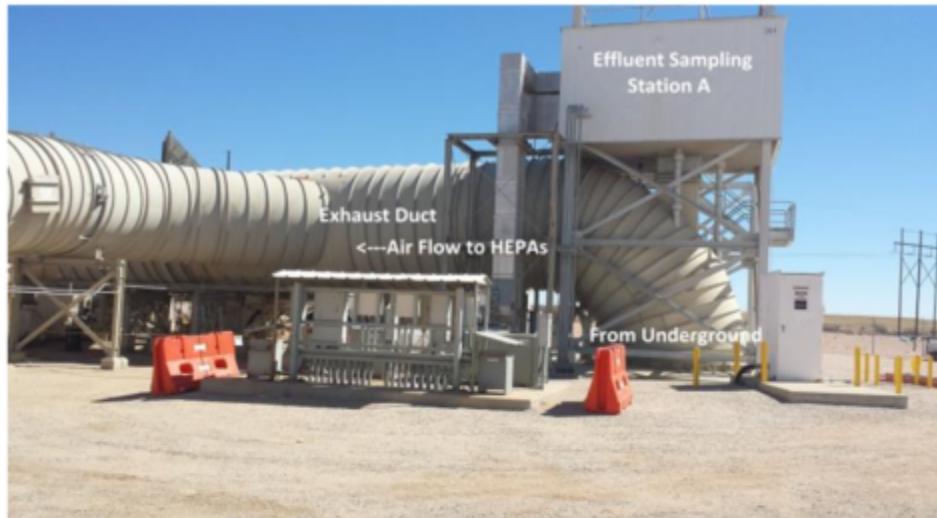
**Figure ES-2: Exhaust Air Shaft and Effluent Sample Station A**

On Saturday, February 15, 2014, the filters were counted at 0715; the RCM reported 4.4 million disintegrations per minute (dpm) alpha contamination on the filters from the effluent sample station upstream from the HEPA filters (Station A) (Figure ES-2). Preliminary data indicated the presence of TRU materials.

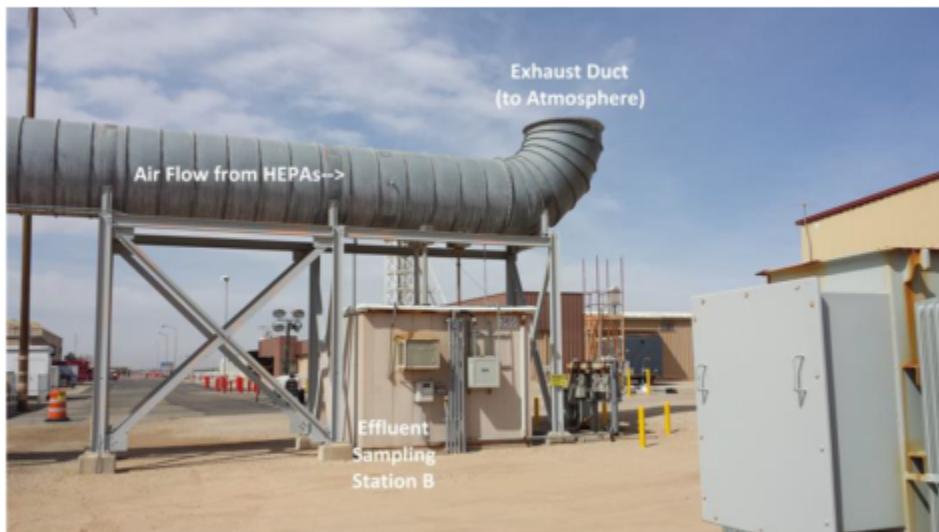
**Figure ES-3: Station B and Exhaust Duct**

Results from analysis of filters from the effluent sample station downstream of the HEPA filters (Station B) and at the discharge point to the atmosphere (Figure ES-3) were reported at 0915 and indicated 28,000 dpm alpha and 5,900 dpm beta contamination. This was the first indication that there was a release of contamination downstream of the HEPA filters to the environment.
