# Aviation Investigation Final Report

| <b>Location:</b> | Bluestem, Washington | <b>Accident Number:</b> | WPR24FA200 |
| <b>Date &amp; Time:</b> | June 19, 2024, 16:20 Local | <b>Registration:</b> | N323TT |
| <b>Aircraft:</b> | ROBINSON HELICOPTER<br>COMPANY R44 II | <b>Aircraft Damage:</b> | Destroyed |

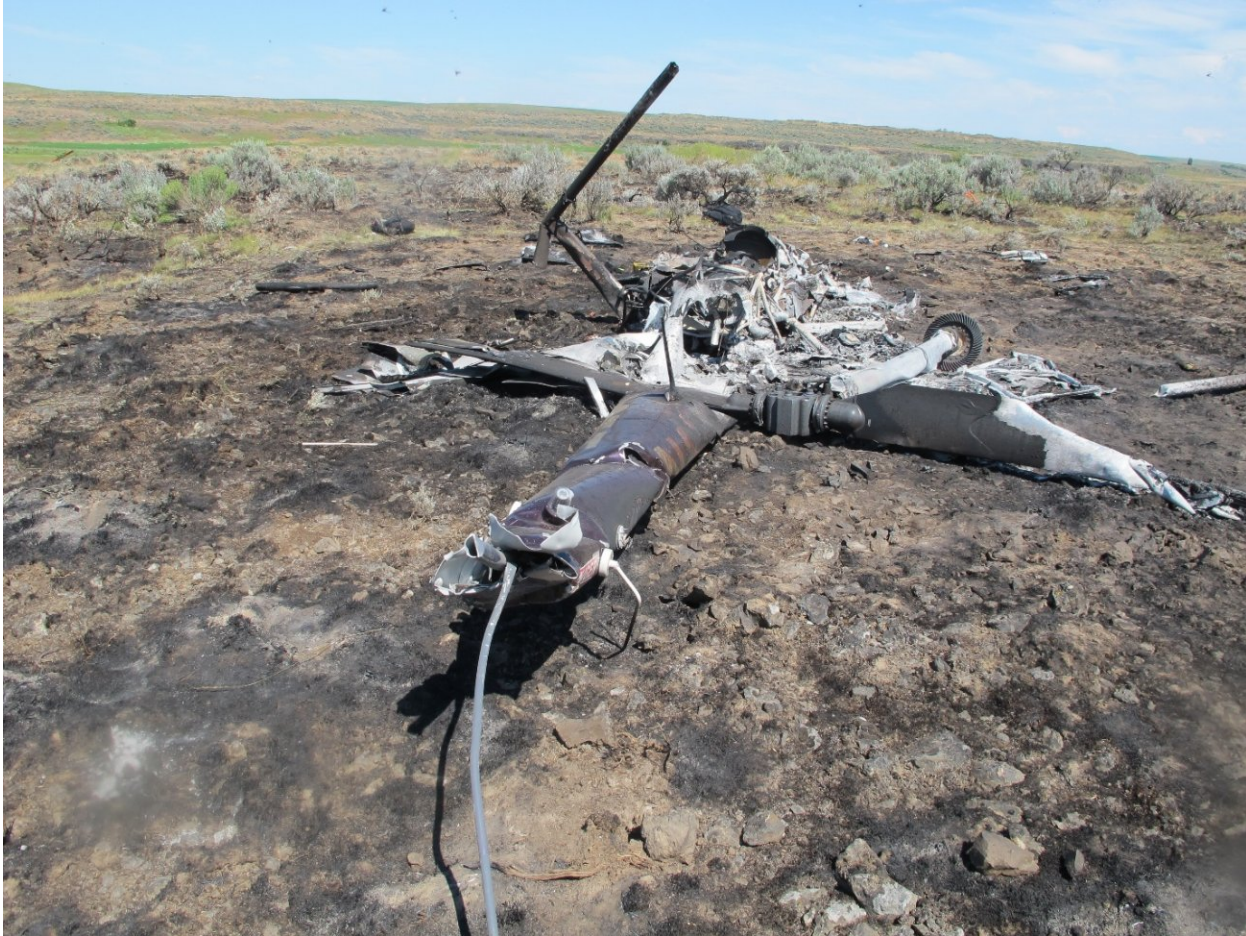
The helicopter impacted open, hilly terrain and came to rest upright at the first point of impact, on a heading of about 086°, at an elevation of 2,182 ft msl. A postaccident fire destroyed most of the wreckage (see figure 1).

Figure 1. Main wreckage (Source: Robinson Helicopters).

Postaccident examination of the main wreckage revealed the attached section of the tailcone exhibited an overall flattened deformity and an upward “scorpion” bending. Both main rotor blades exhibited a significant downward bending along with chordwise creases. One main rotor blade exhibited a color transfer on the leading edge that matched the color of the paint on the tailcone. The main rotor hub surface, adjacent to the main rotor blades, had small arc-shaped scuff marks through the paint, consistent with upward coning and contact of the blade grips with the hub. Each of the elastomeric teeter stops exhibited deep impact marks. One spindle tusk exhibited bending, consistent with excessive downward movement of the parent spindle and blade. The aft section of one of the main landing gear skids was bent upward to about 45°. The left-seat flight controls were installed.

Examination of the engine revealed multiple fractures of the engine case, along with extensive thermal damage. The engine cooling fan exhibited upward crushing with no rotational signatures on the non-impacted top section of the fan. The upper sheave exhibited deep score marks and dents, along with a buildup of material at the end of one deep score mark that showed movement in the direction opposite of normal rotation. Most of the external components of the engine were extensively thermally damaged. Spark plug examination revealed some exhibited normal color when compared with a Champion Check-A-Plug chart,

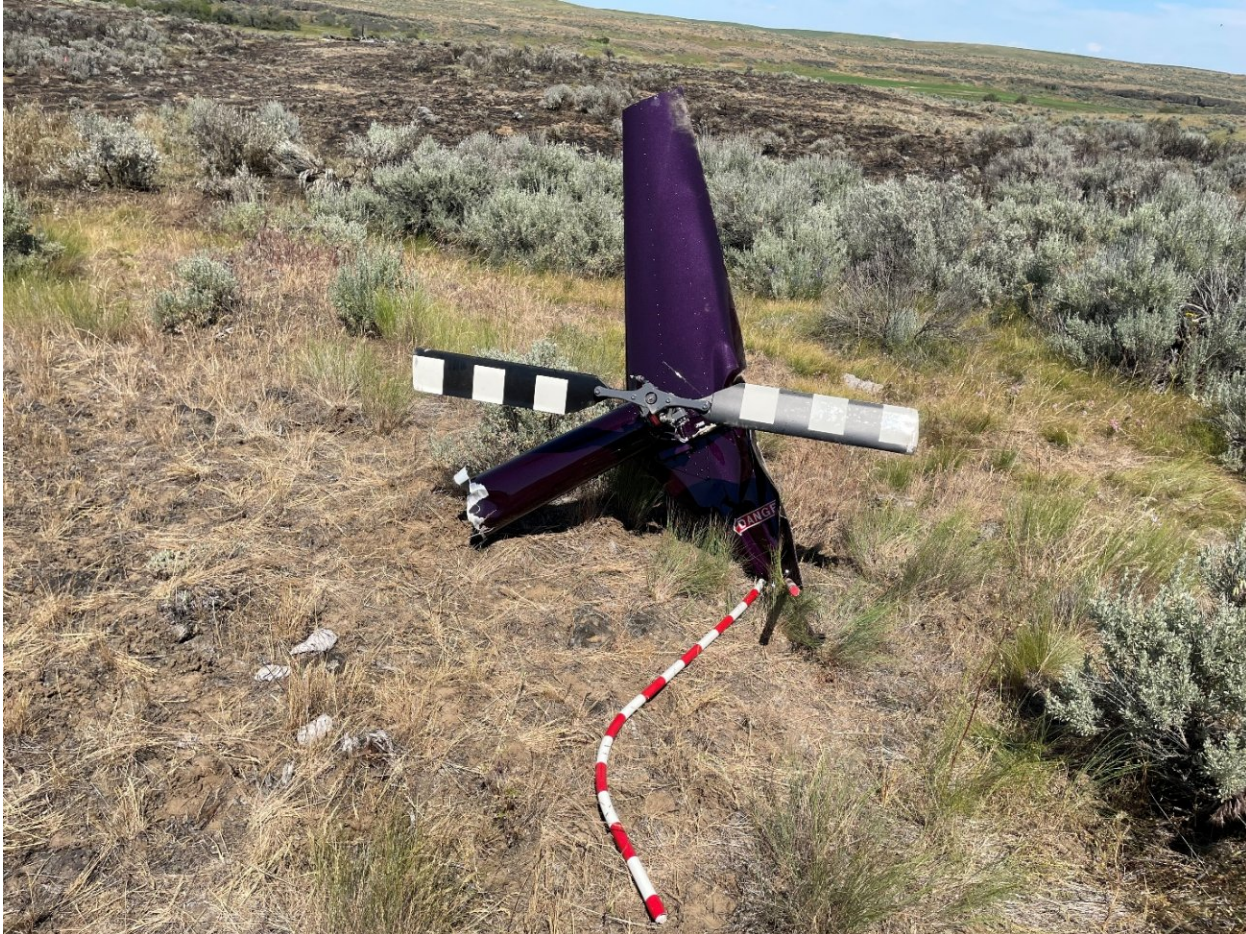
The empennage, including the tail rotor gearbox, tail rotor assembly, and about two ft of the tailcone, separated from the helicopter and was about 338 ft southwest of the fuselage (see figure 2). Examination of the empennage revealed no indication of smoke or soot deposits.

Figure 2. Helicopter empennage, including the tail rotor gearbox and tail rotor assembly.
