INVESTIGATION REPORT

**Person entrapped in lowered CCTV level crossing,
Ashfield, Offaly, 24th May 2020**

RAIU Investigation Report No: 2021 – R003

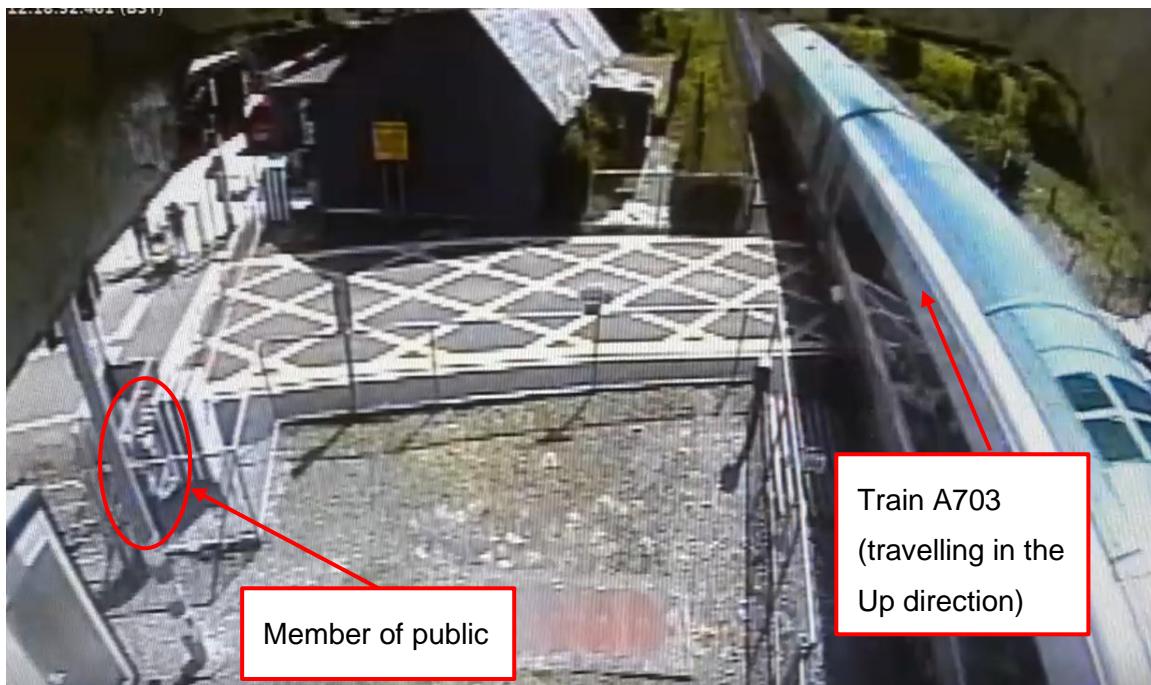
- 13 At ALCC, LCCO1 clears the crossing for the passage of Train A703 with one adult and child trapped inside the confines of LC XA068; the adult lifted the child over the barriers to the other adult. The trapped MOP, using the telephone at the level crossing, contacts LCCO1. LCCO1 advises the MOP that they would raise the barriers and instructs the MOP to stand beside some level crossing equipment (clear of the tracks, but within the confines of the level crossing). However, LCCO1 did not raise the barriers and allowed Train A703 to pass through LC XA068, see Figure 2.

Figure 2 – Train travelling through LC XA068

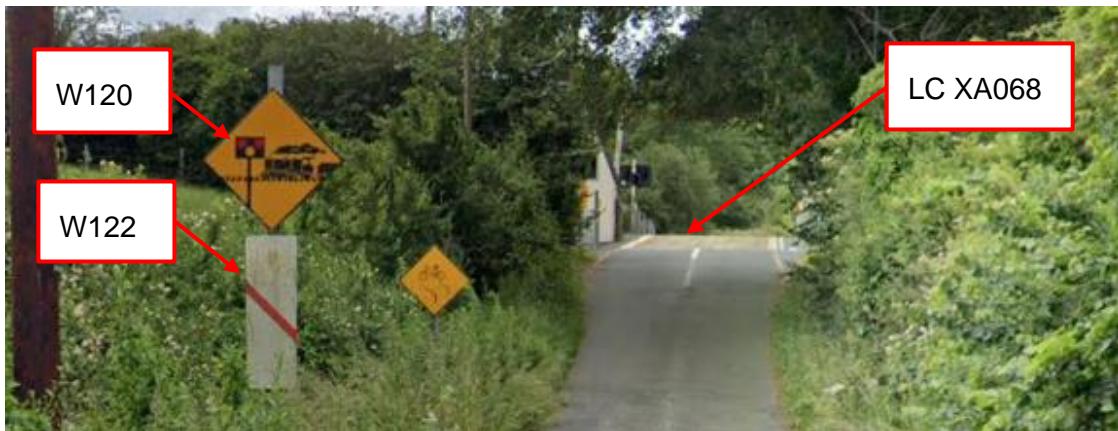
Figure 5 – Road signage on approach to LC XA068

- 40 LC XA068 has the correct approach signage, see Figure 5.

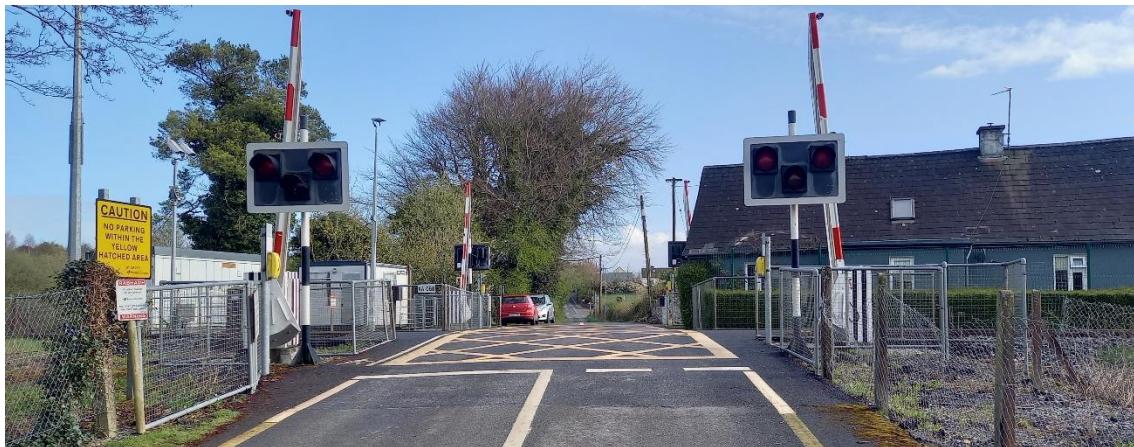
Figure 6 – Flashing Red Signals & Yellow Box Markings

- 41 In addition, LC XA068 has the correct road level crossing signals located on each side of the Stop lines, see Figure 6.

- 42 At the level crossing, the road is covered in Yellow Box Markings (Chapter 7, Traffic Signals Manual); this is to avoid the blocking of road traffic on the level crossing (see Figure 6). These road markings are accompanied by caution signs stating "Caution: No parking within the Yellow Hatched Area). Adjacent to the Yellow Box Marking are marking, indicating where pedestrians should cross the level crossing.
- 43 There are two signs at XA068 states "Drivers of large or slow vehicles or herds of animals must phone before crossing".
- 44 There are no signs warning pedestrians not to enter the level crossing once the warning lights and bells for the level crossing flash and sound; there are also no signs inside the barriers of the level crossing, telling MOPs what actions to take in the event they become trapped.

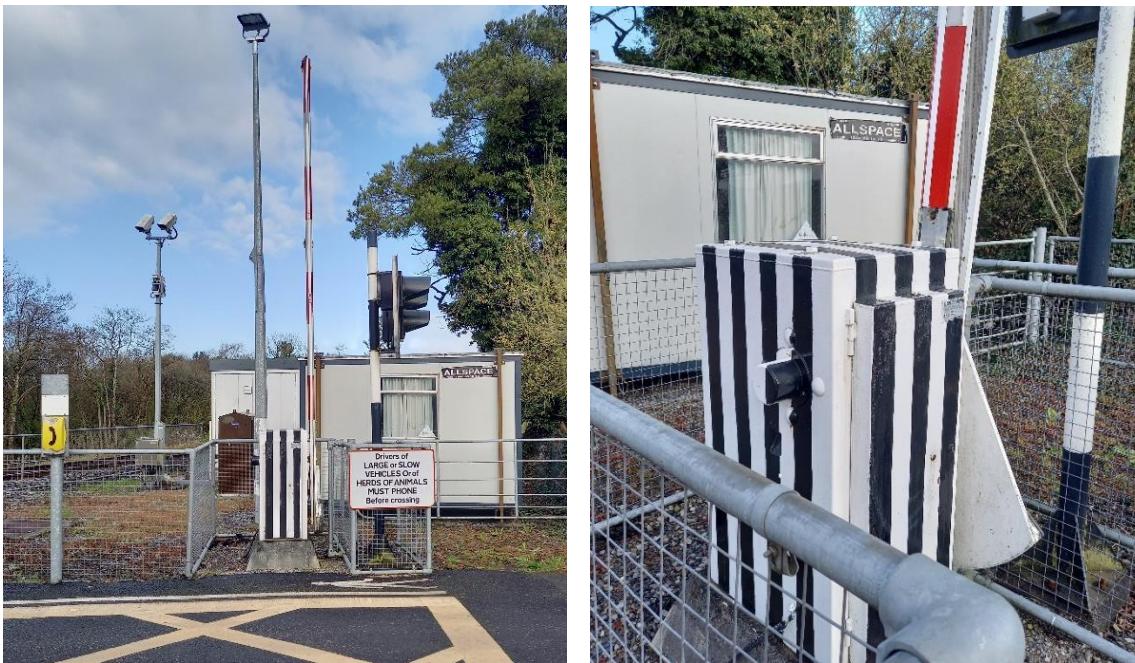
Figure 7 – Barrier machine at LC XA068

- 45 There are four lifting barriers (two *entrance barriers* and two *exit barriers*), each fitted with two boom lamps and a skirt. The lifting barriers are attached to barrier machines (striped boxes in Figure 7) which house level crossing equipment.

- 46 Telephones are provided at LC XA068; two of these telephones are located on the railway side of the barriers and the other two are located on the public roadside of the barriers (see Figure 7 for the telephone used by the MOP on the day of the incident).

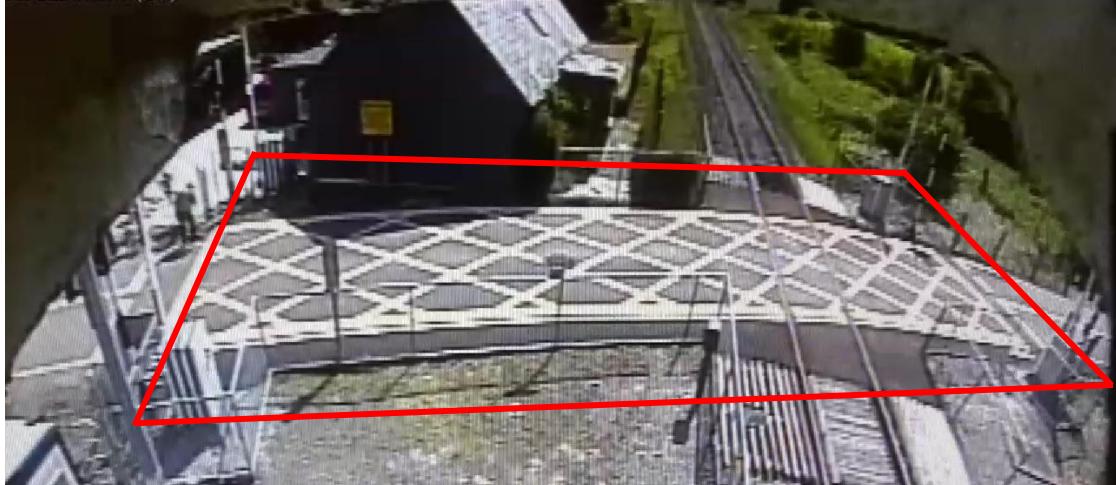
Figure 9 – Viewing area of LC XA068

- 49 I-TEL-3516 also sets out the requirements for the location of the CCTV at the level crossings, which provide the optimum views of the level crossing e.g. nominally perpendicular to road traffic, north-facing, etc.
- 50 The CCTV cameras for LC XA068 are mounted on standard steel poles located on the Athlone side of the level crossing. The orientation of the CCTV cameras is in a south east direction. Figure 9 shows the viewing area of LC XA068.

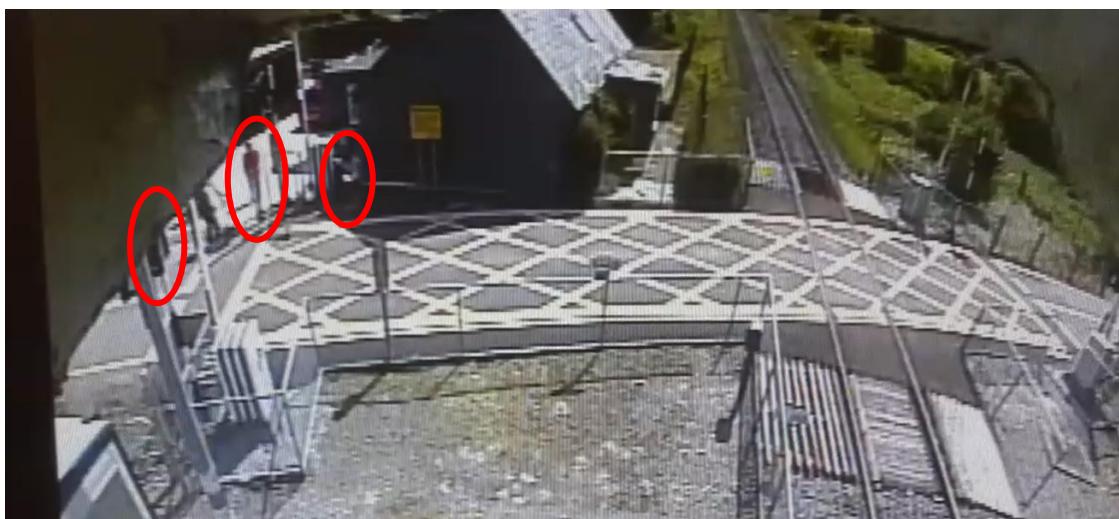
- 86 At 12:13:52 hrs MOPs (MOP1, MOP2 and Child) are at in the vicinity of LC XA068; the Child is playing with a bicycle in the confines of LC XA 068, see Figure 16 (the following CCTV still images are taken from the CCTV footage of LC XA068 from the LCCC Athlone).

Figure 16 – MOPs in the vicinity of LC XA068 (circled red)

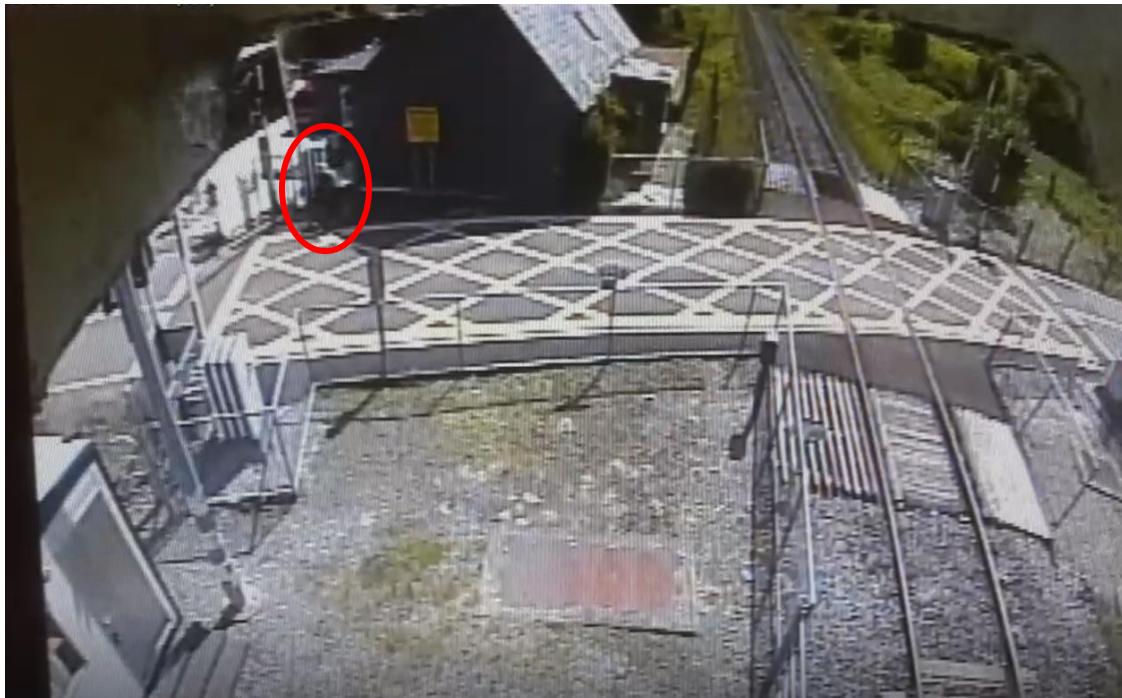
- 88 At 12:14:13 hrs, the entrance barriers begin to lower; two MOPs (MOP1 and Child) remain within the confines of LC XA068, circled together in Figure 17.

Figure 17 – Two MOPs (circled red) within the confines of LC XA068

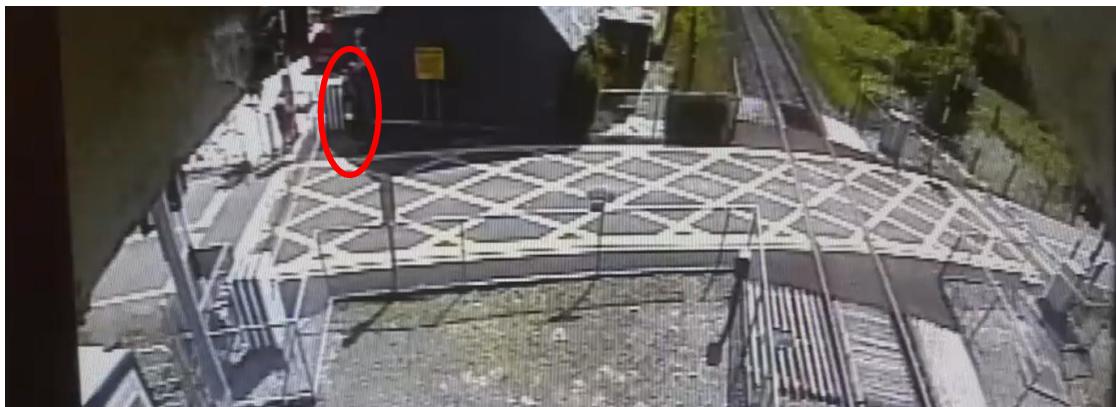
- 91 At 12:14:27 hrs, at ALCC, LCCO1 presses the “Crossing Clear” buttons (two seconds after the four barriers have been fully lowered); one second later, at 12:14:28 hrs, LCCO1 presses the “Signal Controls – Request”, to clear the rail signals to proceed, as set out in paragraph 74. LCCO1 stated that they did not see any MOPs in the confines of the level crossing. It should be noted that in the still image taken at the moment the crossing was cleared, shown in Figure 18, that the MOPs are in the shadows cast from the house and with the house painted a dark colour they are difficult to distinguish in the still; however, when the live CCTV footages is viewed the MOPs movements are clearly visible.

Figure 18 – Moment LC XA068 cleared within two MOPs inside the barriers

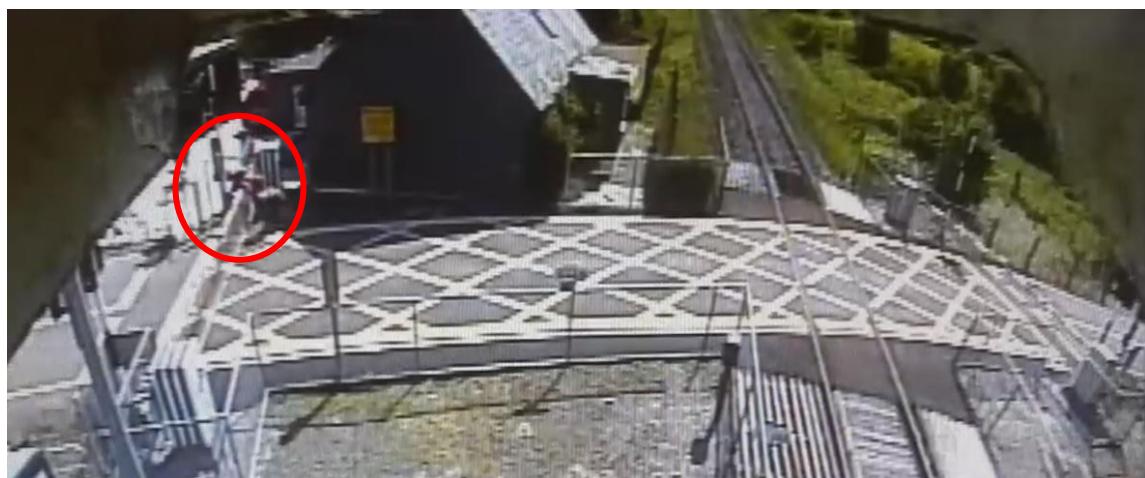
- 92 At 12:14:31 hrs the distant signals (Up Distant and Down Distant) and stop signals (Up Stop and Down Stop) are all displaying proceed aspects.
- 93 At 12:14:34 hrs, MOP1 lifts the Child over the barriers to MOP2 (see Figure 19) and moves the bicycle clear of the road and railway; MOP1 remains trapped within the barriers.

Figure 19 – MOP1 lifts child over the barriers to MOP2 (circled red)

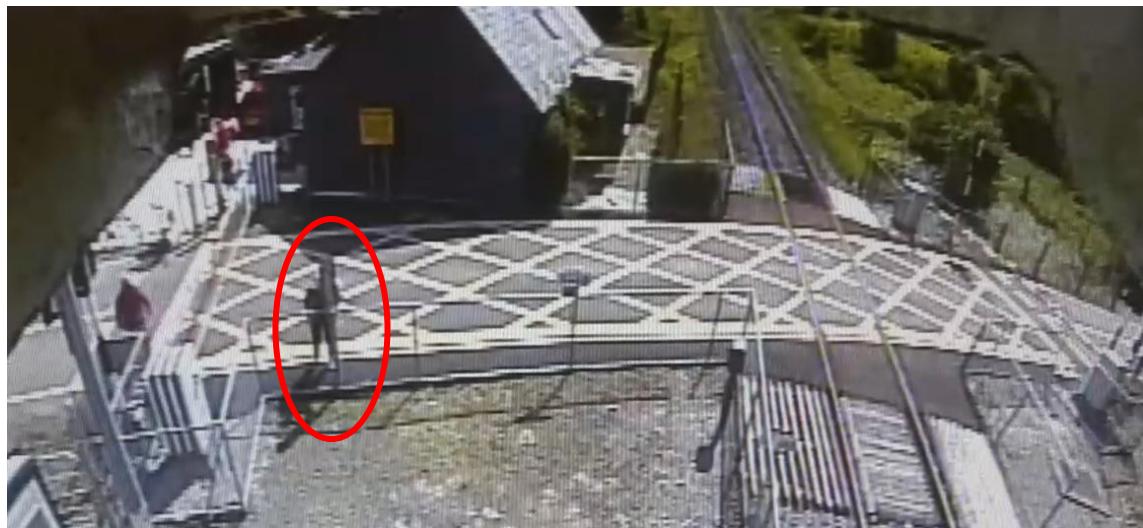
- 94 At 12:14:54 hrs, MOP1 walks over the telephone, see Figure 20.

Figure 20 – MOP1 at telephone (circled red)

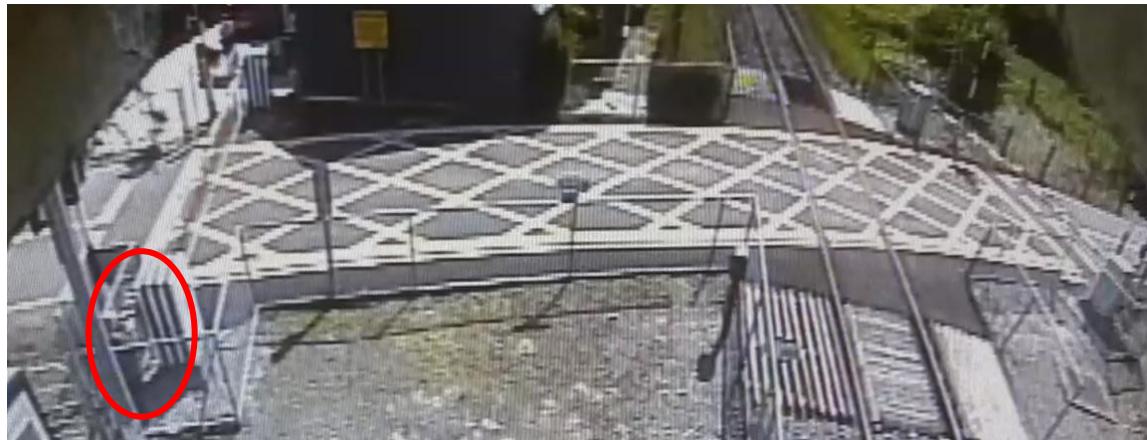
97 At 12:16:14 hrs, after finishing the conversation with LCCO1 and hanging up the telephone, MOP1 walks away from the telephone and stands behind the barrier machine on the Up side of the track, see Figure 21 (circled red).

Figure 21 – MOP1 behind the housing for the level crossing

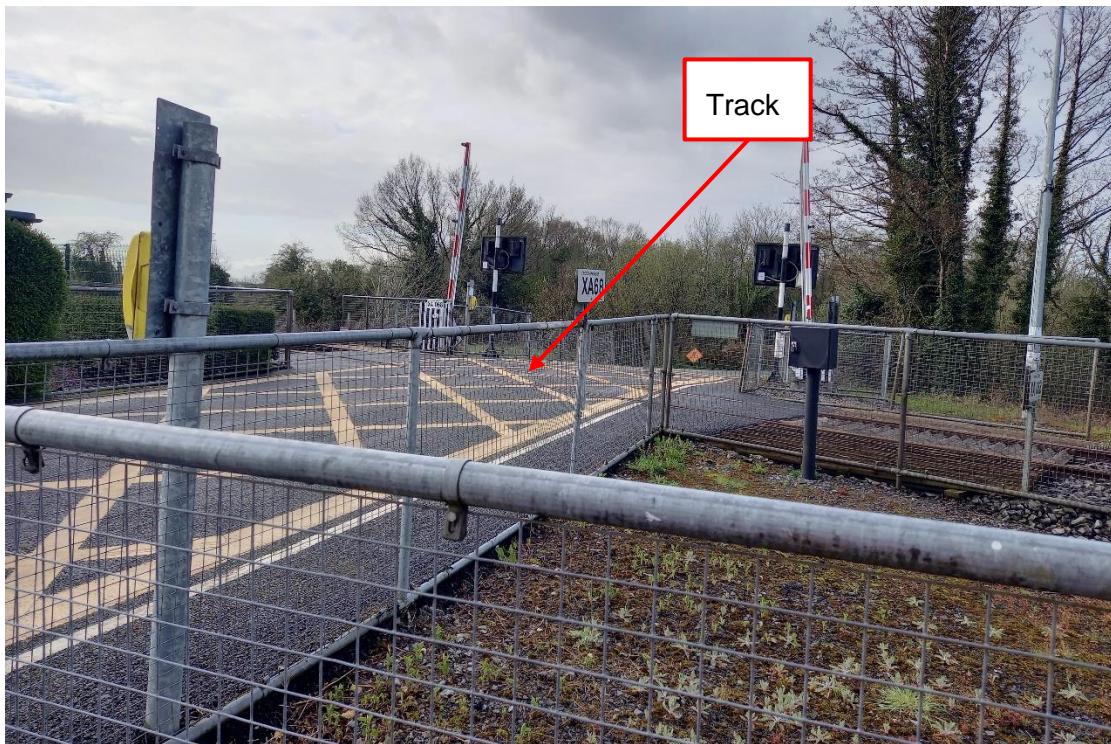
Figure 22 – View from MOP1's position behind the barrier machine taken by the RAIU

98 MOP1 is in this position at 12:16:20 hrs and remains here until Train A703 has passed through the level crossing and the barriers are ultimately raised, see Figure 22 for MOP1's position in relation to the track.

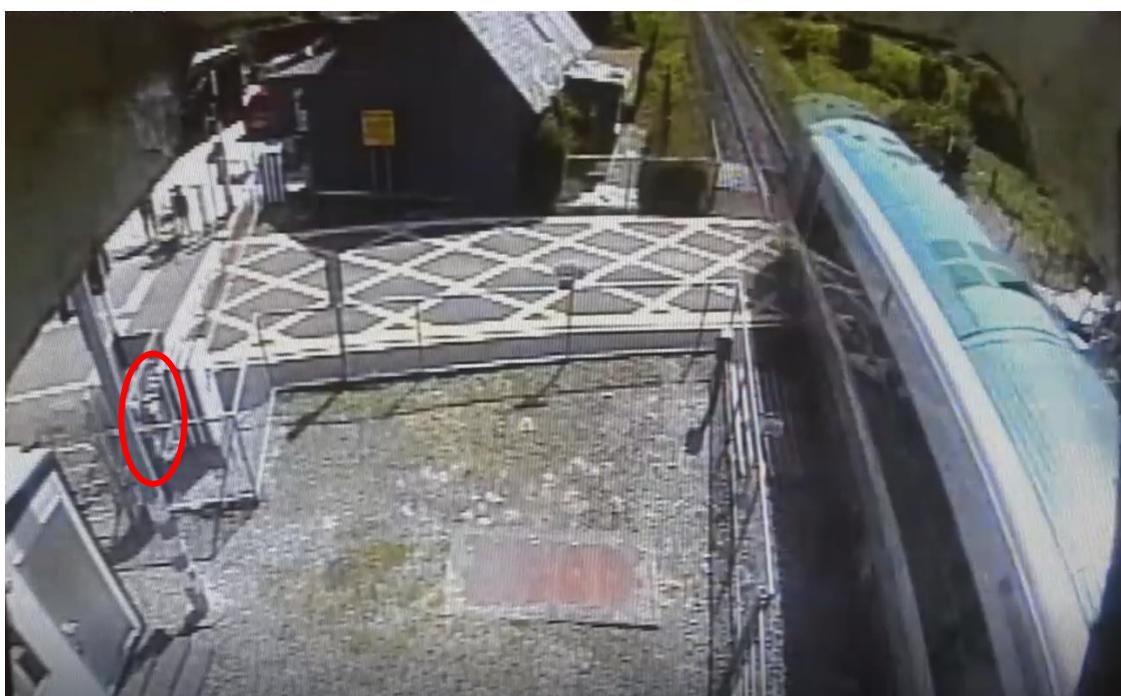
105 At 12:18:50 hrs, Train A703 arrives at and passes over LC XA068 with MOP1 still within the confines of the level crossing behind the barrier machine, see Figure 23.

Figure 23 – MOP inside barriers as Train A703 passes through LC XA068

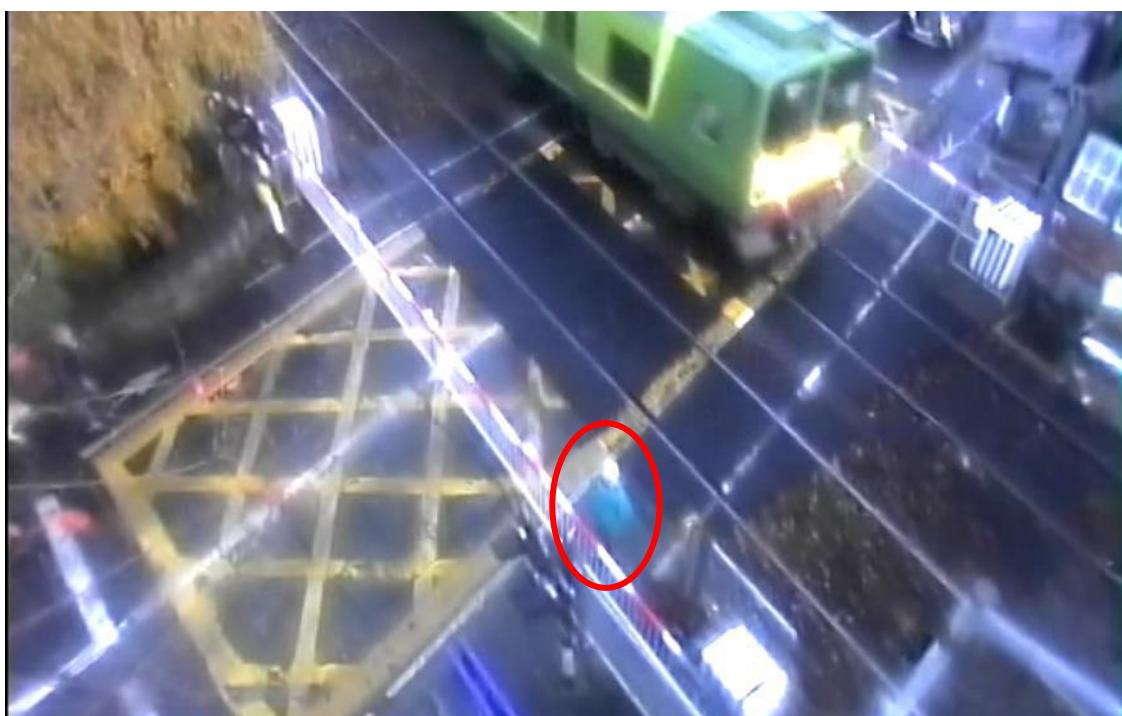
125 The LCCO pressed the “Crossing Clear” buttons at 09:24:18 hrs with the MOP inside the barriers, with Train E212 passing through LC XR004 at 09:25:19 hrs, see Figure 26.

Figure 26 – MOP (circled red) inside the barriers of LC XR004 with Train E212

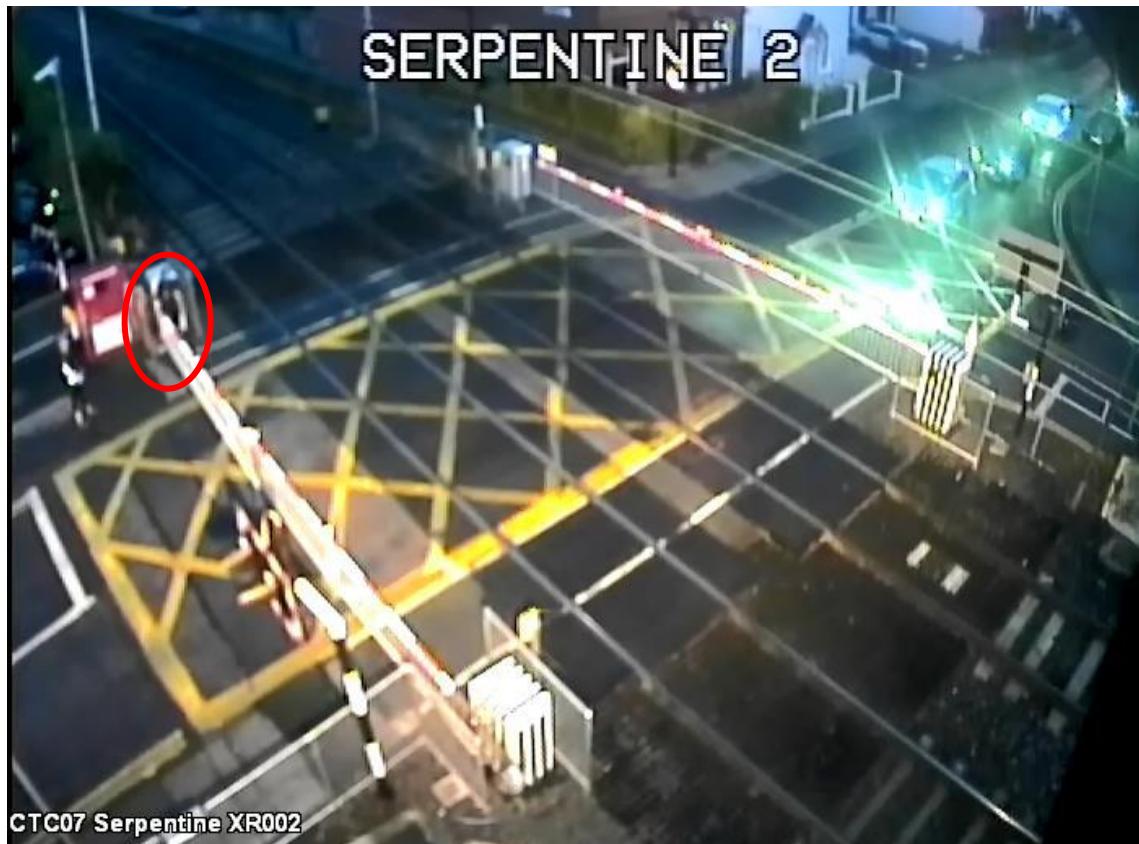
129 On Tuesday the 11th December 2018, the initiation for LC XR002 was triggered by the 07:24 hrs passenger service from Greystones to Howth (Train E906). The warning lights and bells for the crossing flashed and sounded, respectively. Approximately twelve seconds after the initiation sequence commenced a MOP entered XR002 and was unable to exit as the barriers had fully lowered. The MOP stood in front of a barrier machine, with a mesh fence separating the MOP from the running line, see Figure 27.

Figure 27 – MOP (circled red) inside the barriers of XR002

131 There was one recommendation as a result of the incident, namely, the CCE should examine the feasibility of installing signage at CCTV Level Crossings warning pedestrians not to enter the crossing once the warning lights and bells for the crossing flash and sound.

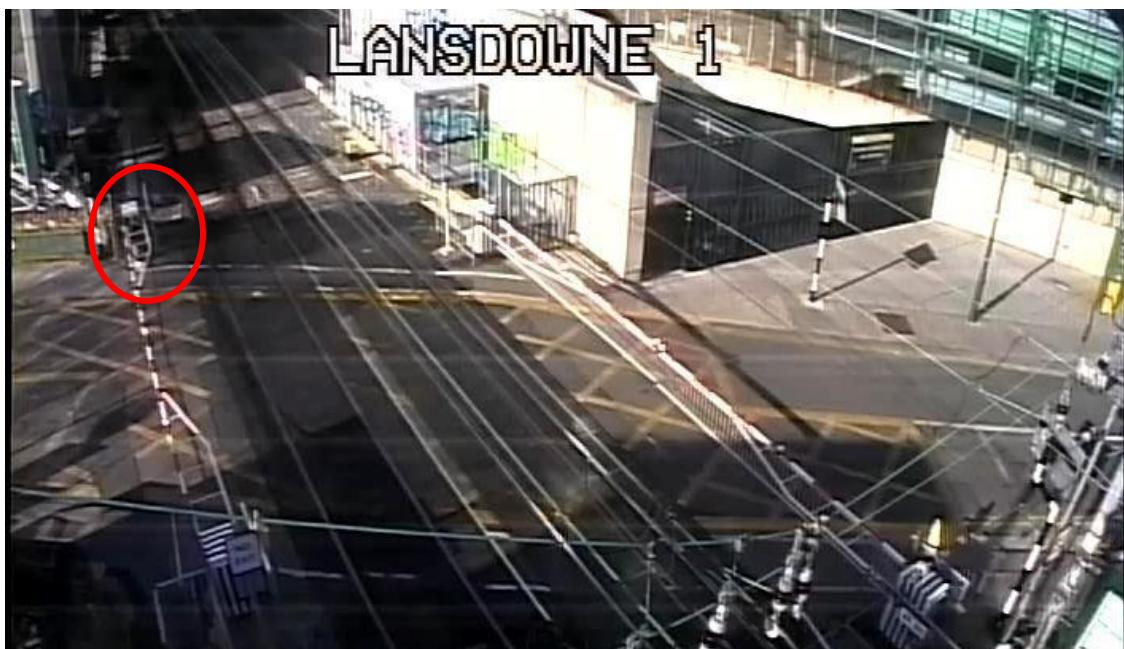
134 A MOP, with a dog, entered LC XR001 after the lowering sequence had commenced and had insufficient time to exit LC XR001 as the barriers had fully lowered. The MOP climbed under the barrier supporting frame and stood between the main barrier boom and the supporting frame, see Figure 28.

Figure 28 – MOP (circled red) inside the barriers of LC XR001

137 There was one recommendation as a result of this incident, namely that the CCE should examine the feasibility of installing signage at CCTV Level Crossings warning pedestrians not to enter the crossing once the warning lights and bells for the crossing flash and sound.

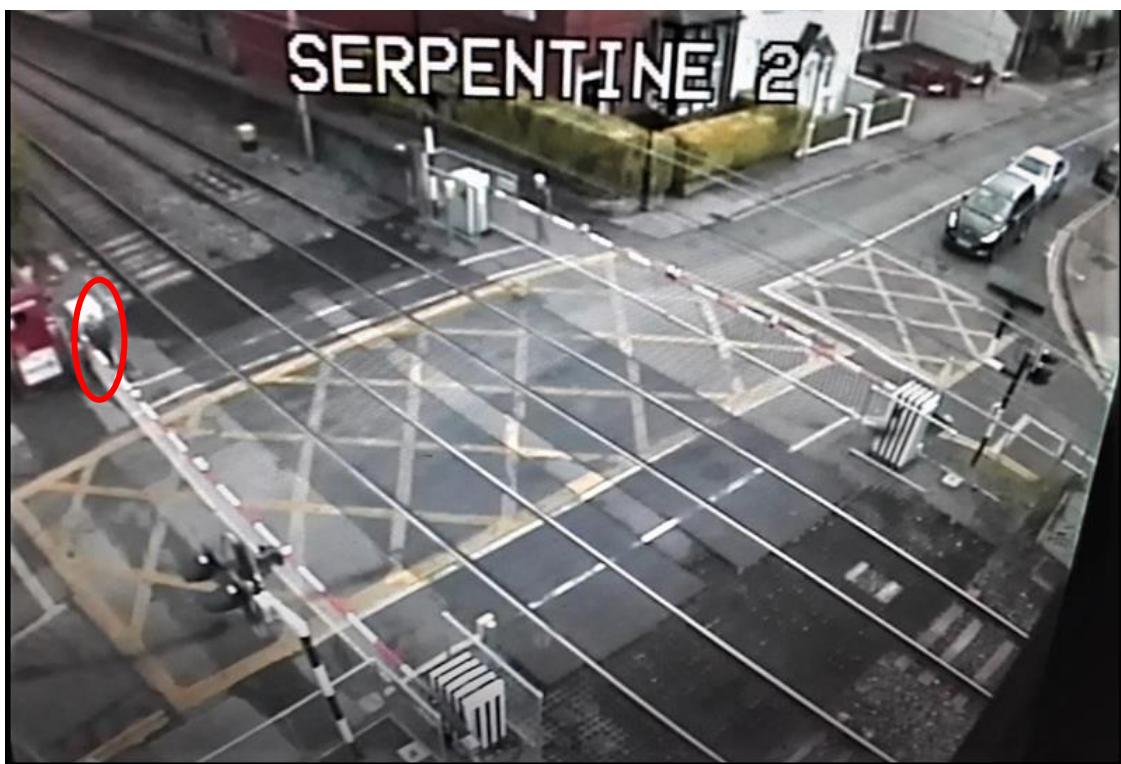
140 At 13:06 hrs the LCCO cleared LC XR002 for the passage of trains with the MOP inside the barriers, Figure 29.

Figure 29 – MOP (circled red) inside the barriers of LC XR002

142 There was one recommendation as a result of the incident, namely, that the CCE should examine the feasibility of installing signage at CCTV Level Crossings warning pedestrians not to enter the crossing once the warning lights and bells for the crossing flash and sound.

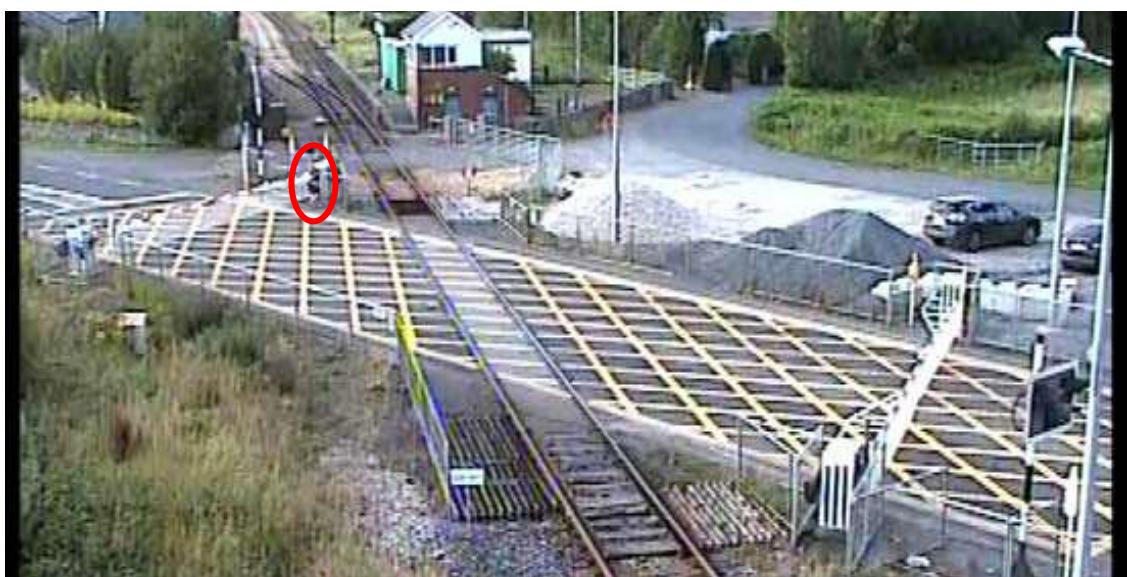
145 After the warning sequence was initiated, a MOP, jogged onto the level crossing but was unable to clear as the barriers had fully lowered. The MOP then stood in front of the level crossing barrier, see Figure 30

Figure 30 – MOP (circled red) inside the barriers of LC XM065

149 One safety recommendation was made, namely that the CCE should examine the feasibility of installing signage at CCTV Level Crossings warning pedestrians not to enter the crossing once the warning lights and bells for the crossing flash and sound.

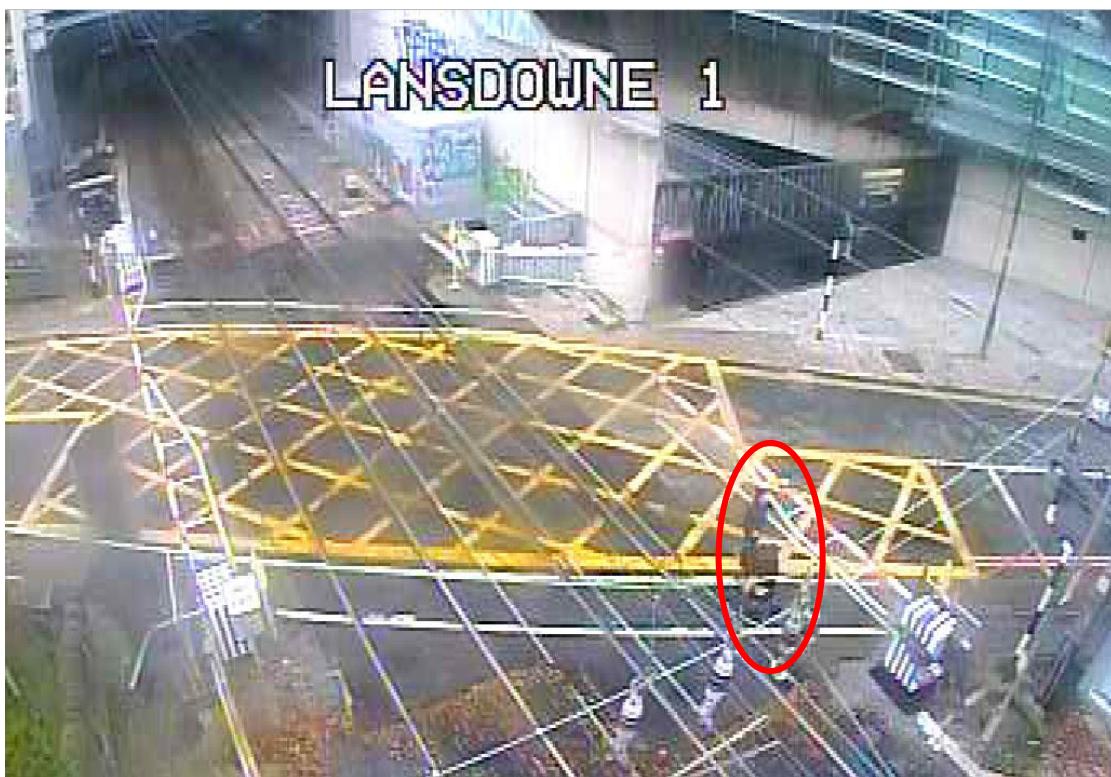
151 The warning lights and bells for the crossing flashed and sounded, respectively. However, at 11:01:58 hrs a MOP pushing a buggy entered the confines of LC XR001 during the warning sequence and was trapped when the barriers fully lowered, Figure 31.

Figure 31 – MOP with buggy (circled in red) inside the barriers of LC XR001

154 There was one recommendation made as a result of the incident: The CCE should examine the feasibility of installing signage at CCTV Level Crossings warning pedestrians not to enter the crossing once the warning lights and bells for the crossing flash and sound.

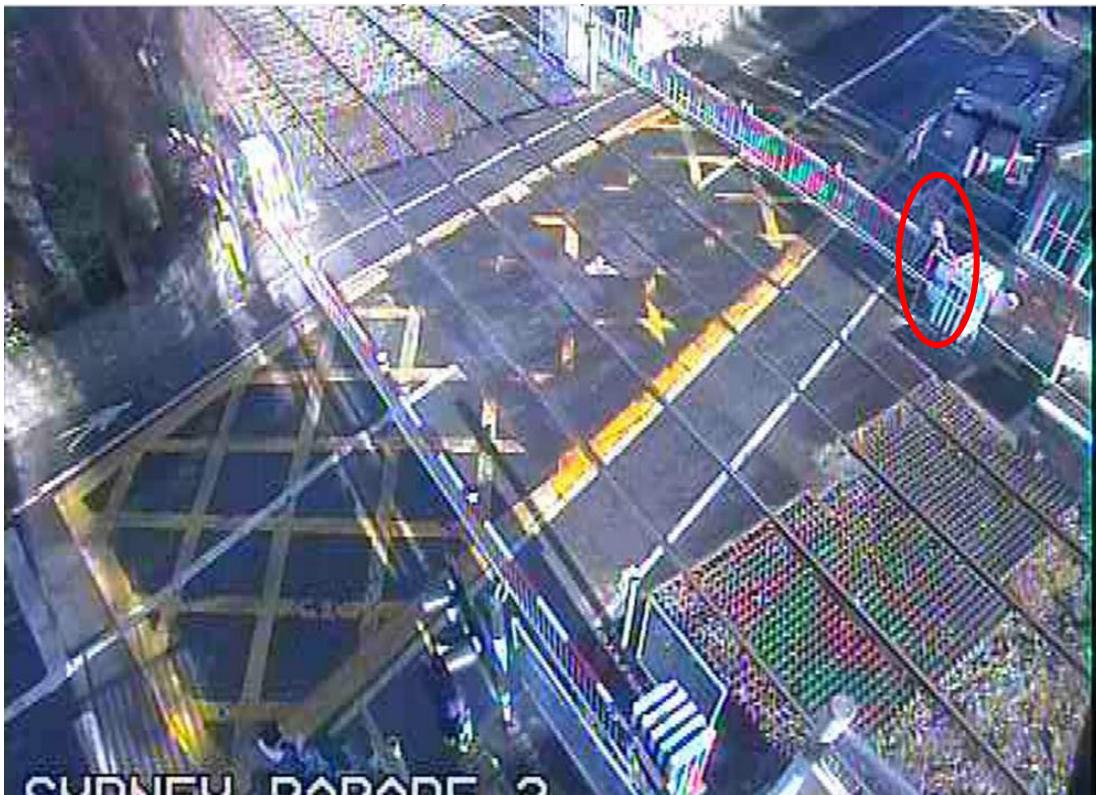
156 The warning lights and bells for the crossing flashed and sounded, respectively. However, a MOP entered LC XR004 and had insufficient time to clear LC XR004. The MOP took refuge between the barrier boom and the protecting mesh fence between the boom and the Down line (Figure 32).

Figure 32 – MOP inside at the barriers (circled red) at LC XR004

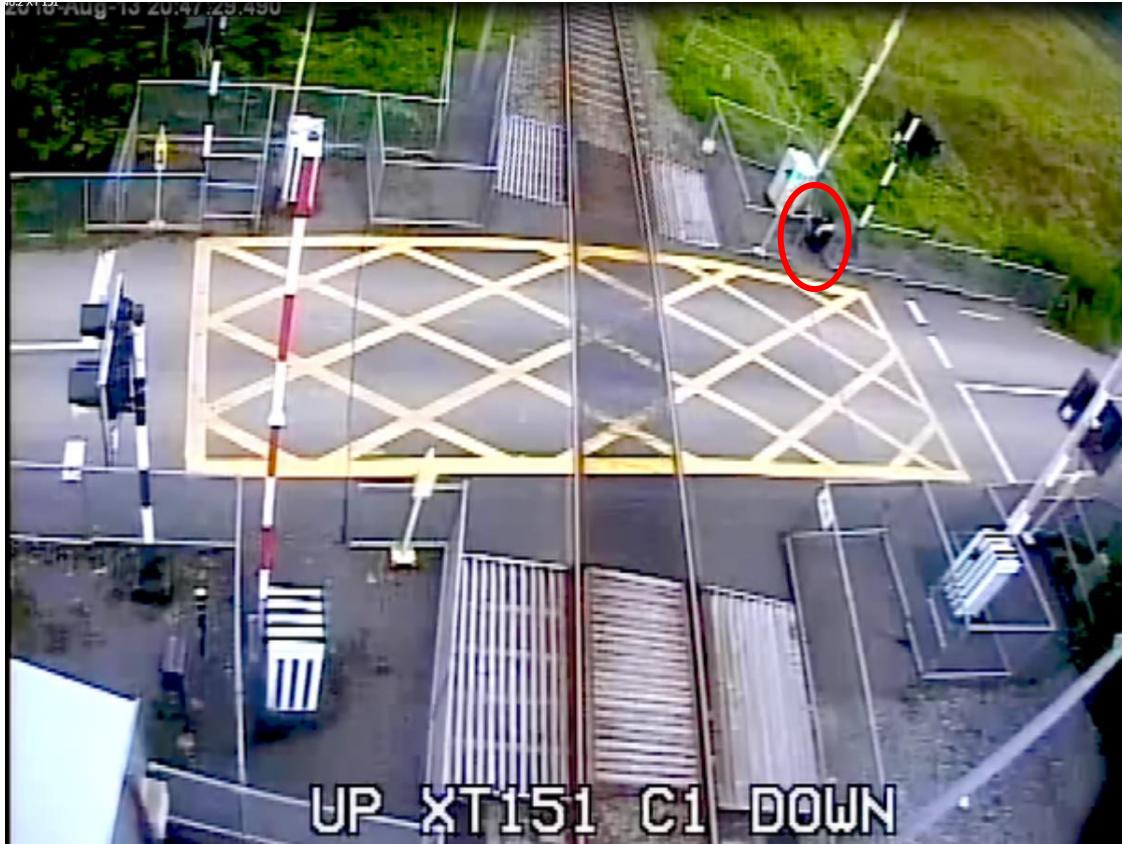
166 On the 13th August 2018, two MOP entered LC XT151 and sat under the exit barrier, see MOPs circled red in Figure 34.

Figure 34 – Two MOPs (circled red) inside the barriers of XT151

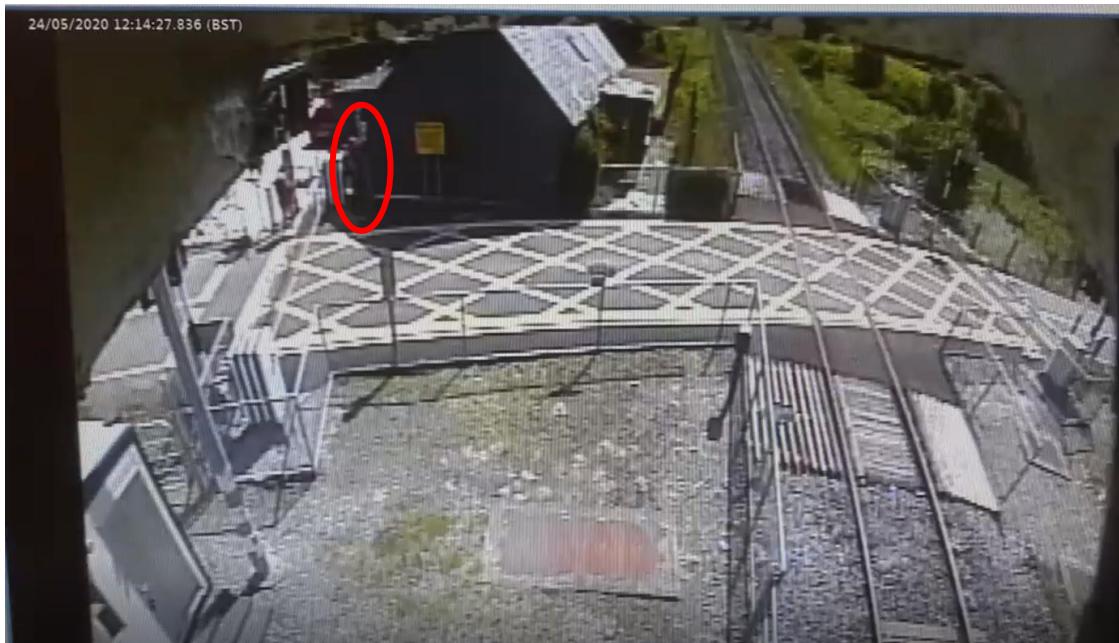
Figure 35 – Moment LC XA068 cleared within two MOPs inside the barriers

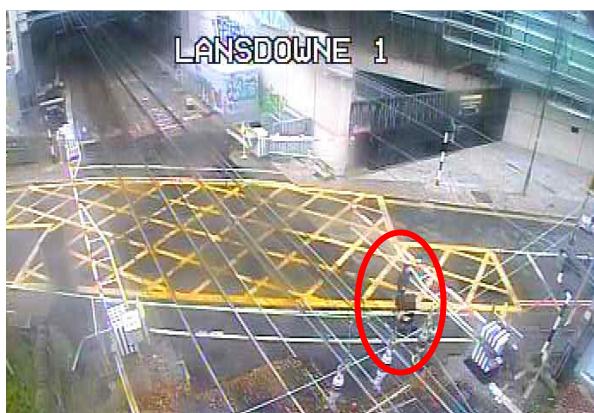
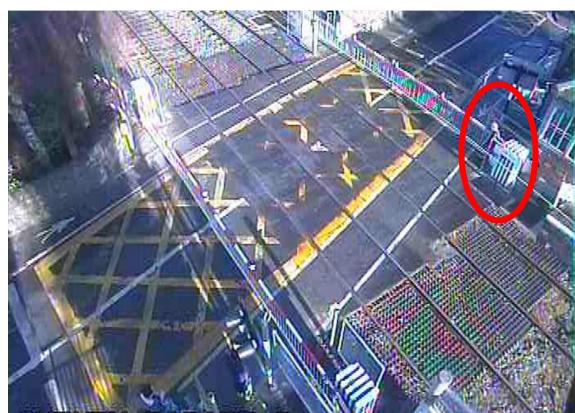
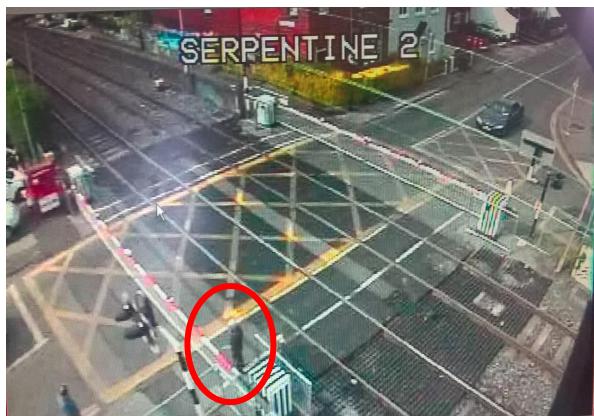
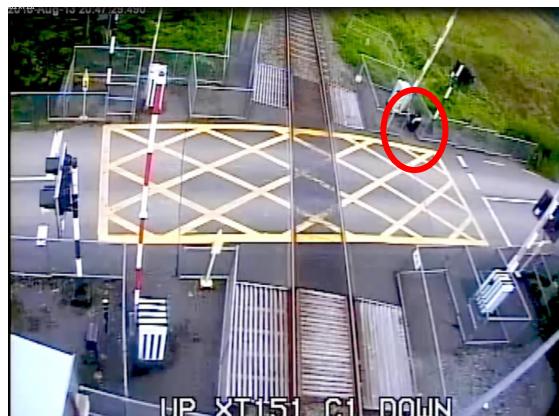
195 Of the eleven similar occurrences highlighted in this report, where MOPs were trapped inside the barriers, it was noted that in four of these incidents (paragraphs 113, 150 - 173) the LCCOs saw movement at the last moments and pressed the “Emergency Alert” function or cancelled the signals (in the case of Ahane No. 2, paragraph 194). The still CCTV images of these occurrences are presented in Figure 36.

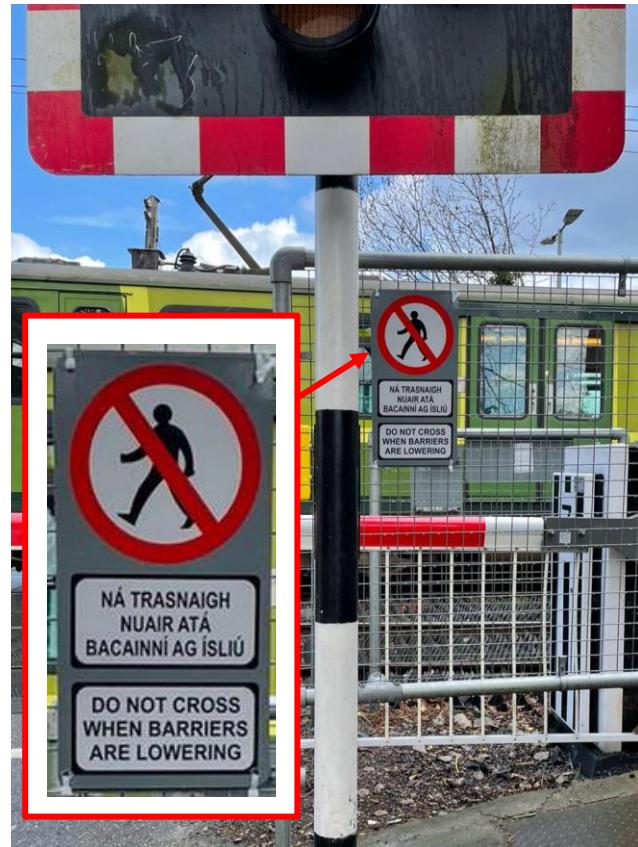
Figure 38 – Signage at CCTV level crossings

218 As of the time of publication of this report, signage is being erected at CCTV level crossings, see Figure 38.
