**State Commission on Rail Accident Investigation  
Ministry of Infrastructure**

## **Report No. PKBWK/03/2018 (summary)**

**from an investigation of serious accident - category A04  
which occurred on 30 August 2017. at 21:53  
at Smętowo station, in station track No. 2,  
in km 457,485 railway line No. 131 Chorzów Batory - Tczew**

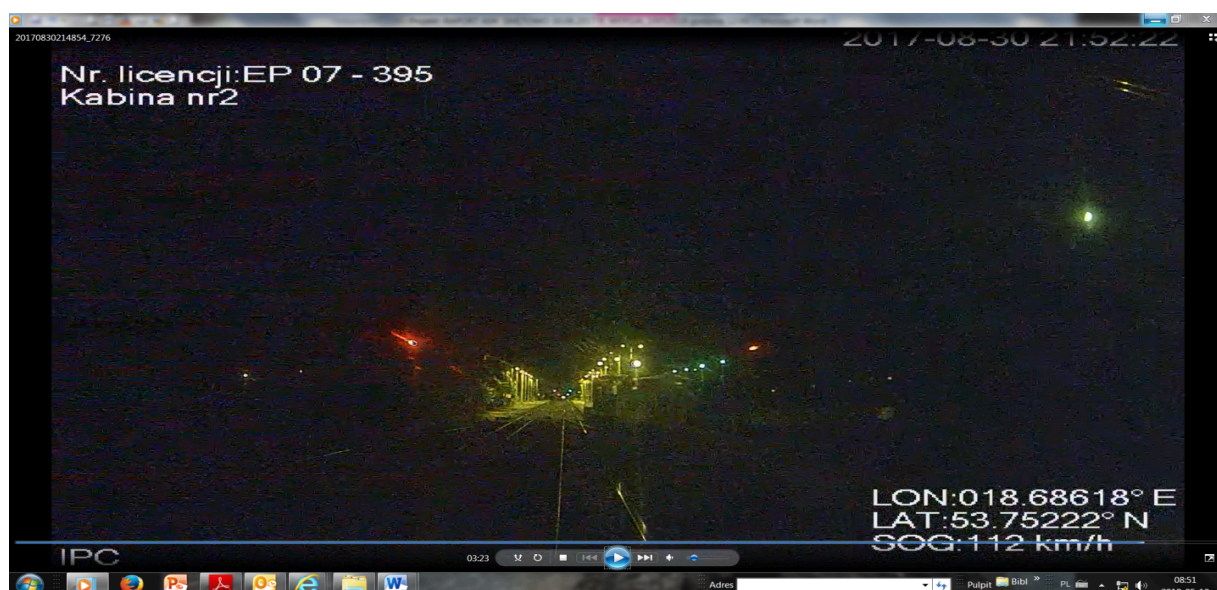
Picture from about 80 meters before the collision site

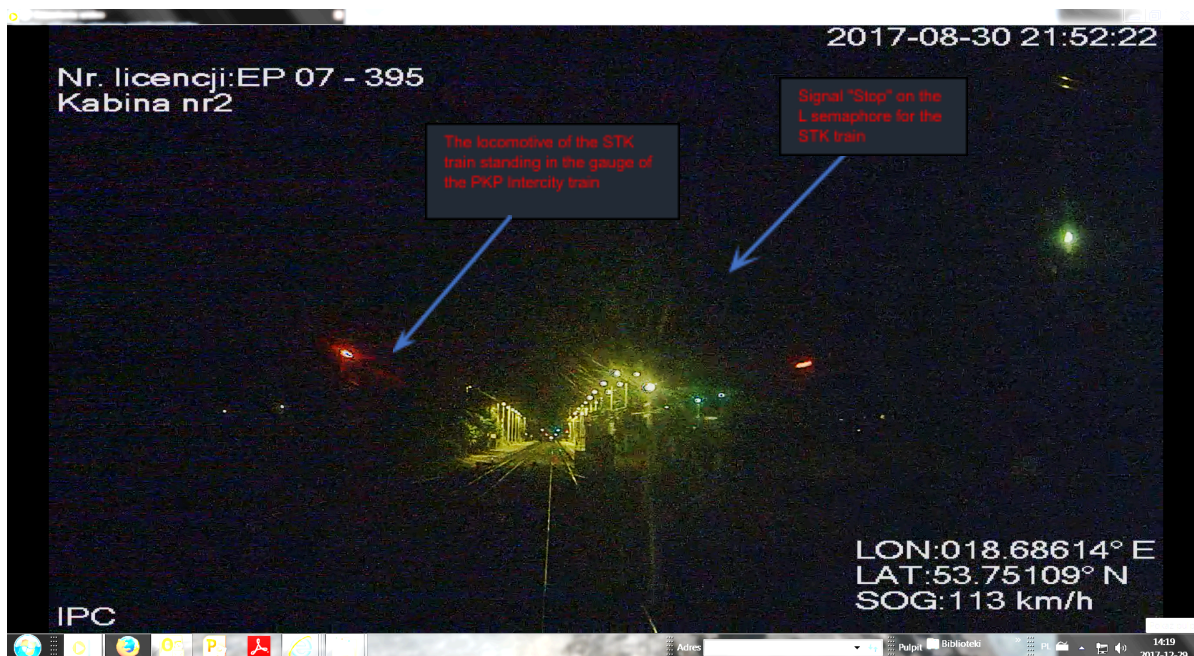
View from the PKP Intercity S.A. locomotive cabin from about 40 m before the impact

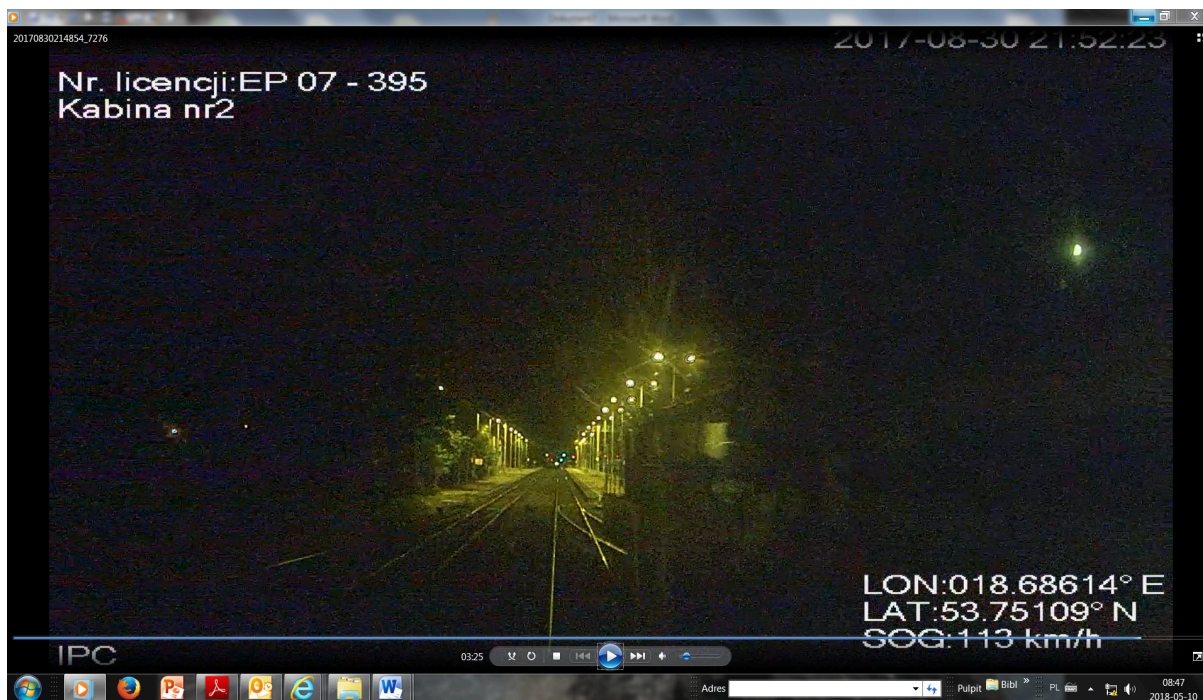
View from the PKP Intercity S.A. locomotive cabin from about 10 m before the impact
