The NStar Chronicle

The Project North Star Association of Canada

Volume 16 | Issue 2 | September 2020

The Four Merlins: The First Two

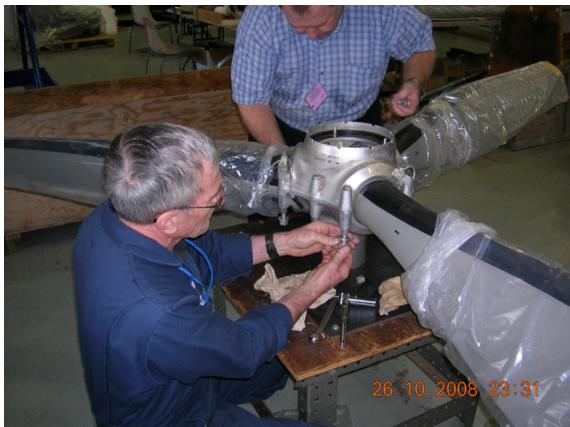
Mike Hope and Bruce Gemmill assembled Prop 1 ready to install on Engine 1 October 26, 2008.

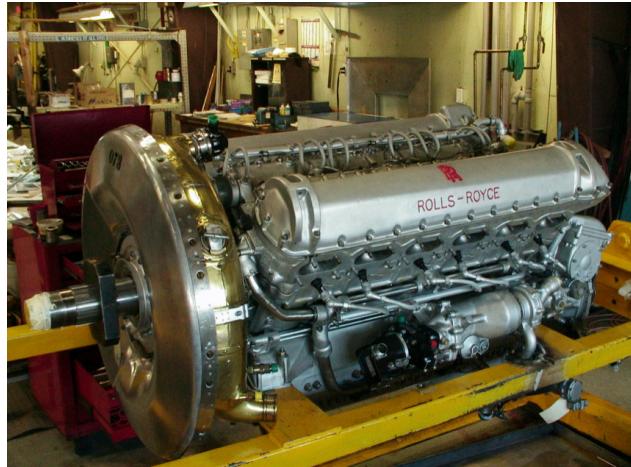
Engine 1 assembled in the Conservation shop Feb 2, 2010.

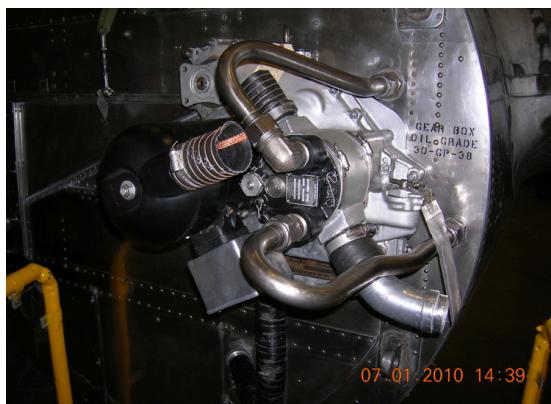
Firewall ready, auxiliary gearbox installed Jan 7, 2010.

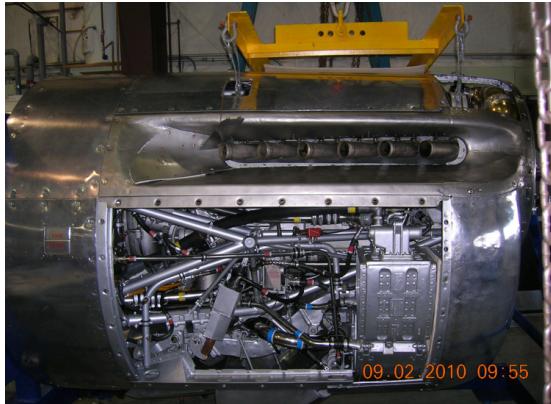
Engine 1 complete at the Restoration Shop Feb 9, 2010 .

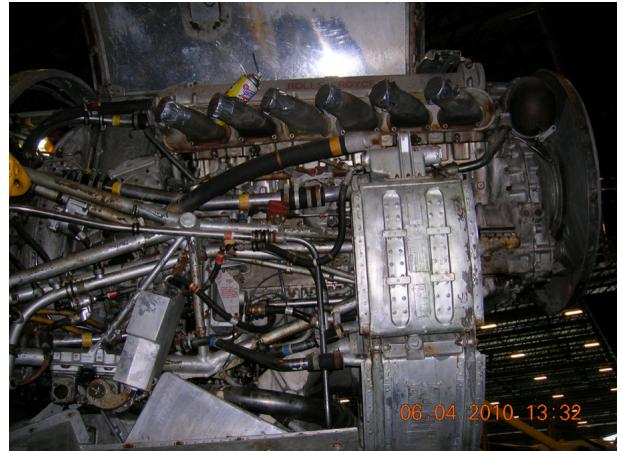
Engine 2 with cowl panels removed, April 6, 2010.

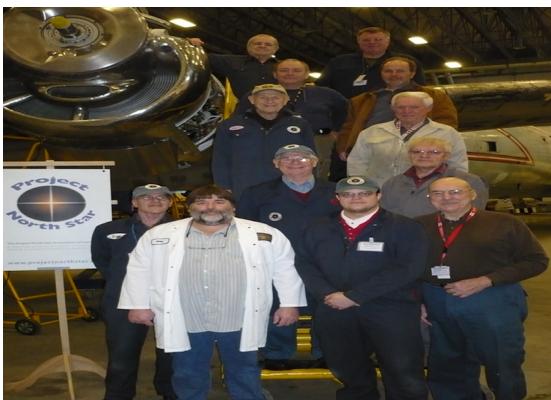
Engine 1 installed Feb 24, 2010. Shown top left to bottom right, engine supervisor Ted Devey, Bill Tate, Ron Lemieux, Giuseppe Zanetti, John Corby, Garnet Chapman, Volunteer Project Manager Jim Riddoch, John Tasseron, Bruce Gemmill, Museum Project Coordinator Mike Irvin, Charles Baril, and then Association President Tim Timmins.

The engine was reinstalled on February 24, 2010 and the crew could take a short break before beginning work on engine 2.

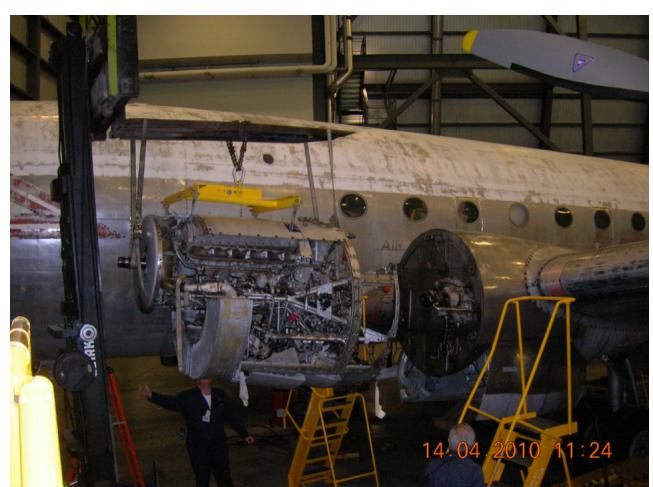
Engine 2 removed April 14, 2010.

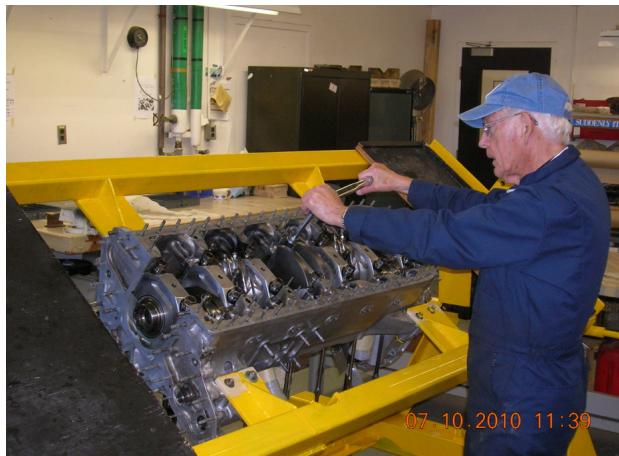
Stan Rideout working to reassemble Engine 2 in engine shop, Oct 7, 2010.

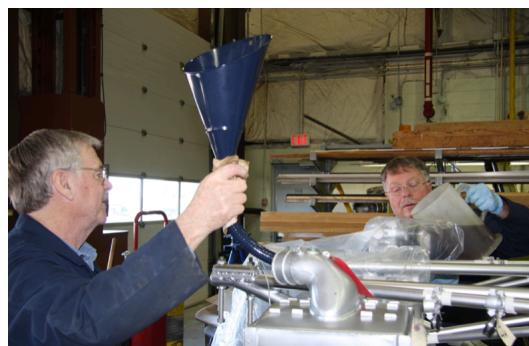
Jim Riddoch and Bill Tate fill the radiators with inhibiting oil.

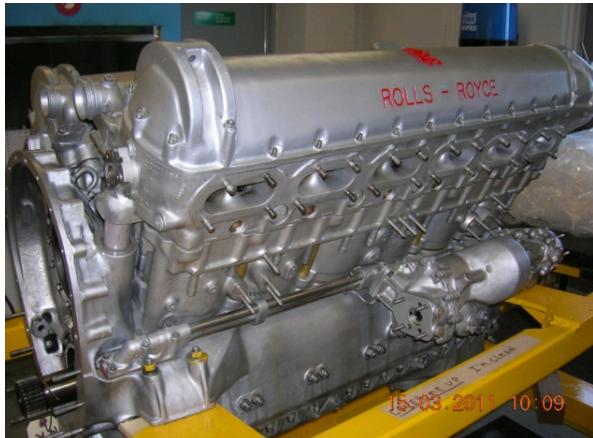
Engine 2 on rotating assembly stand.

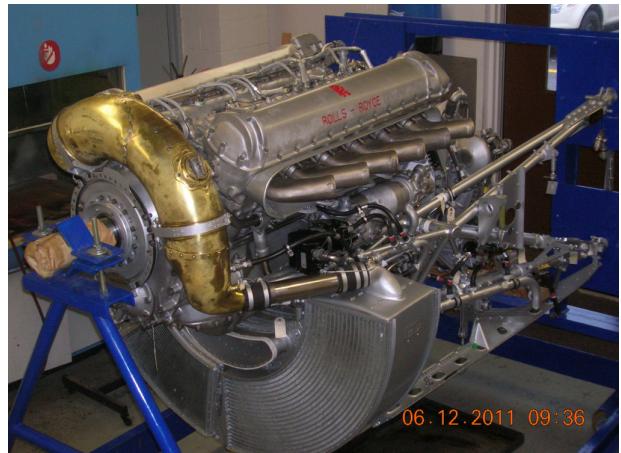
Engine Nr 2 being re-assembled in the engine shop.

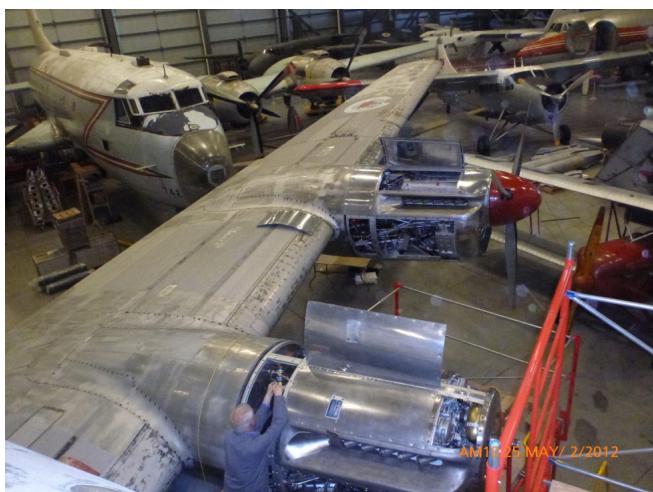
Finally, after six years of work by a host of dedicated volunteers, both restored engines were once again fitted to the North Star by May 2012 as shown in the photo below.
