The Project North Star Association of Canada

Volume 16 | Issue 2 | September 2020

## The Four Merlins: The First Two

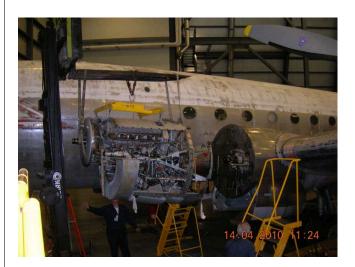
Engine 2 removed April 14, 2010.
