## Section 2: - Proposal to Preserve St David's Abbey Site

Carrigtwohill & District Historical Society

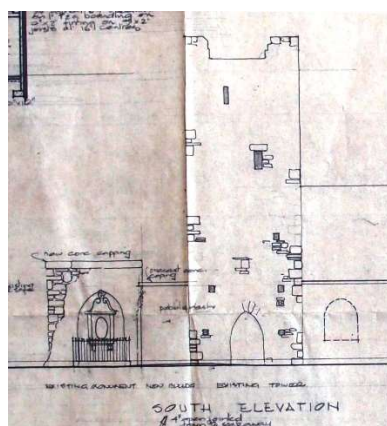
*South Elevation of Tower*

The first of these most important drawings was of O'Flynn Architects dated, 15<sup>th</sup> May 1979, for the extension to abut the north face of the tower. From the south elevation it is clear the Cotter vault was in the middle of the carpark attached to the remnants of the Abbey wall on the north wall, with a construction note stating, 'build up existing wall & make safe'. With wall was to 'new conc [concrete] capping'.

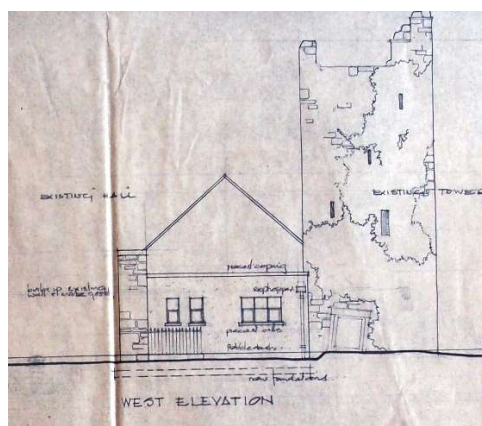
*West Elevation of Tower*

The west elevation also shows an outline of the Cotter vault in the same location. The construction note against the north face of north wall states, 'build up existing wall & make good,' and on the tower is a feature which could possibly be a doorway into the tower which has partially subsided. It is equally possibly a family vault which has suffered the same fate. The ground level at this point shown to be higher. This elevation proves the then surviving wall was of substantial thickness. As the images of these drawings are not to scale, it is impossible to determine its thickness. It is also sadly noted that this wall no longer exists, and must have been removed during the construction of the extent.

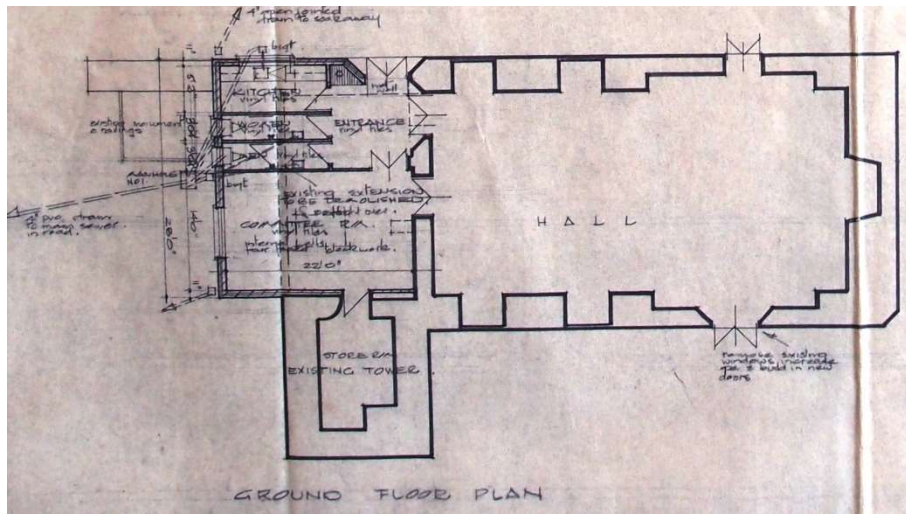
*Ground Floor Plan*

From the ground floor plan, it is clear to see the remnants of the Abbey outline forming the 'Hall', and the thickness of these walls which are shown as a shadow line beneath the north elevation of the extension, presumably used as foundations, but there is no comment to that effect on the drawings.

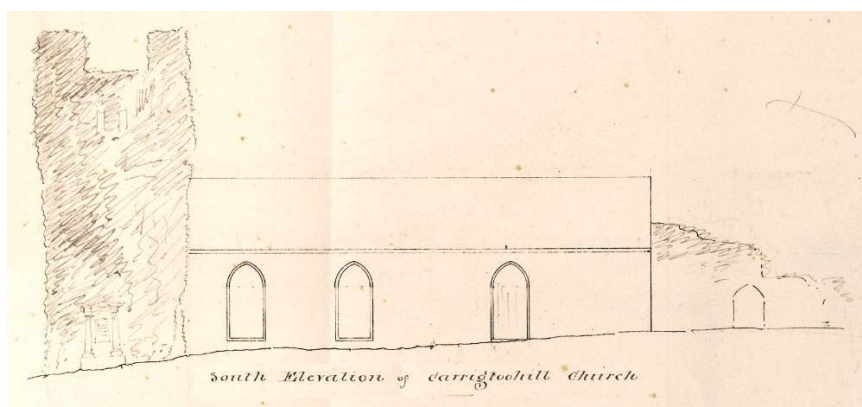
*James Pain's South Elevation (1835)*

The south elevation appears to indicate a family vault near, or abutting the tower. It also seems to indicate a sloping ground east to west just below the window opes. The rough sketch manner in which the details of the tower and ruins drawn would seemingly indicate that they were of no relevance to the architect. Whereas the church outline is clearly defined. There were no other elevation drawing in this series.

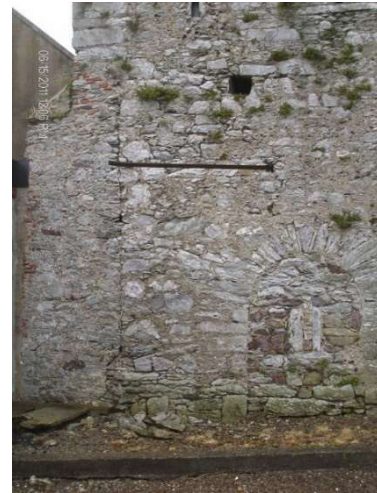
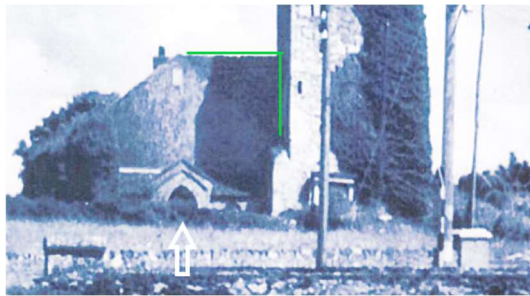
*Carrigwohill Through the Centuries*

A structure can clearly be seen alongside which has been modified and zoomed into from its original which appeared in the publication, *Carrigwohill Through the Centuries*. The date and source are unknown. There appears to be a peaked doorway in front of a wall and structure seemingly running north-south as seemingly is shown below.

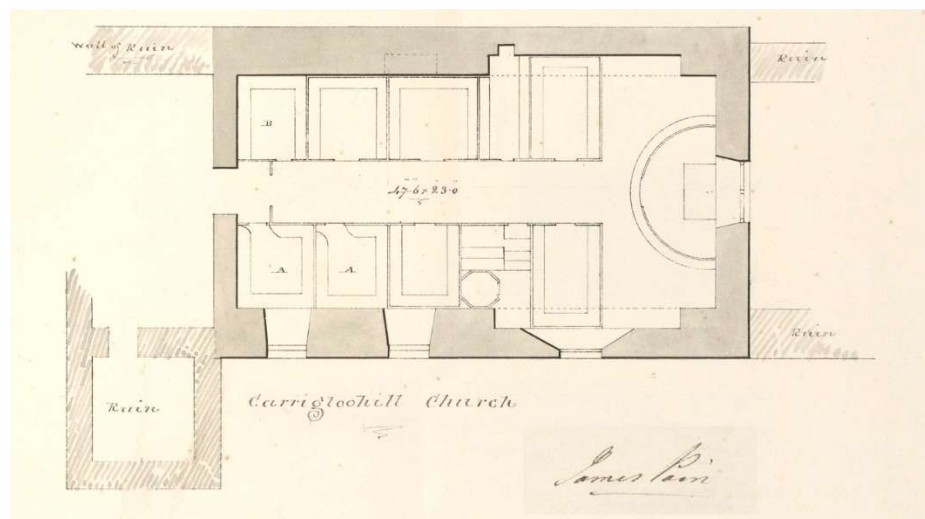
*James Pain Ground Floor Plan*

Pain's ground floor plan indicates a wall running northward off the northwest corner of the tower described as in 'ruin' was of the same thickness of the tower walls which is consistent with a recent photograph highlighting this junction as a vertical straight line. It is also consistent with Samuel Lewis' description of the church when he said, '... the chapel is situated on the site of an old abbey near the churchyard, and near it is a parochial house for the priest.' If correct, this must have been the location of Father Horgan's Church which was replaced by Father Seymour's Church.

The plan seems to indicate that the church was built on the ruins of the Abbey. At the eastern end it would appear is a window behind the altar which today is filled in.

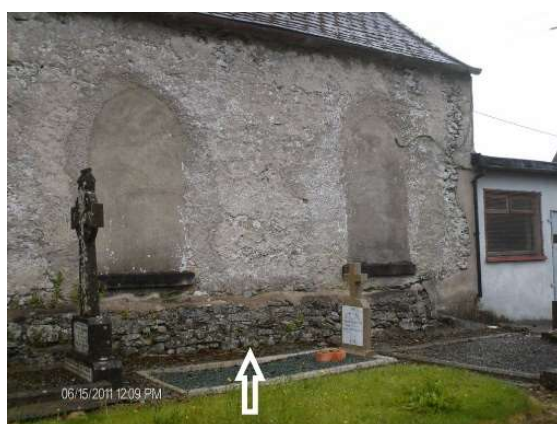
Concerning other structures of the site, Chris found it interestingly apparent that the older eastern section appeared to be the mostly constructed of 'competent mortar with fine well prepared mainly limestone aggregate and was surprisingly hard. This showed a high competence of an experienced mortar mason.'

He further explained that the central section (St David's church circa 1830s) differed by the inclusion of Cork Red sandstone. The addition of this rounded aggregate from a riverbed typically 8mm down suggested to him it was of different phase of construction. On the Northern wall of this section, he found that lower and wider course at foundation level had been pointed in sand and cement with no mortar being visible. He confirmed that this course was not visible on the southern
