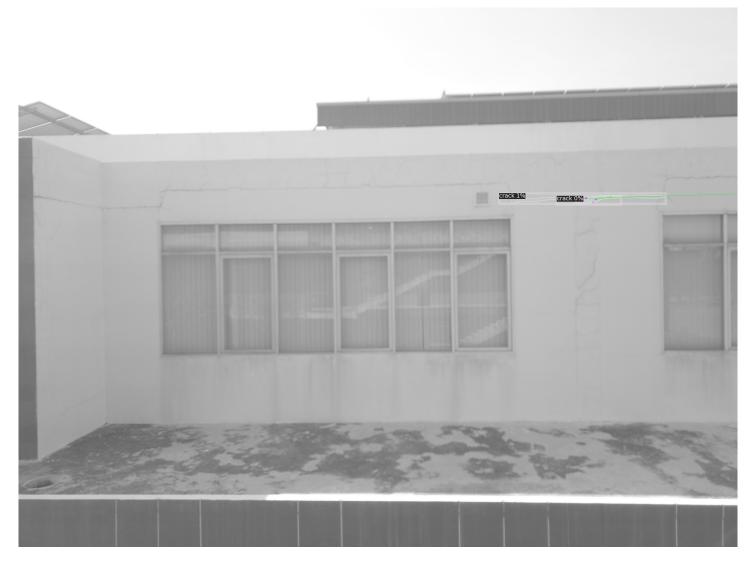
Crack number 1

The detected crack is on wall component in this image.

Crack density: 0.25% Crack width: 6.14 mm

Angle wrt horizontal line: 1.69 degree

Configuration: longitudinal

Position: Middle fourths of the wall Severity index for this crack: 2

Crack number 2

Crack density: 0.08% Crack width: 6.40 mm

Angle wrt horizontal line: 9.51 degree

Suggested corrective action: General repair but no detailed investigation

required
