LFM-0122-200-056

ReportNumbe	er:	_0	1														Pro	oje	ect	N	un	nb	er	:						LFN	∕ 1-01	L22-2	200-	056
PartNumber:		L	F٨	/ 1-0	112	22-	20	0-0)5	6							Inc	ηu	iry	N	un	nb	er	:					_	LFN	∕ 1-01	L22-2	200-	056.001
Requirements	::		DO-01										DrawingNumber:														LFM-0122-200-056.idw							
PartTitle:			Tube honeycomb										Visual testing date:														04.05.2022							
												1	Te:	sti	ng	; iı	nfo	or	m	at	io	n												
Test standard	s:	-	D	IN	ΕN	11:	30	18									Pri	nt	tin	g I	pro	oc	ess	s:					_	FDI	M (n	neta	l)	
Test instruction	n:	_	internal										Order specifications:													_	Sintered (external)							
Test scope:		_	100%											Ac	ce	pt	ar	ıce	e r	ule	9:					_	internal

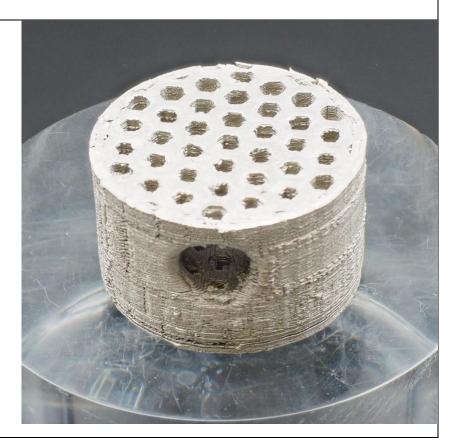
View of the defects

Rough surface with defects, waves and gaps
