LFM-0122-200-166

ReportNumber: 01											_	ProjectNumber:												_	LFM-0122-200-166							
			FM-0122-200-166								_	InquiryNumber:													LFM-0122-200-166.001							
				0-01								_	DrawingNumber:												_	LFM-0122-200-166.idw						
PartTitle: Turk			rbine blade							_	Visual testing date:												_(05.04.2	2022							
												Te	est	tin	g i	inf	or	m	at	io	n											
Test standards: DI			DIN EN 13018										Printing process/ machine:											ne		FDM (metal)/ Makerbot Method X						
Test instruction	on:	-	in	internal									_	Printing specifications:												_	-					
			100%										Acceptance rule:												i	internal						
																_														_		
Test device:		-								lipe	er			_			esti					J.						_	Lamp, Camera, Lens			
Illuminance m				Voltcraft LX-10 1662853									-		LU	ו או	me	245	sur	ec	J.						_	455				
Measuring de	vice n	···	Т.	002	203	03								_

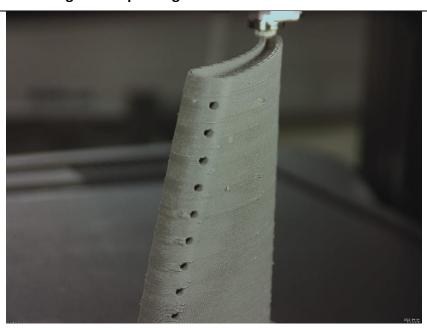
General view immediately after printing

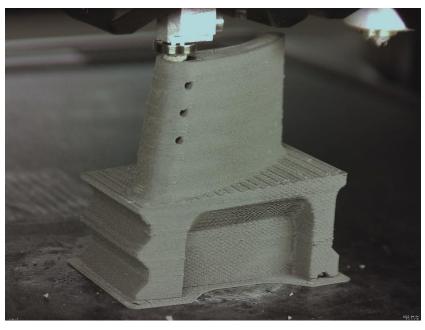
View under test conditions	
View of the defects (if occurred)	
Blobs

Bad initial layer due to difficult raft removal	
Rough surfaces
