Alexandria Arlington Resource Recovery Facility

Fiscal Year 2019
First Quarter Operations Report

November 2018

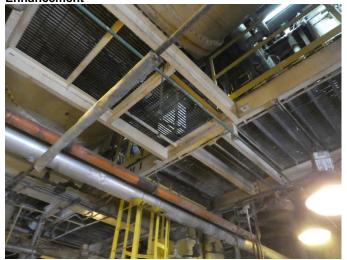
Figure 6: Modified Platform between Condensers for Safety – Facility Enhancement

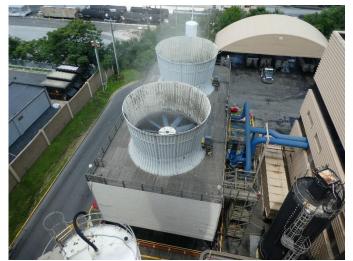
Figure 11: Cooling Tower from SDA Penthouse Platform

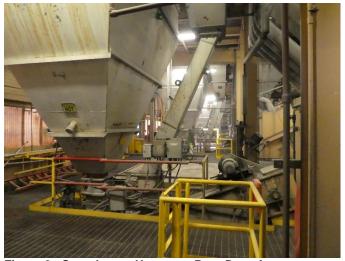
Figure 8: Superheater Hopper at Barn Door Access Elevation

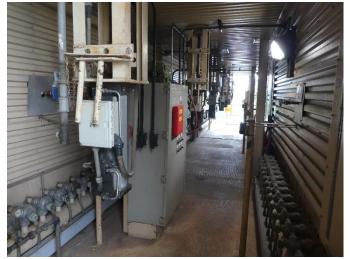
Figure 10: Baghouse Compartment Aisle – No Issues Observed on Any Boilers

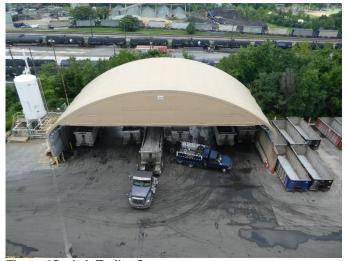
Figure 15: Ash Trailer Canopy

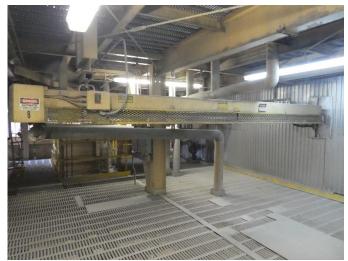
Figure 17: Retractable Sootblower

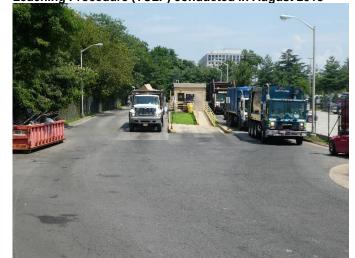
Figure 23: Haulers Exiting Facility Scales

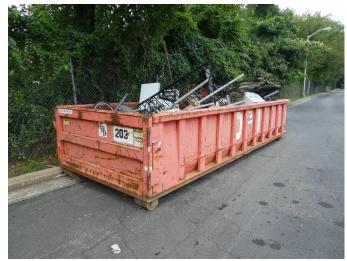
Figure 24: Metal Roll-off

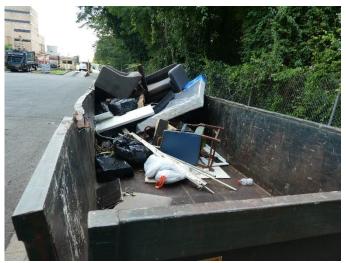
Figure 25: Citizens Drop-off Roll-off

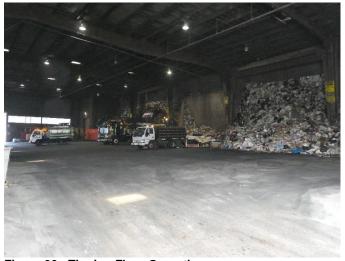
Figure 30: Tipping Floor Operations
