# Alexandria Arlington Resource Recovery Facility

Fiscal Year 2019
Second Quarter Operations Report

February 2019

# Alexandria/Arlington Waste-to-Energy Facility Second Quarter Operations Report – Fiscal Year 2019

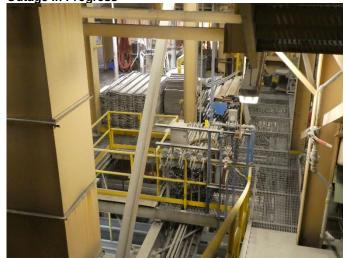
Figure 5: Scaffolding staged for use during Boiler Nos. 1 (November) & 2 (December) Outages

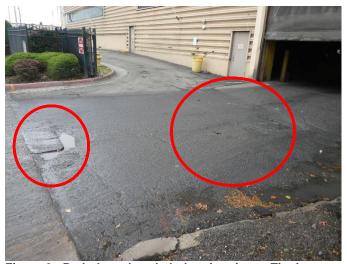
Figure 2: Pothole and asphalt deteriorating at Tipping Floor Exit – New Deficiency

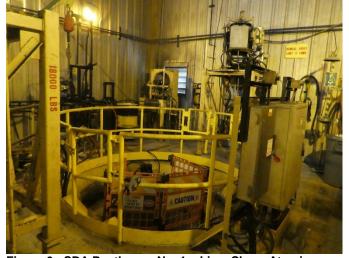
Figure 6: SDA Penthouse No. 1 – Lime Slurry Atomizer Removed for Boiler No. 1 Outage

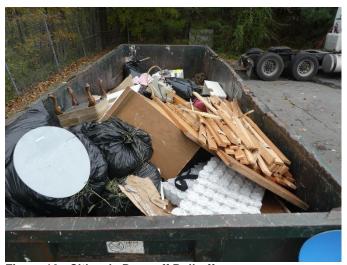
Figure 16: Citizen's Drop-off Roll-off

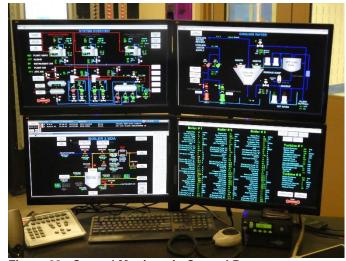
Figure 28: Control Monitors in Control Room

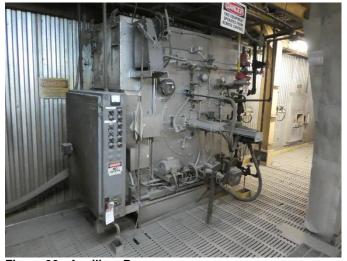
Figure 30: Auxiliary Burner
