Alexandria Arlington Resource Recovery Facility

Fiscal Year 2020 Second Quarter Operations Report

February 2020

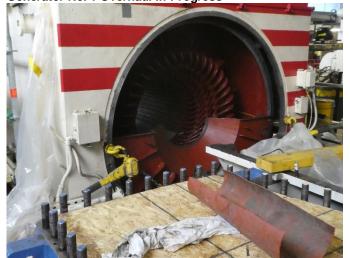
Figure 11: Generator Stator – Turbine Generator No.1 Overhaul

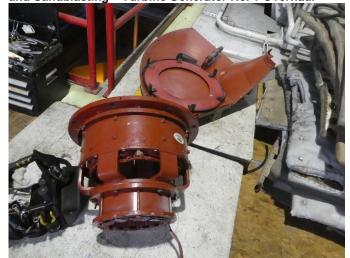
Figure 17: Generator Exciter Removed – Turbine Generator No. 1 Overhaul

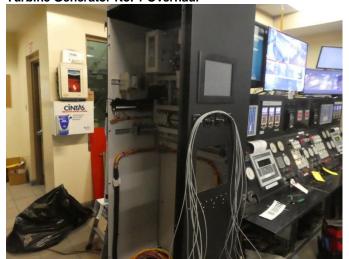
Figure 18: New Automatic Voltage Regulator Cabinet Installation in Control Room – Turbine Generator No. 1 Overhaul

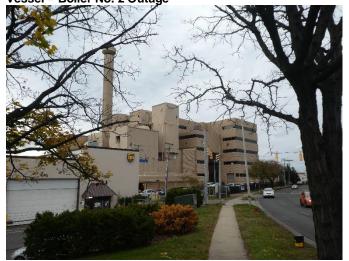
Figure 30: General Facility Photo - Southwest Corner of Facility
