Alexandria Arlington Resource Recovery Facility

Fiscal Year 2019
Third Quarter Operations Report

May 2019

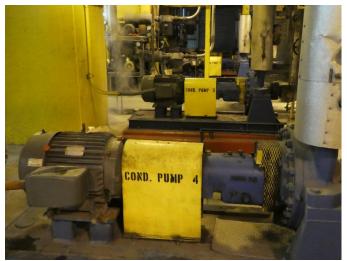
Figure 6: Condensate Pumps

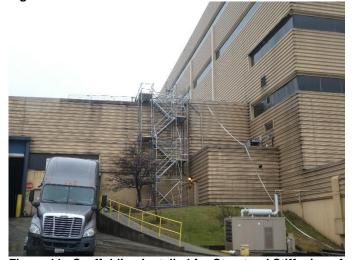
Figure 11: Scaffolding Installed for Structural Stiffening of East wall above Refuse Pit

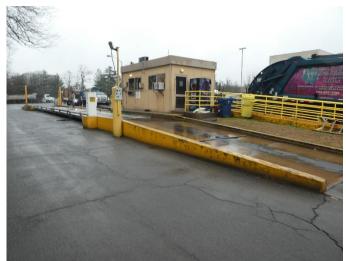
Figure 13: Scale House and Scales

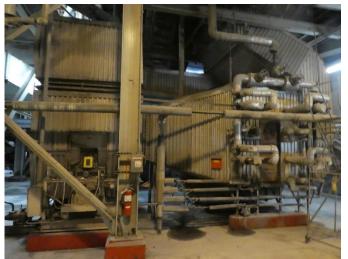
Figure 19: Steam Coil Air Heaters and Forced Draft Fan

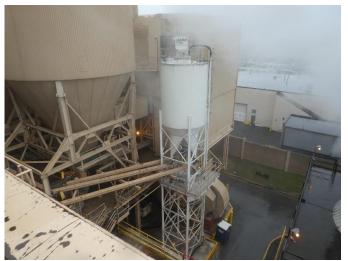
Figure 21: Dolomitic Lime Silo from Turbine Generator Enclosure Roof

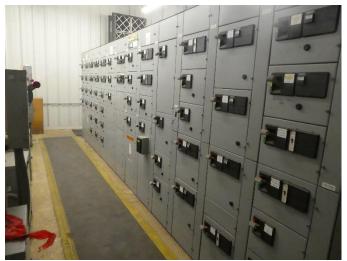
Figure 24: Air Pollution Control System Electrical Room
