PROJECT REPORT

# Diagnostics & Repair of Boston Dynamics Spot

Wang Yizhang | A0315457B

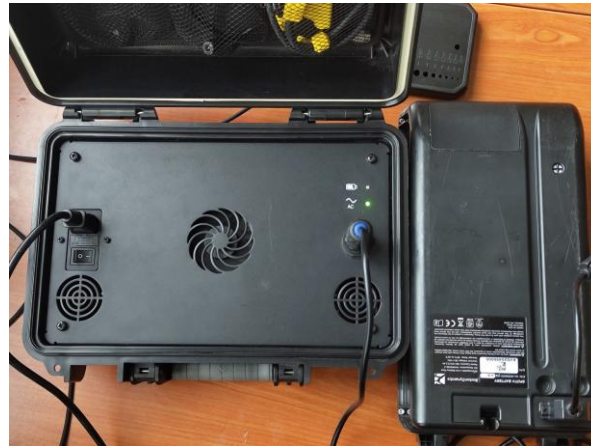
**Figure 2:** Charging indicator turns off after blinking red, indicating a charge fault.

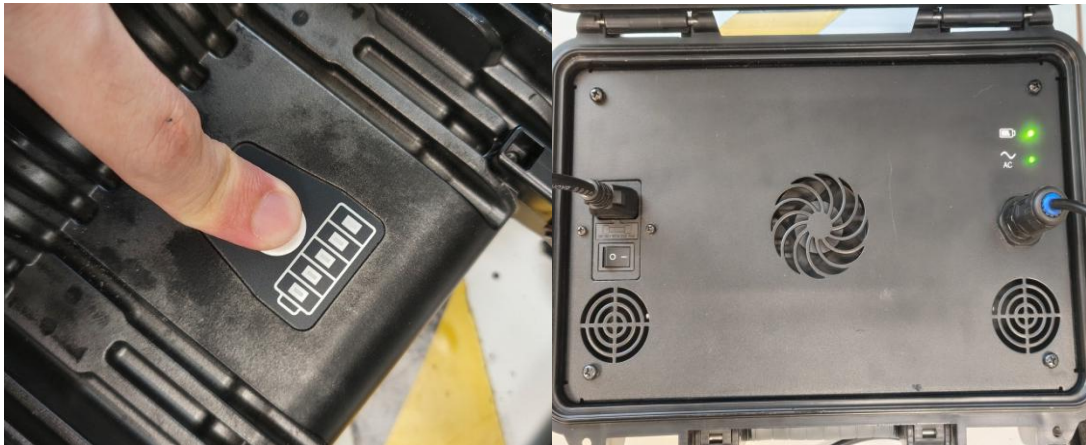
After each group is manually charged to about 3.0V, a green LED beside the STM32 MCU blinked, indicating the cells have enough charge to power the control circuitry. The module was tested with the charger again, but the charge indicator remained a static green, reporting a “full” charge on cells that were obviously discharged (Figure 4). The Spot manual attributes a false “full” to highly imbalanced cells and suggests leaving the pack plugged in to auto-rebalance, which had no effect. After idling, the cells were warm to the touch and individual cell-group voltages collapsed from about 1.6 V to 0.6 V. The combination of warmth and rapid voltage collapse is consistent with resistive self-discharge through dead cells now behaving as internal short circuits<sup>[5]</sup>; the cells were therefore judged degraded beyond recovery. Hence, a replacement of all cells was mandatory.

**Figure 4:** Battery state of charge (SoC) reports no charge, but charger reports full charge (static green indicator).

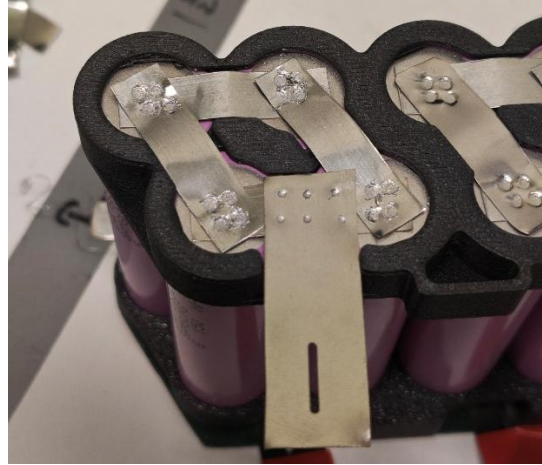
The cells were seated in the spacers and their terminals joined with nickel strips (Figure 11). Only 10×0.15 mm and 12×0.2mm strip was available, so it was trimmed to about 8 mm before use. The 12 mm BMS PCB tabs were thicker and tended to pop off since they were stacked on up to 2 layers of 8mm strips (Figure 12), hence some were soldered rather than welded.

**Figure 12:** Unsecure welds due to strip stacking.

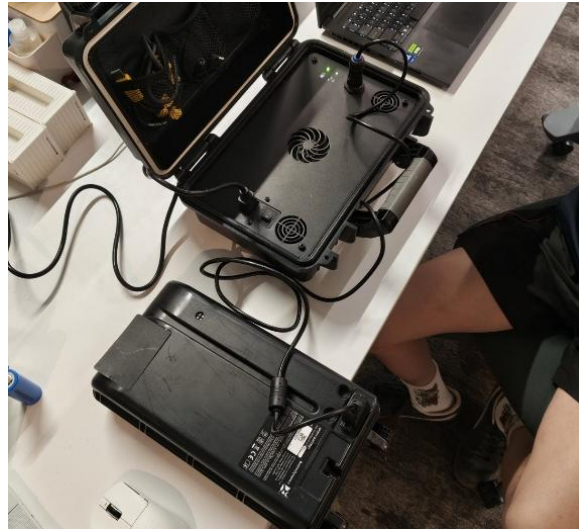
This observation was unexpected as half the cells were randomly tested before installation, and the initial charge was within  $3.6 \pm 0.05\text{V}$ . Hence, the voltage imbalance issue was attributed to the charging process.

**Figure 14:** Static green light on charger when pack is obviously discharged.

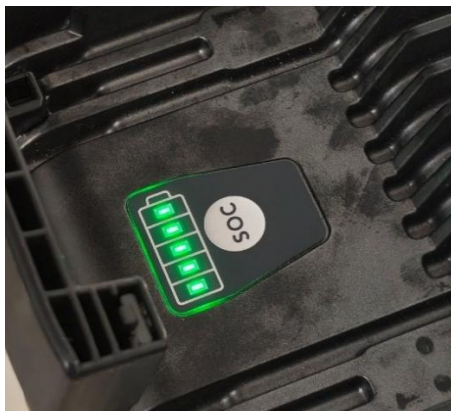
**Figure 21:** First full charge with healthy battery balance index.

The pack had all its BMS welds undone and the packs separated for a detailed check to eliminate any further intermittent connections. After re-welding, the SoC fault lights cleared, the pack charged normally, and it reached a full, balanced charge for the first time (Figure 21). Battery module #1 was thereby repaired and verified.

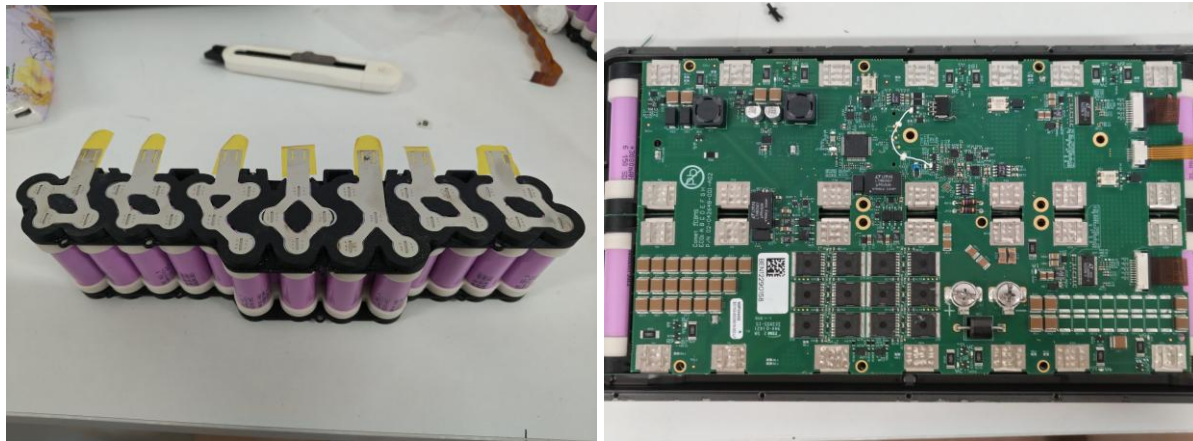
The improvement was borne out in assembly. After assembly, the SoC button was initially unresponsive; this was traced to a sheared SoC flat-flex cable (Figure 24). The weld quality achieved is visible in the completed pack (Figure 25). The broken cable was repaired by scraping back the insulation and soldering the exposed traces, with Kapton tape added as a strain relief on the joints. The SoC then read correctly. Pack #2 charged to full within about an hour, reported a very healthy balance index of **0.02** (Figure 26), and accepted a battery firmware update once installed in Spot. Both modules were thereby restored to a full, balanced charge, meeting the power-system objective.

**Figure 25:** Pack #2's laser-cut nickel strips perfectly welded in one pass.

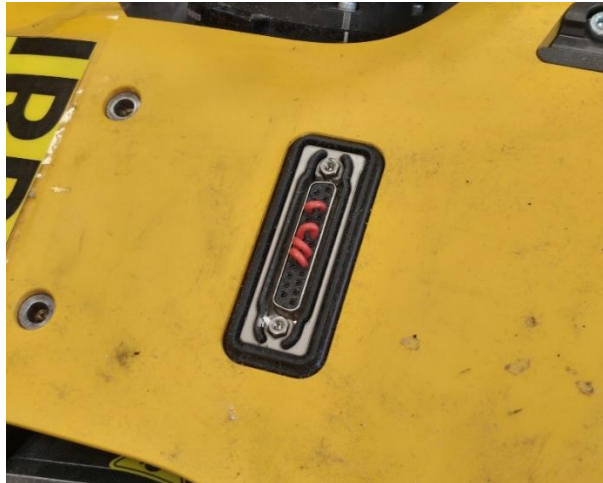
Spot was received with one of the DB25 payload port covers missing. Enabling motor power raised an “uncovered payload port” stop function. Inspection showed the cover contained no active components, only a mating female DB25 in a shell, so the detection must be passive. Probing the cover for continuity revealed that four sets of pins are shorted together inside it. Replicating those shorts on the open port, first with tinned jumper wires (Figure 27), later with a

**Figure 27:** Jumping payload port connector with wires to replicate cover.

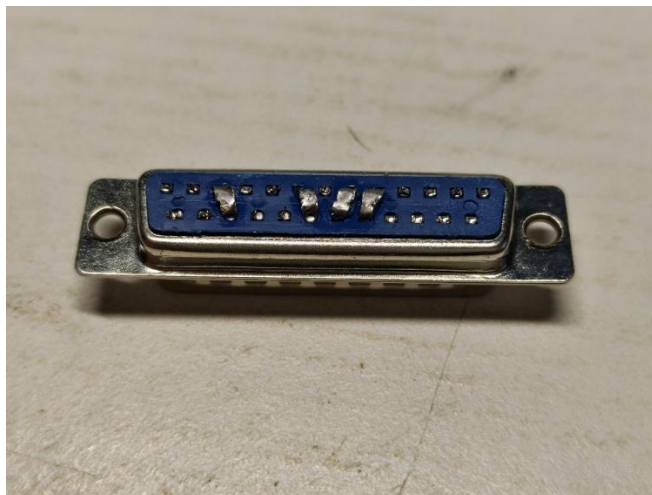
**Figure 28:** DIY mating payload port connector with safety detection pins shorted.

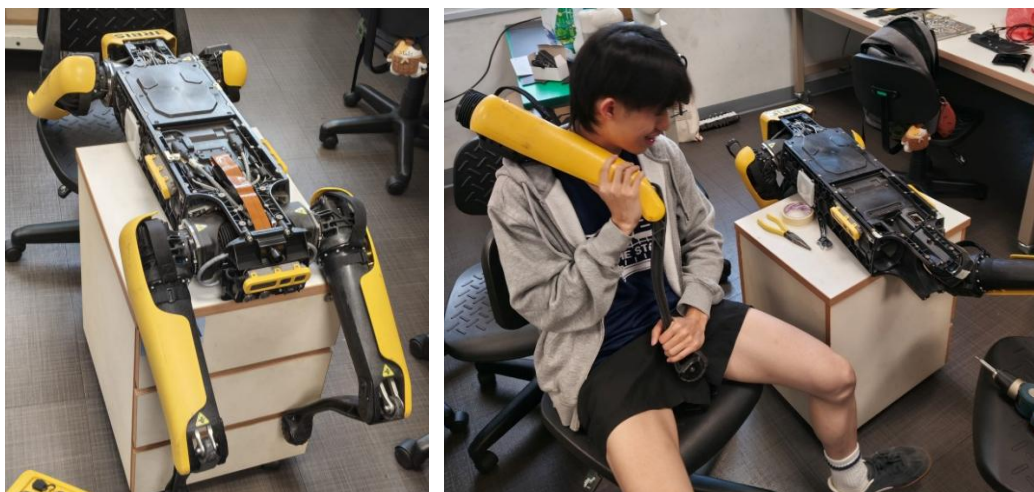
Spot was disassembled to extract the left hind leg (Figure 30). The full disassembly procedure is found in Appendix J. During teardown the leg wiring and controller board were inspected for physical defects and none were found. Hence, the investigation was framed around comparison with the healthy right hind leg.

**Figure 30:** Spot disassembled to isolate defective leg for testing.

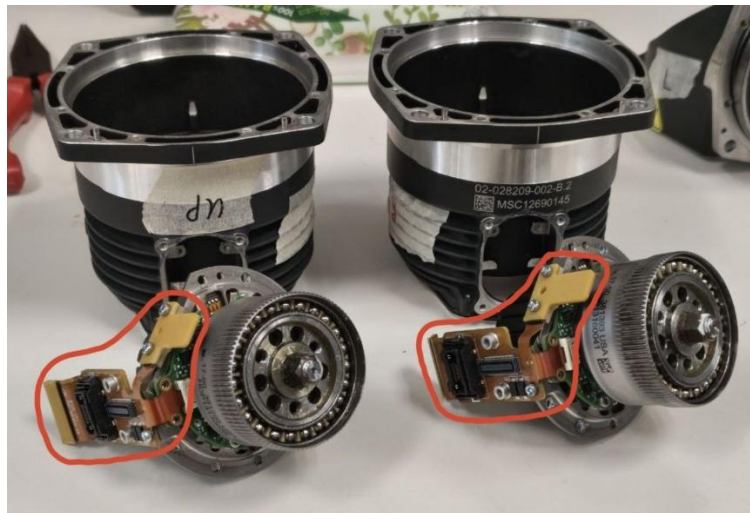
The output-stage encoder module, which is one piece with the main connector PCB, was isolated and swapped between *hl.hx* and *hr.hx* (Figure 38). On power up, the frozen angle issue cleared and all joints were responsive as reflected in the 3D live view.

**Figure 38:** Output-stage encoder & connector PCB swap, highlighted in red.

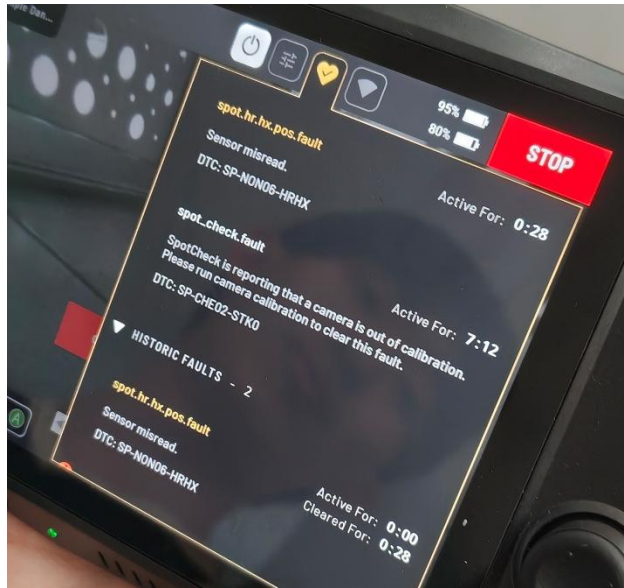
This warning, however, does not impact robot operation. While teleoperating Spot to walk around, the console also intermittently shows warnings of “sensor misread” for both the *hl.hx* and *hr.hx* joints (Figure 46). However, the misread warning clears almost instantly and has no observable effects on Spot’s motion; it was tested to still perform emotes and traverse staircases without issue with the warning present.

**Figure 46:** Intermittent “Sensor misread” warnings with no observable effects on operation.

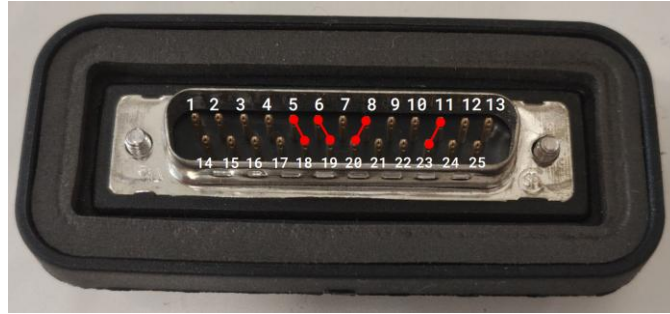
The four sets of pins shorted inside the OEM payload-port cover, reverse-engineered by continuity probing and replicated on the open port to bypass the cover-detection lockout (Section 6).

**Figure 56:** The DB25 payload-port cover pin shorts. Replicating these four shorts on the open port clears the “uncovered payload port” motor-power lockout.
