# Home Survey – Level 2

Semi-detached house understood to have been constructed around 1970, with a single-storey rear extension added around 1985. Brick cavity walls (approx. 300mm thick) with cavity wall insulation, concrete tile pitched roof with UPVC guttering and downpipes, predominantly double glazed windows (some single glazing to toilet and entrance door), and a polycarbonate-roofed conservatory to the rear.

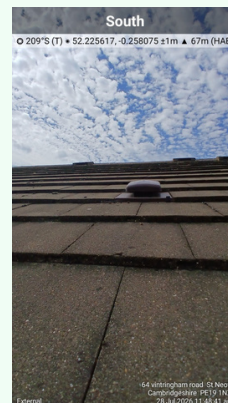
Fig. 5

Rear rainwater downpipe appears incorrectly fitted and requires adjustment. Gutter observed to be partially blocked with debris/leaves.

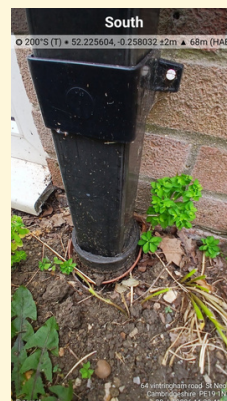
Fig. 7

Mortar deterioration and higher moisture readings (approximately 10-13%) noted beneath the planted area to the front elevation. A Wi-Fi cable was also observed fixed externally above the damp proof course (DPC), approximately 150mm above ground level. External electrical wiring nearby appeared untidy.

Review external service penetrations and cable fixings to ensure they do not compromise the building fabric or damp protection. Monitor areas of mortar deterioration and repair where necessary. External electrical wiring should be inspected by a qualified electrician.

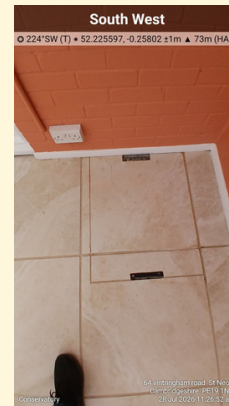
Fig. 15

Concrete Crack on the front right-side corner: There is a visible crack running across the concrete slab starting right near the outer brick corner. Over time, water ingress into this crack could cause further settling or freeze-thaw damage.

Dampness & Surface Wear: The concrete shows uneven weathering, potential water staining, and aggregate exposure, typical for aged outdoor concrete paths.

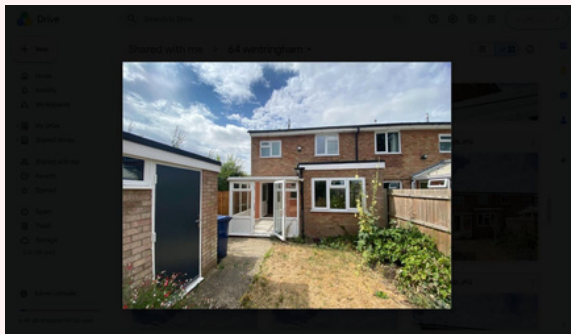
Fig. 16

Signs of movement were noted to the external wall of rear extension during the inspection, including a noticeable horizontal line at damp-proof course (DPC) level on the rear elevation, which may be indicative of historic settlement or movement. Based on the visual inspection, there was no clear evidence to suggest ongoing progressive movement; however, this cannot be confirmed without further investigation. It is noted that there is reportedly an existing insurance claim relating to this movement.

Potential structural movement to the rear extension could affect the stability of the structure if progressive. Further investigation by a Structural Engineer is required before exchange of contracts to rule out ongoing risk.

We recommend that the purchaser instructs a Structural Engineer to undertake a detailed structural assessment of the rear extension. This should establish the cause and extent of the movement, confirm whether it is historic or ongoing, assess the structural stability of the extension, and specify any remedial works that may be required. The findings of the Structural Engineer should be considered before exchanging contracts, and full details of the existing insurance claim relating to this movement should be obtained via the legal advisers.

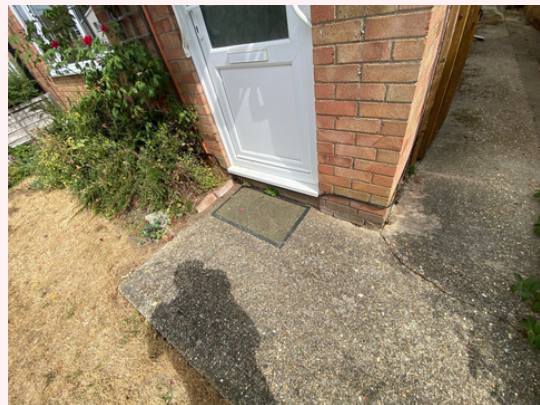
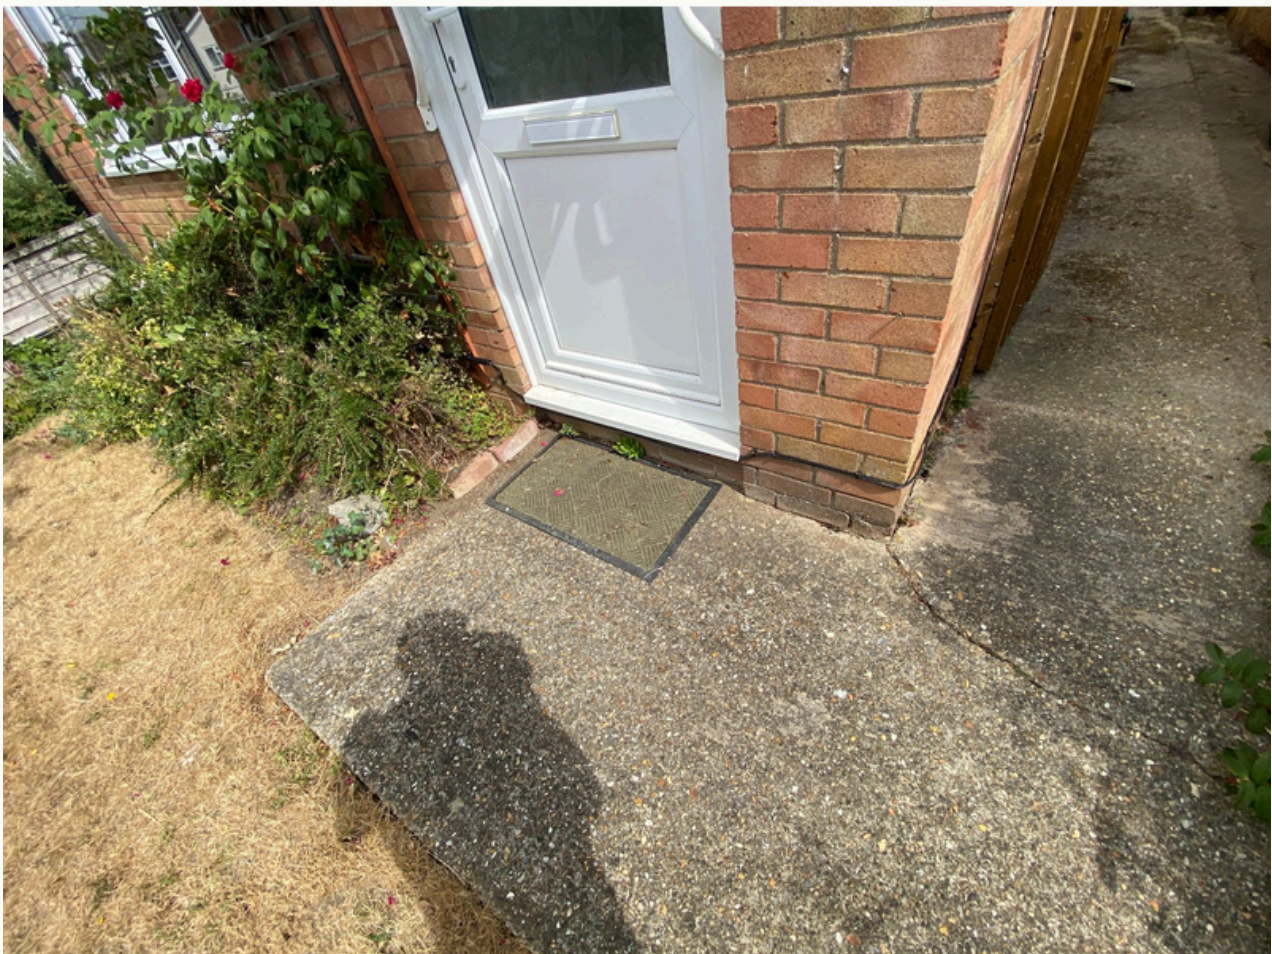
Fig. 17

A historic movement was noted to the rear extension DPC level. Although there was no clear evidence of active movement during the inspection, its long-term stability cannot be confirmed by a visual inspection alone. A suitably qualified structural engineer should confirm that the movement is historic and stable, particularly if there are concerns regarding previous movement or if alterations are proposed.

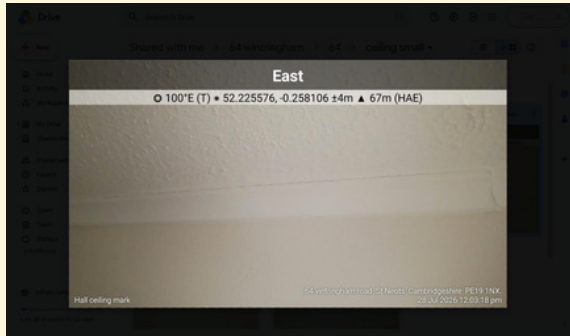
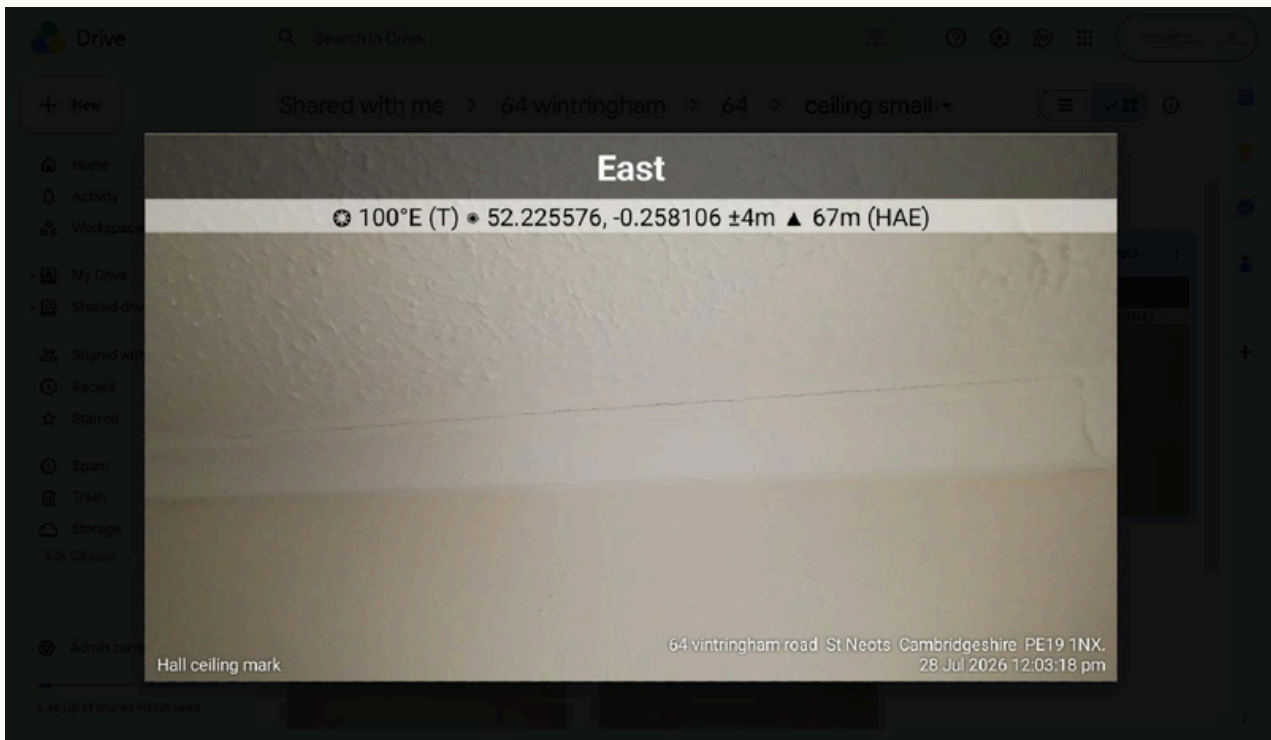
Fig. 19

Minor hairline gaps/cracking noted between the coving and ceiling near the understairs area in the entrance hall.

Monitor for any progression or signs of movement; minor cosmetic repair only likely needed.

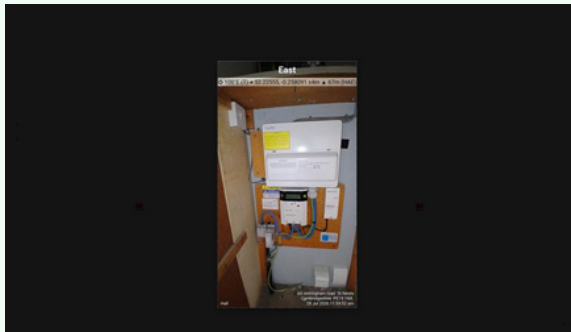
Fig. 29

Consumer unit (fuse box) and electricity meter located within a cupboard off the entrance hall. Electricity meter also present; external electrical wiring to the front elevation appeared untidy and should be inspected by a qualified electrician.

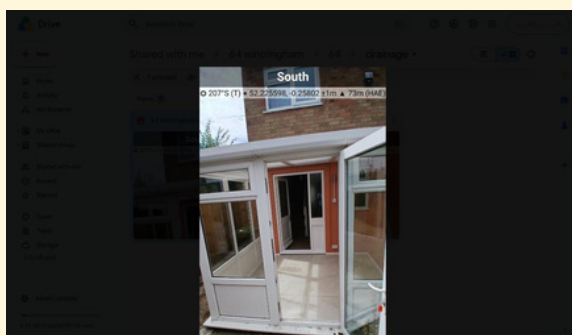
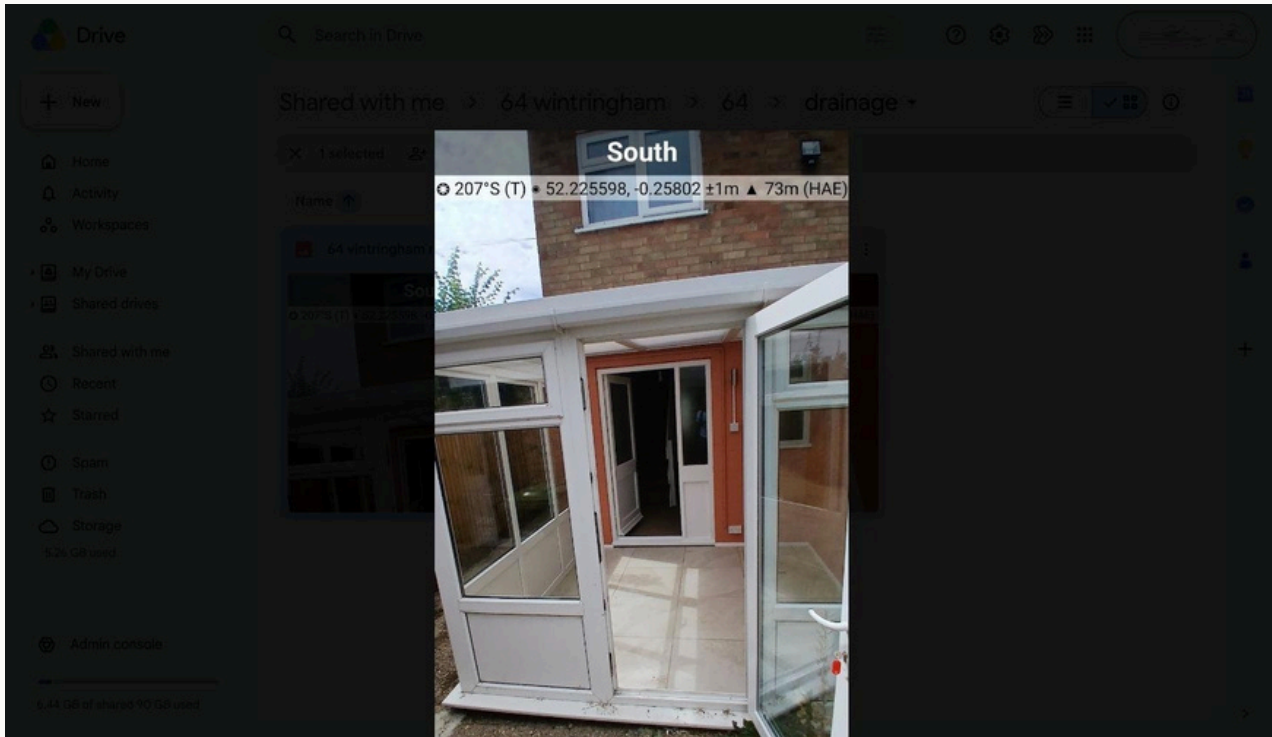
Fig. 33

The inspection chamber could not be opened because the cover was sealed. As a result, the condition of the

An inspection chamber is located within the conservatory. This is not uncommon in properties, its position within an enclosed space may increase the risk of odour escape, leakage and restricted access for maintenance. The chamber should be kept accessible and monitored for signs of defects. If there is any evidence of drainage problems or before undertaking significant alterations, a specialist CCTV drain survey is recommended to assess the condition of the underground drainage system.

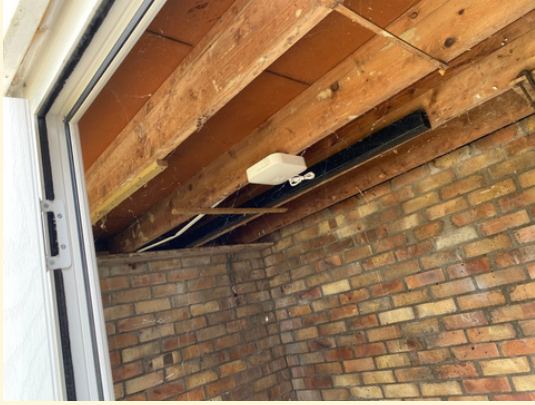
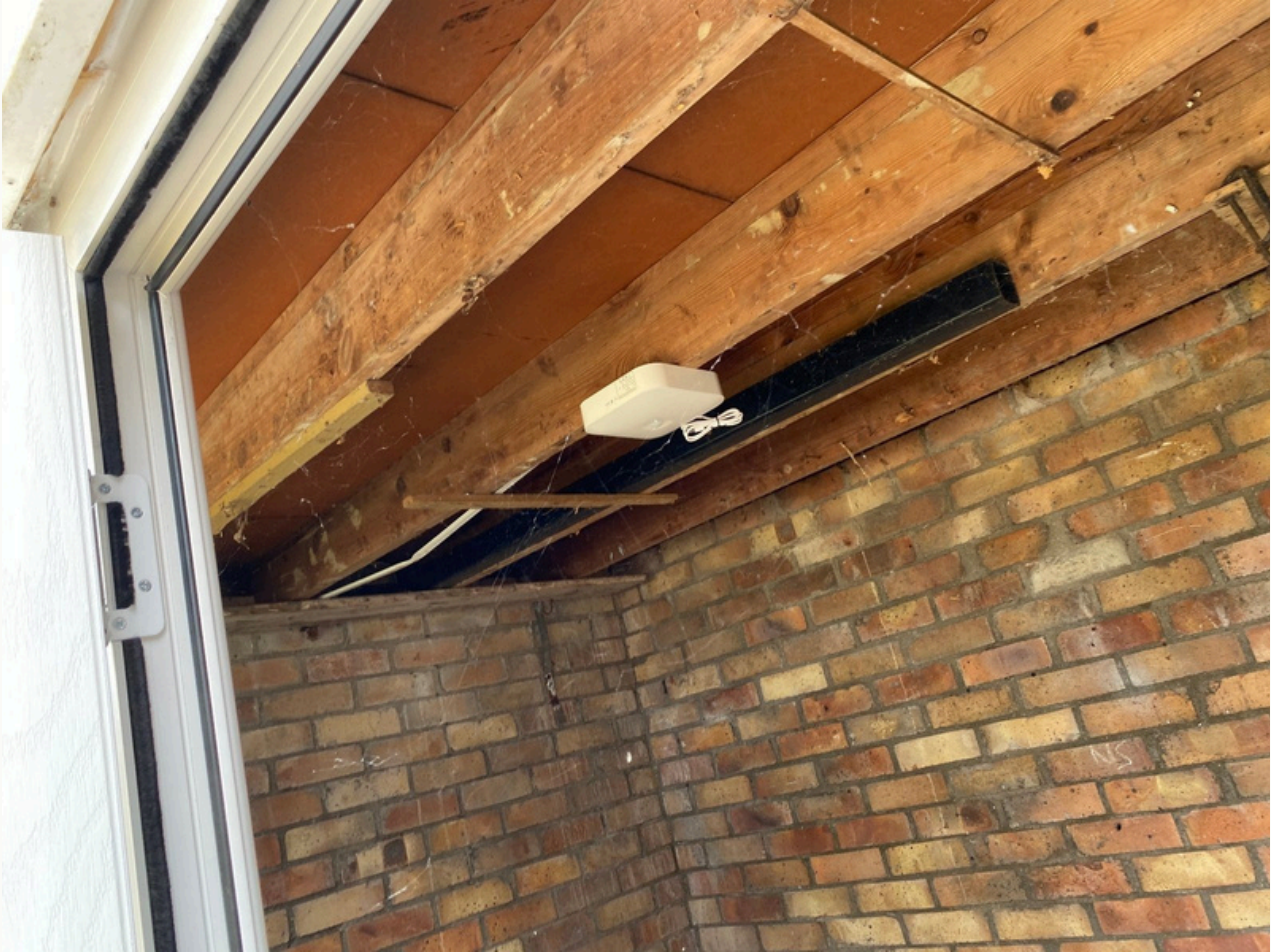
Fig. 35

A crack was noted to the upper right-hand side of the rear wall. The crack may be associated with minor movement, localised masonry failure, thermal movement, or other causes.

The defect should be monitored to establish whether there is any evidence of ongoing movement, such as widening, displacement, or associated cracking internally. If the cracking deteriorates or there are concerns regarding stability, further investigation by a suitable building professional or structural engineer is recommended. If the cracking deteriorates or there are concerns regarding stability, further investigation by a suitable building professional or structural engineer is recommended.
