Betong International Airport

Report File Name: 07000178.pac Date of Report: 12/12/2022 Time of Report: 18:50:27

Way Name: RUNWAY EDGE - 07L Agent: FBT_Sp (Not Cross Checked)

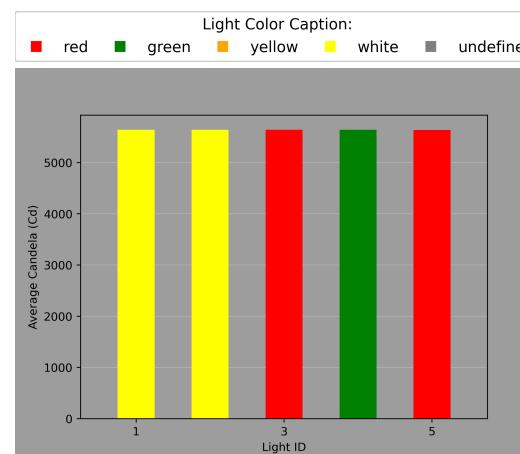
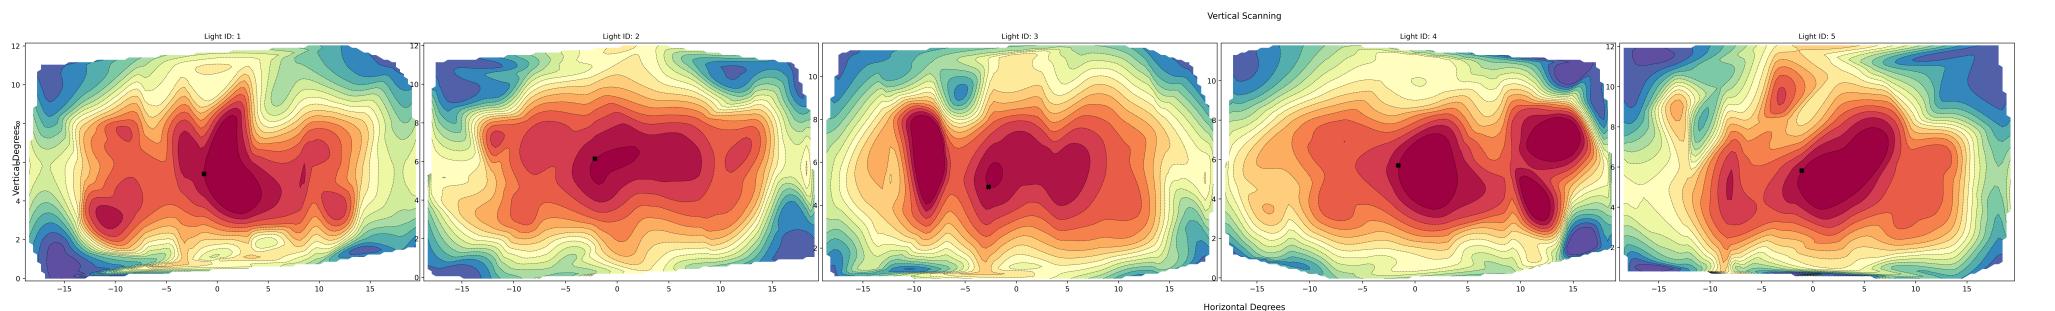
%ICAO	AVG(cd)	Max(cd)	Hmax(Deg)	Vmax(Deg)	C	S
Light ID							
1	183.00	5638.808393	12108.63	-1.30	5.39	W	✓
2	138.85	5640.856786	12112.84	-2.15	6.14	W	✓
3	153.44	5638.519821	12103.10	-2.71	4.85	R	✓
4	87.87	5639.975714	12074.00	-1.59	5.70	G	✗
5	89.20	5637.558929	12077.93	-1.08	5.82	R	✓

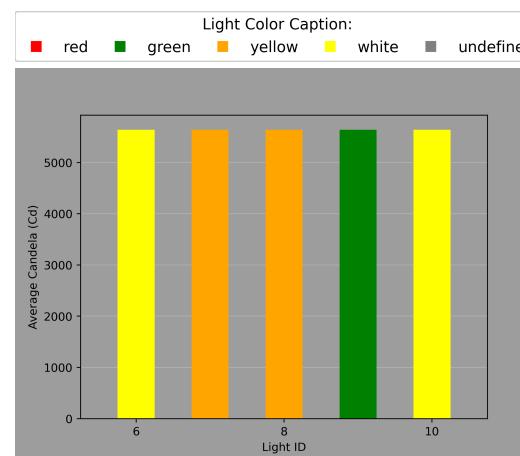
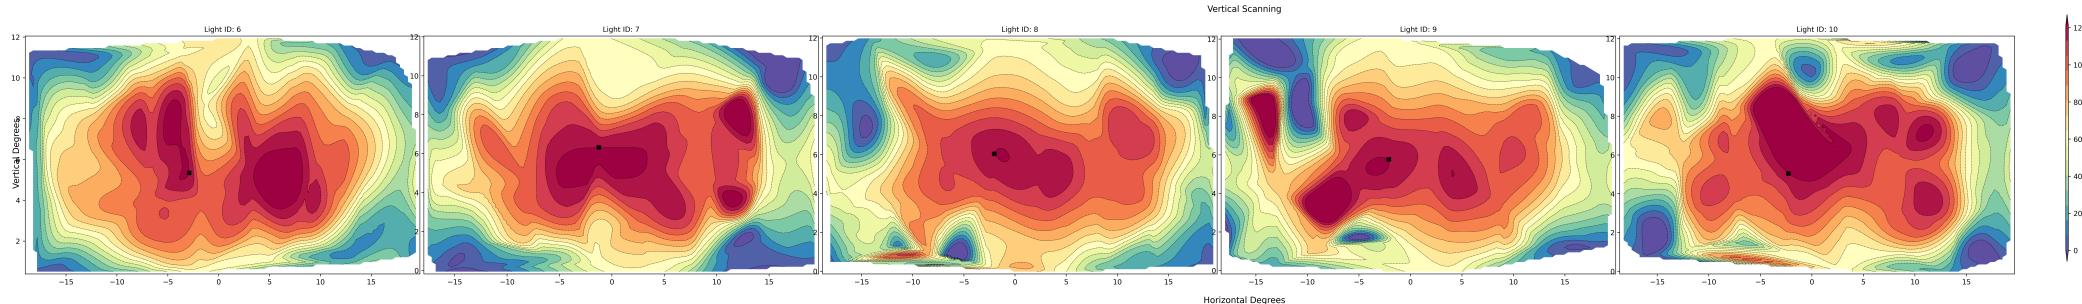
%ICAO	AVG(cd)	Max(cd)	Hmax(Deg)	Vmax(Deg)	C	S
Light ID							
6	178.93	5637.355714	12116.58	-2.90	5.34	W	✓
7	161.50	5639.786071	12107.34	-1.25	6.32	Y	✓
8	132.02	5637.523036	12096.12	-2.03	6.04	Y	✗
9	121.69	5638.891250	12098.85	-2.11	5.76	G	✗
10	95.06	5638.161786	12086.20	-2.28	5.04	W	✗

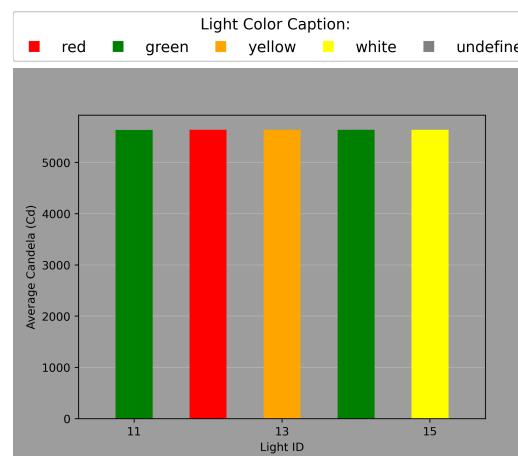
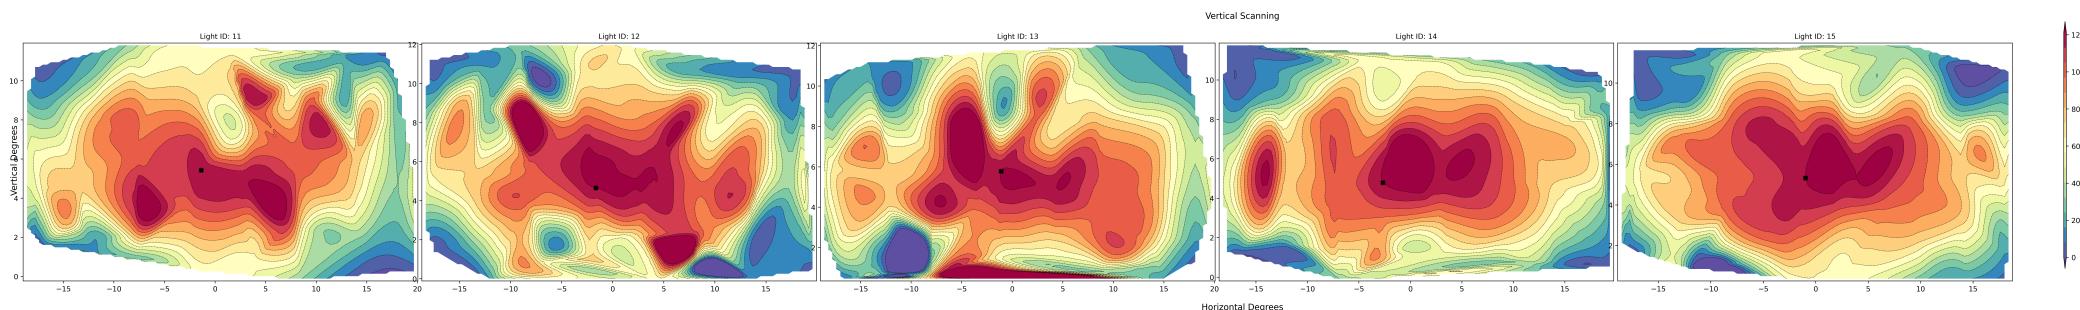
Light ID	%ICAO	AVG(cd)	Max(cd)	Hmax(Deg)	Vmax(Deg)	C	S
11	76.04	5635.361964	12072.89	-1.37	5.43	G	X
12	147.27	5637.632143	12109.97	-1.65	4.65	R	✓
13	159.10	5638.522500	12109.65	-1.10	5.78	Y	✓
14	119.93	5638.865893	12103.53	-2.68	4.79	G	✓
15	159.16	5638.630000	12107.86	-0.97	5.32	W	✓

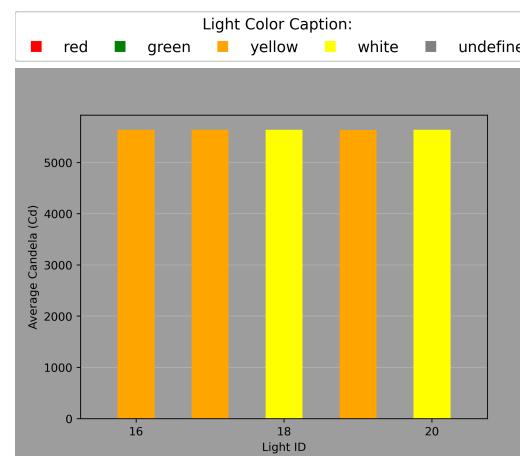
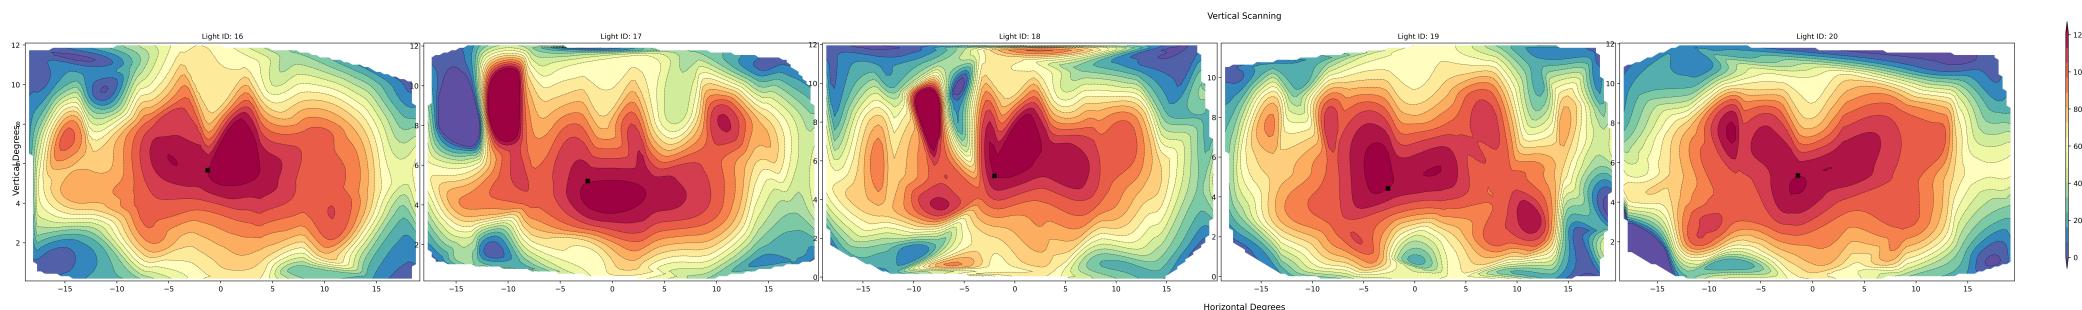
%ICAO	AVG(cd)	Max(cd)	Hmax(Deg)	Vmax(Deg)	C	S
Light ID							
16	193.78	5639.092321	12087.87	-1.26	5.67	Y	✓
17	180.29	5638.776429	12072.73	-2.36	5.20	Y	✗
18	140.06	5637.610893	12097.41	-2.01	5.22	W	✗
19	78.31	5635.526429	12104.79	-2.60	4.42	Y	✓
20	102.42	5639.748571	12087.41	-1.41	5.35	W	✓

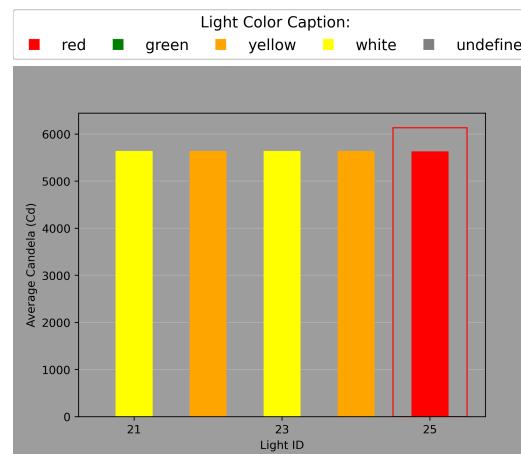
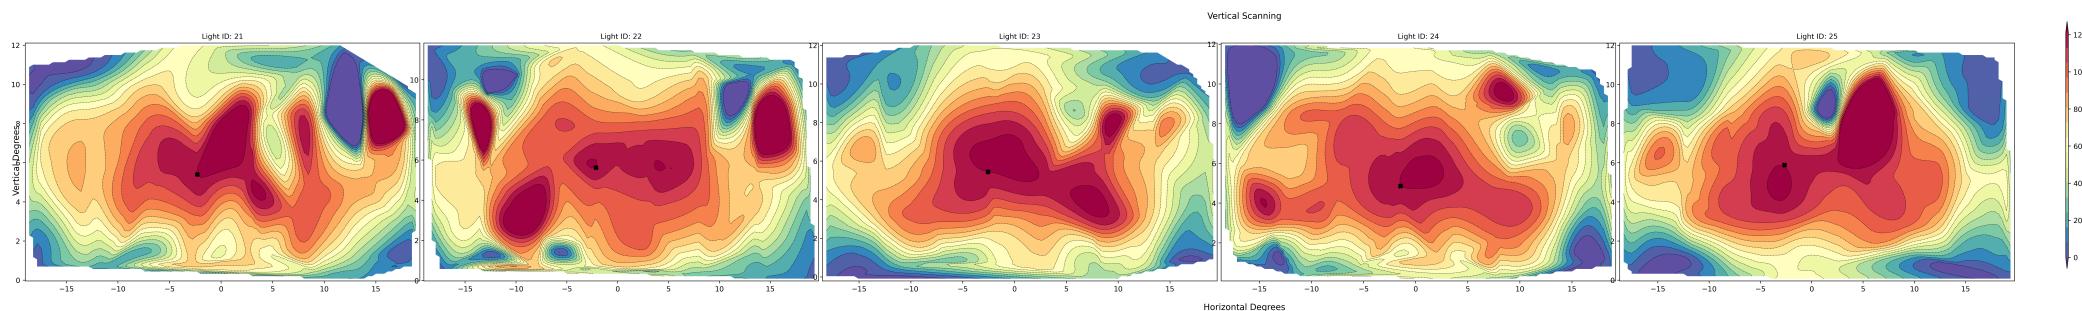
%ICAO	AVG(cd)	Max(cd)	Hmax(Deg)	Vmax(Deg)	C	S
Light ID							
21	123.55	5640.459643	12110.18	-2.31	5.40	W	X
22	115.64	5640.720893	12077.53	-2.14	5.62	Y	✓
23	153.02	5641.668571	12108.14	-2.56	5.44	W	✓
24	120.02	5640.924107	12094.59	-1.45	4.86	Y	✓
25	47.97	5635.862679	12076.78	-2.65	5.88	R	X

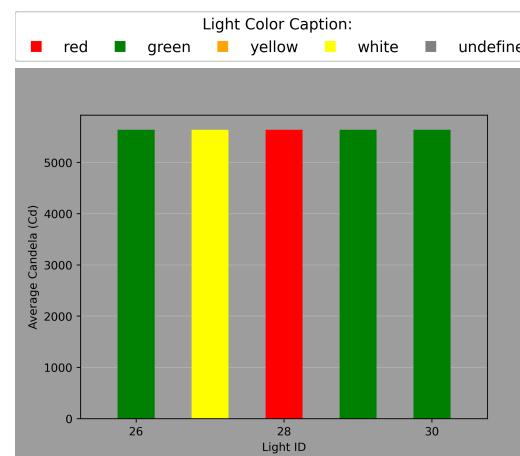
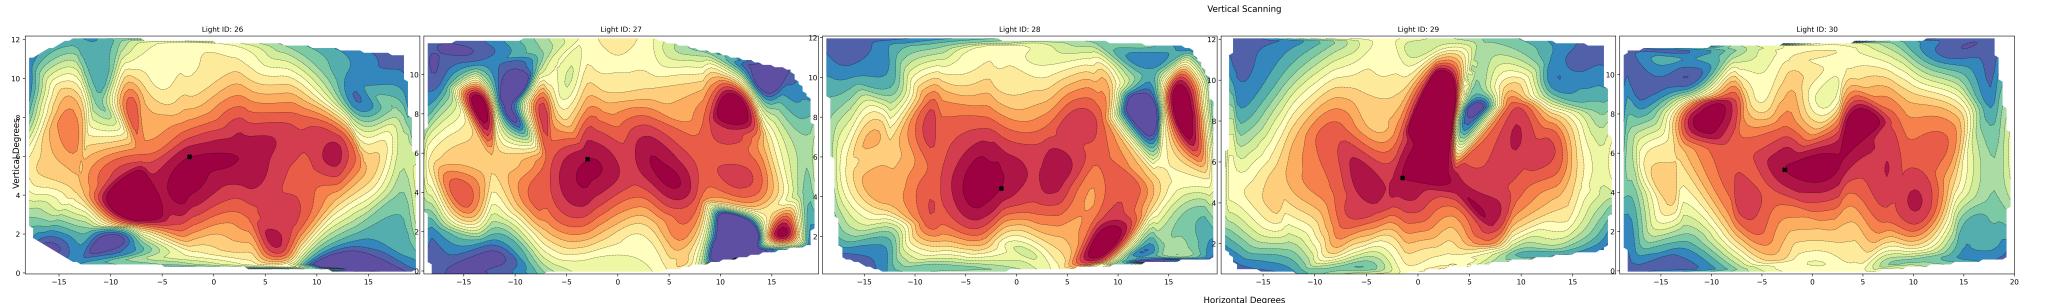
%ICAO	AVG(cd)	Max(cd)	Hmax(Deg)	Vmax(Deg)	C	S
Light ID							
26	79.74	5637.863571	12100.54	-2.34	5.97	G	X
27	124.58	5636.833571	12101.21	-2.94	5.69	W	✓
28	194.82	5639.169643	12086.52	-1.49	4.42	R	✓
29	169.13	5636.738750	12113.98	-1.49	5.21	G	✓
30	101.72	5637.960357	12096.33	-2.73	5.15	G	✓

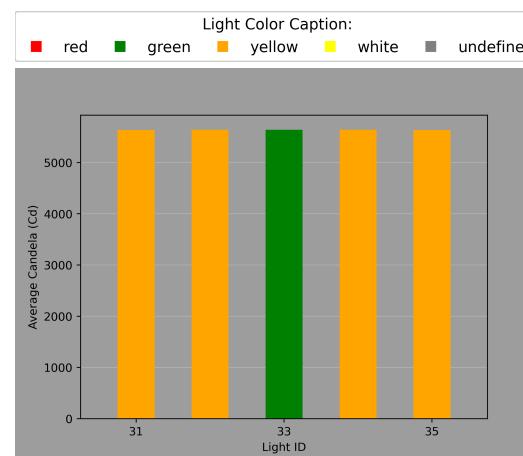
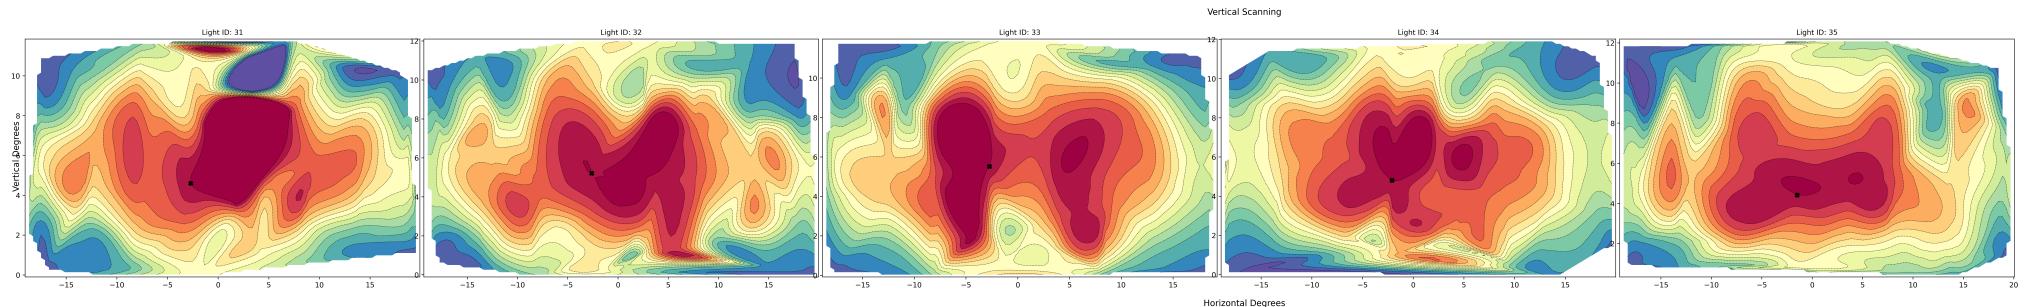
%ICAO	AVG(cd)	Max(cd)	Hmax(Deg)	Vmax(Deg)	C	S
Light ID							
31	169.59	5635.811786	12091.94	-2.70	4.60	Y	X
32	197.99	5640.837321	12114.37	-2.61	5.21	Y	✓
33	130.30	5640.257857	12073.88	-2.74	5.52	G	✓
34	199.42	5638.876964	12115.43	-2.09	4.81	Y	✓
35	96.63	5637.281964	12073.98	-1.49	4.41	Y	✓

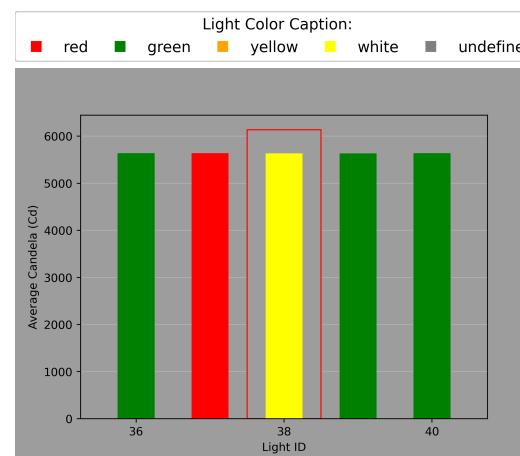
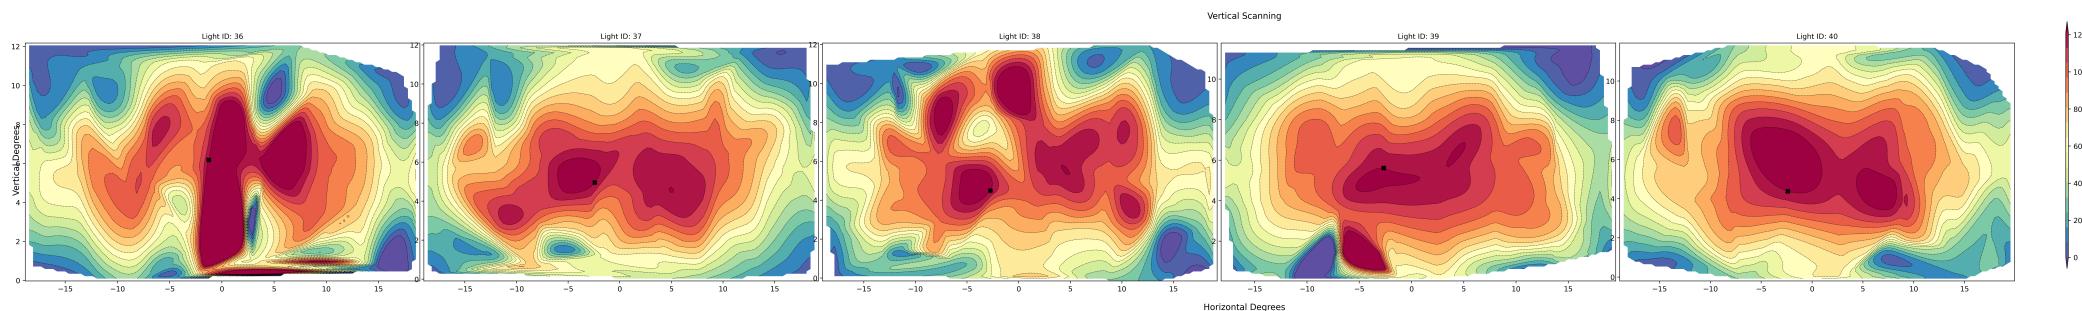
%ICAO	AVG(cd)	Max(cd)	Hmax(Deg)	Vmax(Deg)	C	S
Light ID							
36	128.14	5639.256071	12088.58	-1.27	6.18	G	X
37	97.56	5638.460357	12116.88	-2.42	4.95	R	✓
38	45.52	5637.191964	12069.86	-2.73	4.49	W	X
39	66.17	5635.357500	12104.81	-2.66	5.61	G	✓
40	72.29	5637.616607	12095.99	-2.39	4.37	G	✓

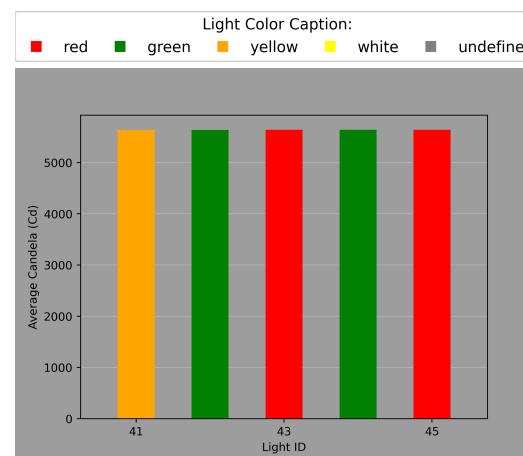
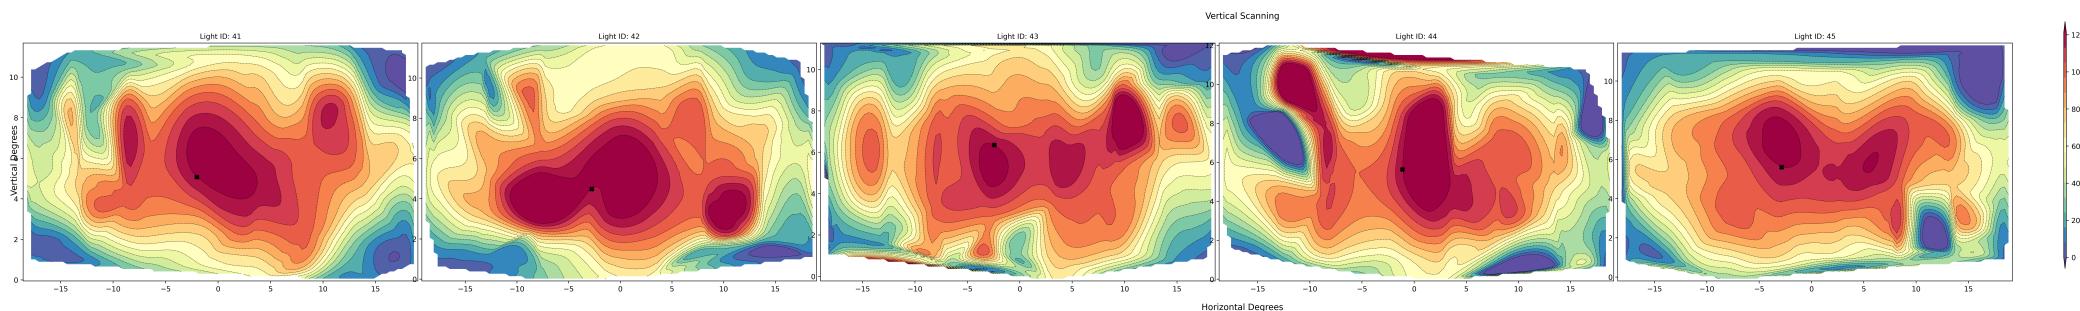
%ICAO	AVG(cd)	Max(cd)	Hmax(Deg)	Vmax(Deg)	C	S
Light ID							
41	84.09	5635.847321	12103.68	-2.01	5.07	Y	X
42	99.08	5637.946071	12084.52	-2.76	4.48	G	X
43	116.11	5638.942857	12106.86	-2.44	6.35	R	X
44	54.86	5641.014643	12081.83	-1.11	5.63	G	X
45	182.73	5640.561607	12089.01	-2.84	5.60	R	✓

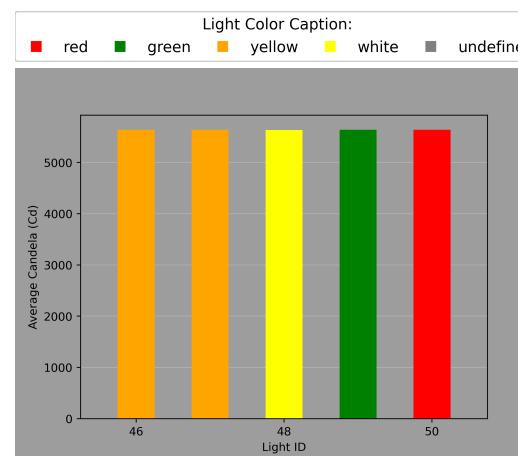
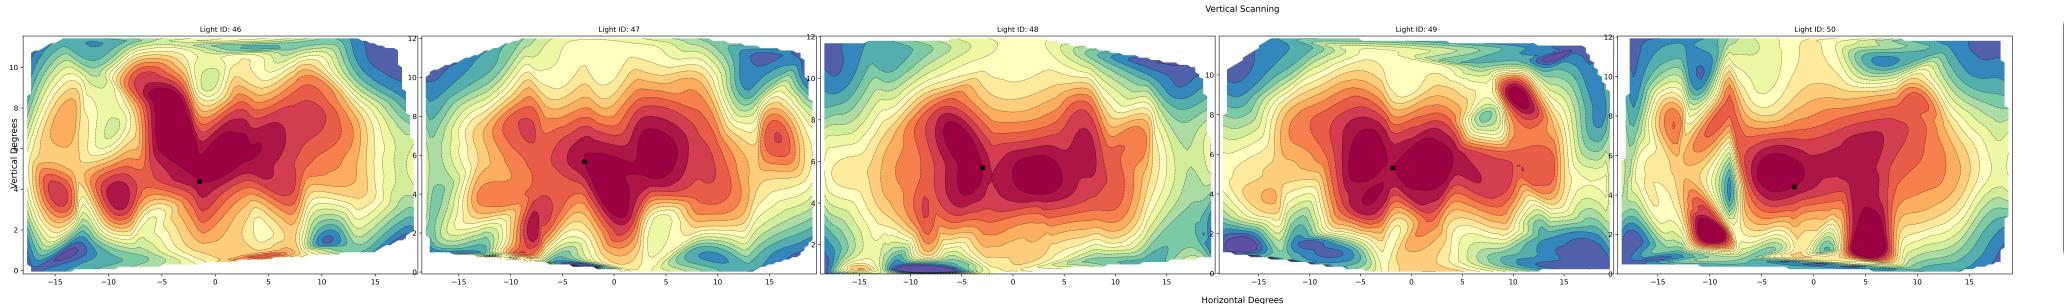
%ICAO	AVG(cd)	Max(cd)	Hmax(Deg)	Vmax(Deg)	C	S
Light ID							
46	111.70	5639.035179	12079.26	-1.45	4.38	Y	✓
47	100.71	5639.112143	12112.32	-2.87	5.66	Y	✓
48	162.71	5636.245893	12093.02	-2.94	5.69	W	✗
49	196.66	5637.914643	12083.21	-1.82	5.31	G	✓
50	52.00	5638.933571	12080.18	-1.83	4.41	R	✓

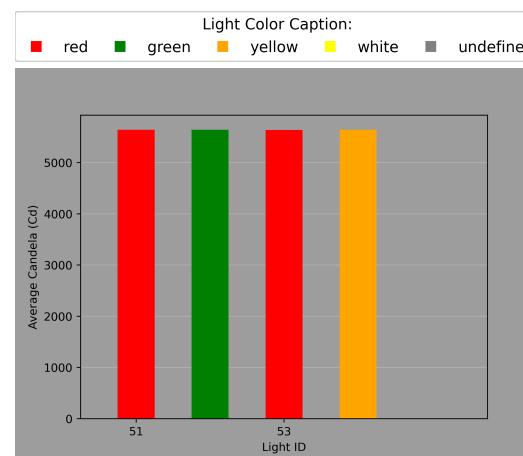
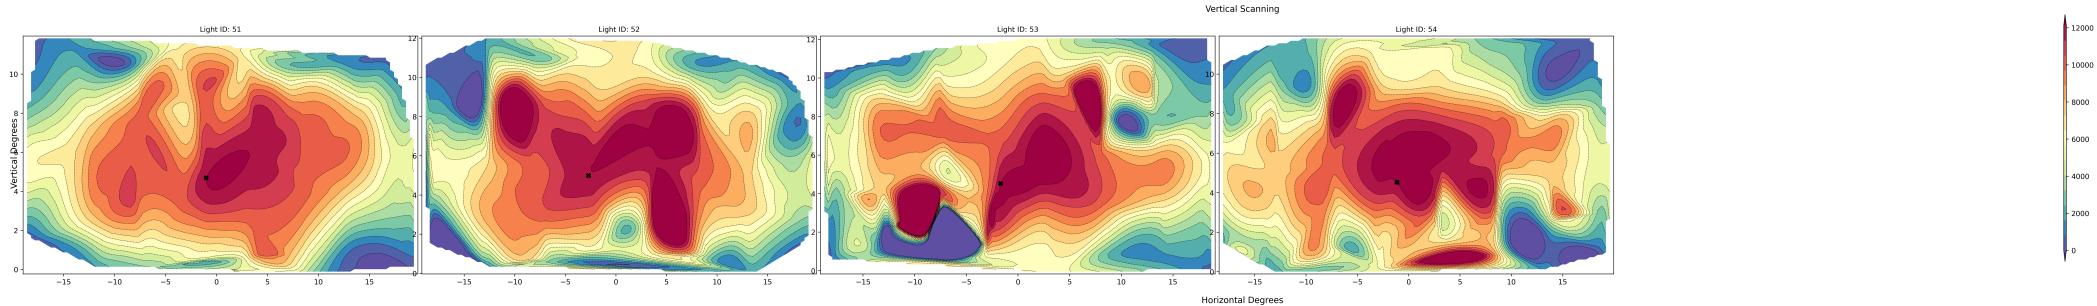
%ICAO	AVG(cd)	Max(cd)	Hmax(Deg)	Vmax(Deg)	C	S
Light ID							
51	192.29	5641.639464	12075.91	-1.02	4.69	R	✓
52	137.55	5641.635179	12073.02	-2.71	4.99	G	✗
53	188.94	5636.715357	12078.51	-1.68	4.53	R	✓
54	164.60	5639.150536	12116.31	-1.14	4.53	Y	✗
