# Betong International Airport

**Report File Name:** 07000178.pac **Date of Report:** 17/01/2022 **Time of Report:** 22:43:29

**Way Name:** RUNWAY EDGE - 07L **Agent:** FBT\_Sp (*Not Cross Checked*)

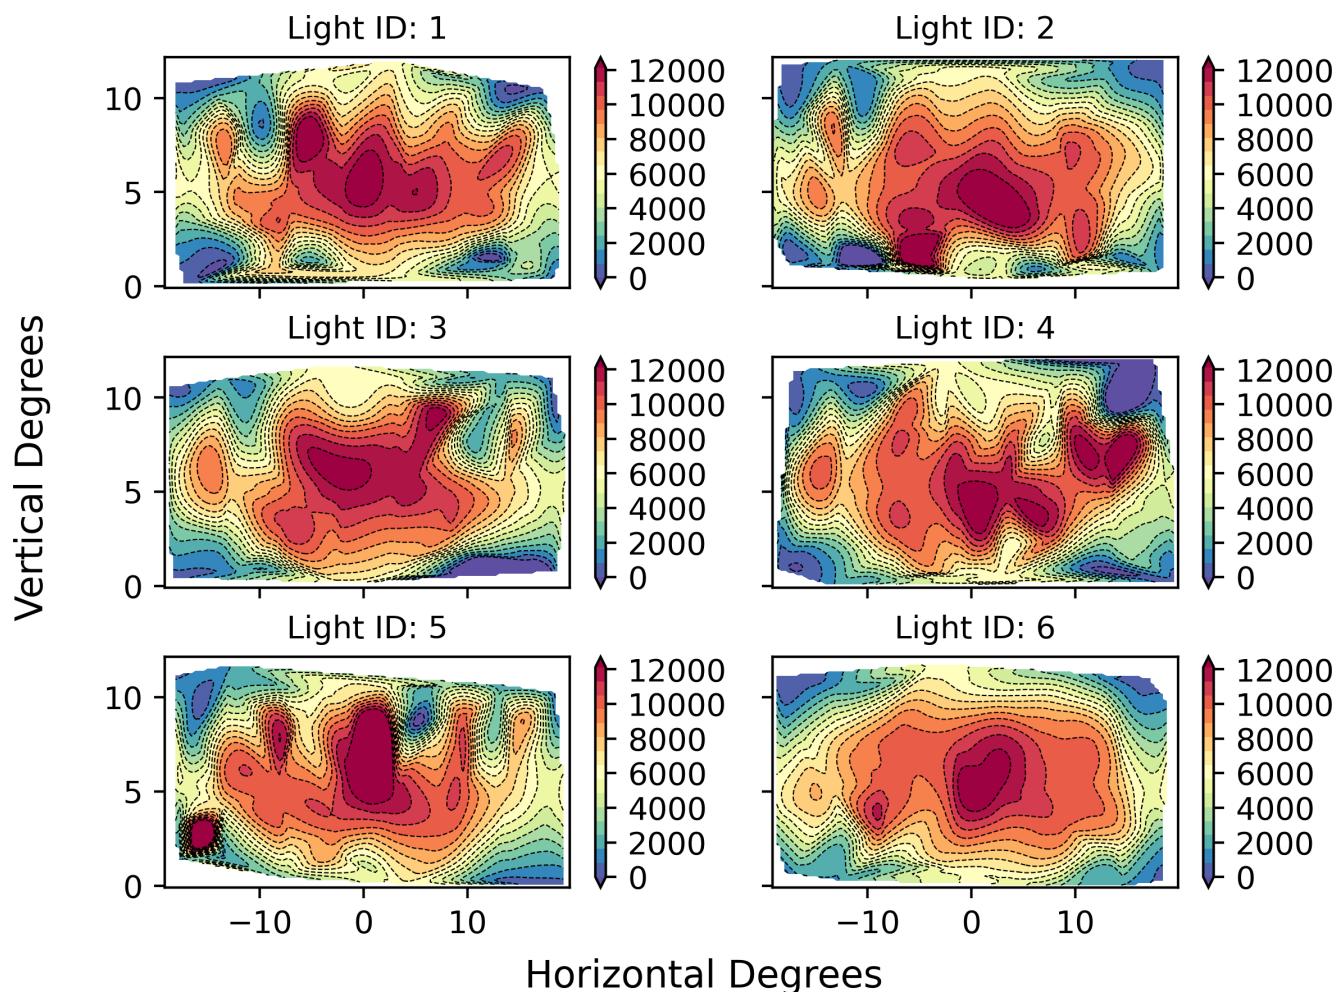
## Vertical Scanning

%ICAO	lavg	I <sub>max</sub>	H <sub>max</sub>	V <sub>max</sub>	C	S
Light ID							
1	92.77	5640.002143	12084.22	-1.39	6.03	G	X
2	46.32	5634.515893	12090.14	-1.42	5.08	W	X
3	42.60	5641.043750	12093.82	-2.46	5.18	R	✓
4	84.97	5639.824286	12072.21	-1.43	5.11	R	X
5	177.31	5638.946250	12085.95	-1.38	5.27	R	✓
6	89.42	5637.667321	12104.57	-0.96	4.36	G	✓

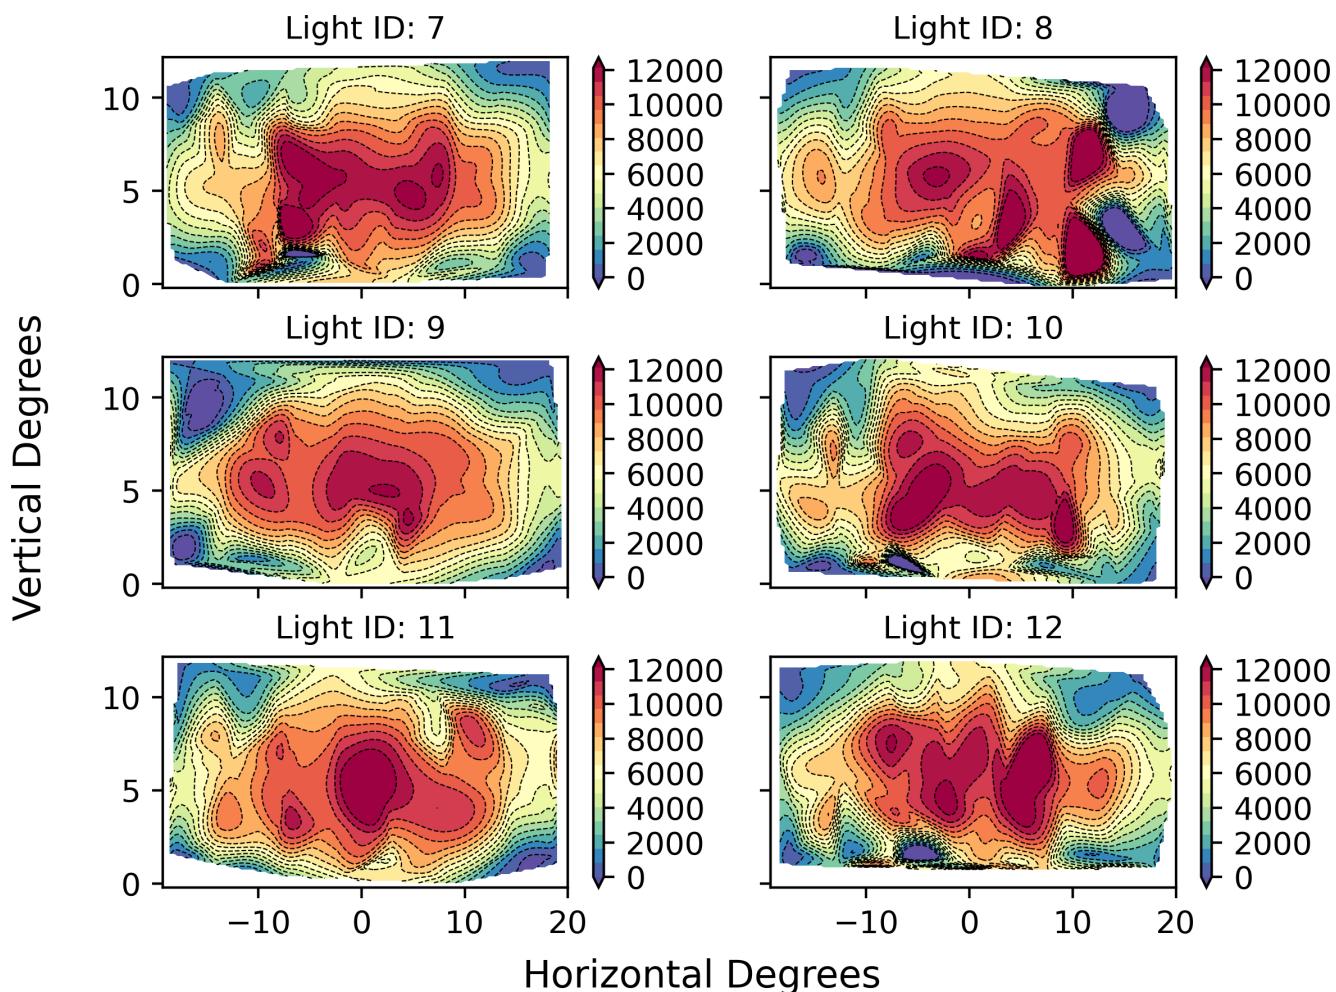
## Vertical Scanning

%ICAO	lavg	I <sub>max</sub>	H <sub>max</sub>	V <sub>max</sub>	C	S
Light ID							
7	83.20	5639.220893	12097.57	-1.95	5.31	R	✓
8	58.06	5636.794643	12079.31	-2.30	5.38	Y	✓
9	75.84	5637.228929	12068.69	-1.69	5.11	W	✓
10	199.33	5635.725536	12104.06	-2.71	4.44	W	✗
11	177.87	5637.600536	12107.86	-1.91	6.10	G	✗
12	123.18	5637.065536	12088.00	-2.00	5.58	G	✓

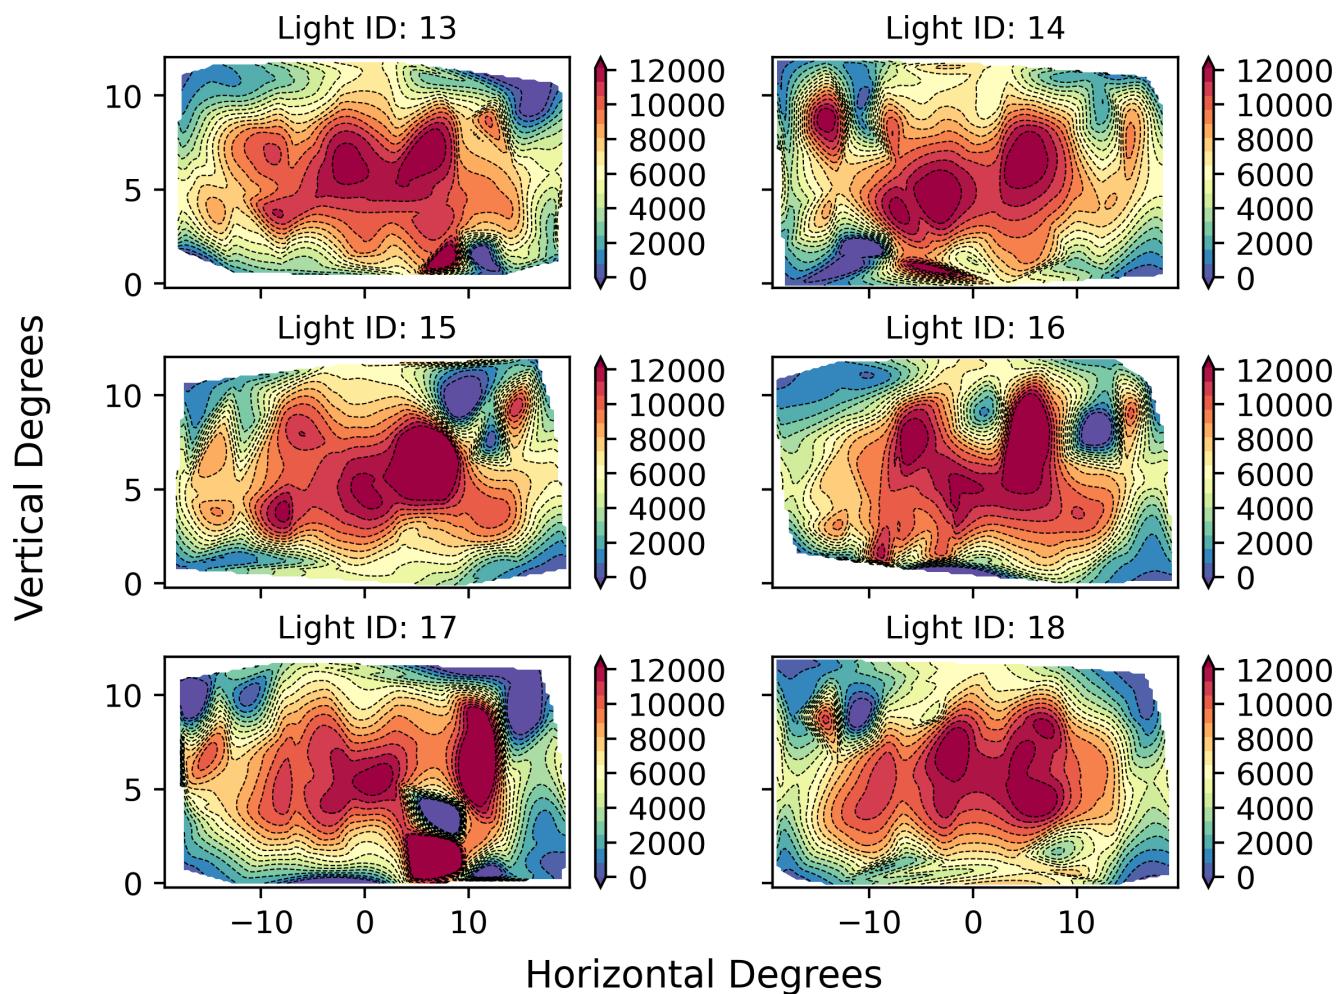
## Vertical Scanning

%ICAO	lavg	I <sub>max</sub>	H <sub>max</sub>	V <sub>max</sub>	C	S
Light ID							
13	124.63	5638.904821	12094.89	-2.61	5.36	R	✓
14	108.78	5637.948214	12093.40	-1.95	5.83	G	✓
15	54.43	5636.826964	12097.66	-1.09	5.68	Y	✓
16	171.03	5635.932500	12115.19	-2.34	5.56	W	✗
17	144.81	5638.010179	12094.00	-1.24	5.38	R	✗
18	188.01	5634.750536	12069.00	-1.03	5.57	W	✓

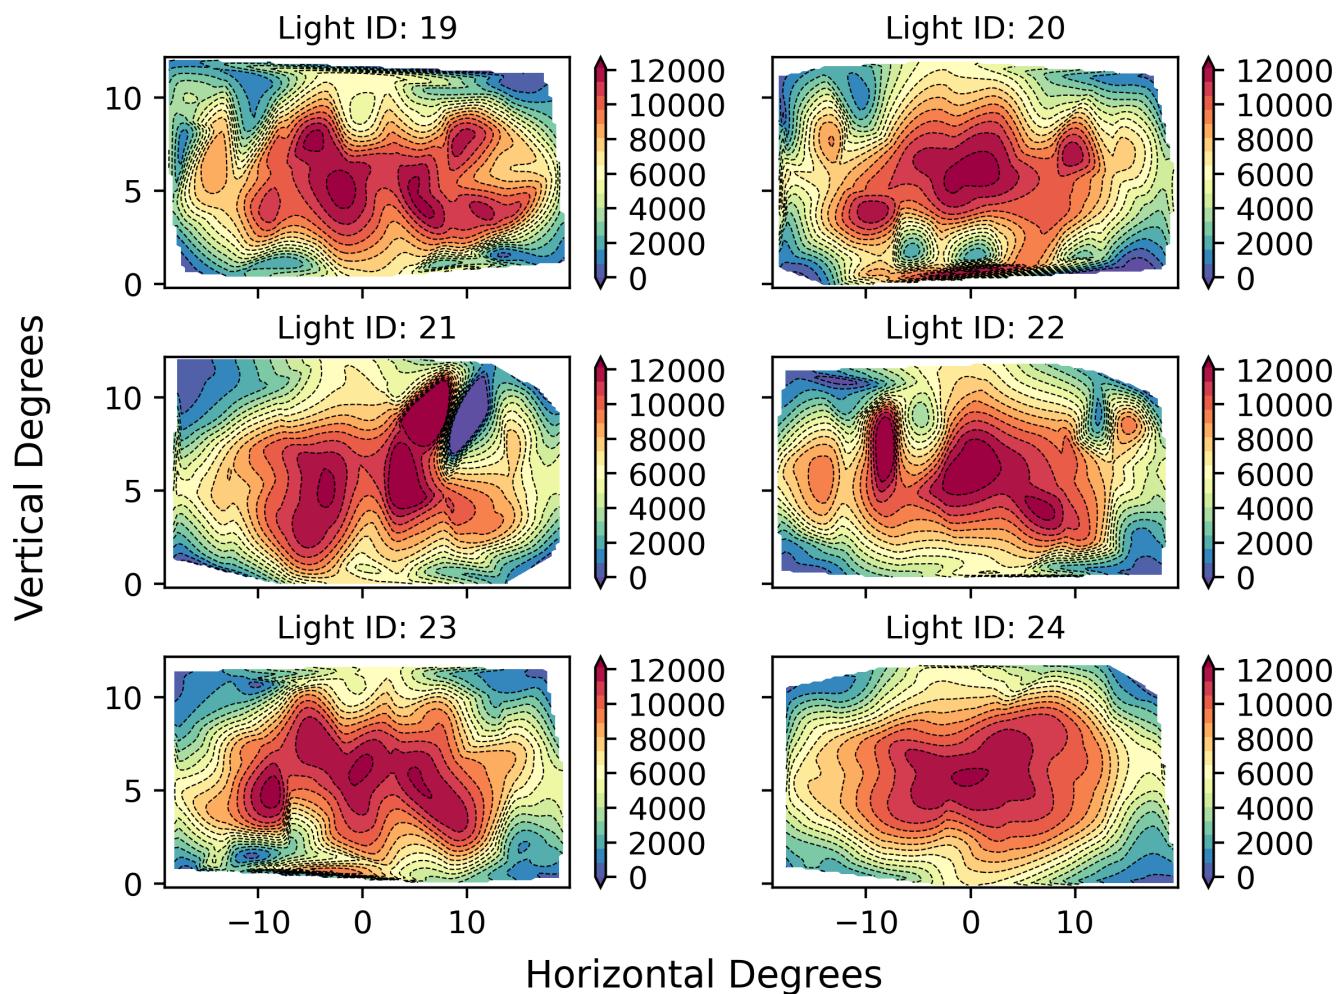
## Vertical Scanning

%ICAO	lavg	I <sub>max</sub>	H <sub>max</sub>	V <sub>max</sub>	C	S
Light ID							
<b>19</b>	193.44	5637.766786	12086.13	-1.54	6.04	G	X
<b>20</b>	88.83	5636.488750	12099.03	-2.07	6.23	Y	✓
<b>21</b>	64.46	5635.568750	12077.12	-2.94	6.04	G	✓
<b>22</b>	128.92	5637.809464	12079.21	-2.63	5.00	G	✓
<b>23</b>	44.29	5637.452143	12078.69	-1.36	5.55	W	✓
<b>24</b>	198.24	5636.230357	12094.02	-1.97	5.70	Y	✓

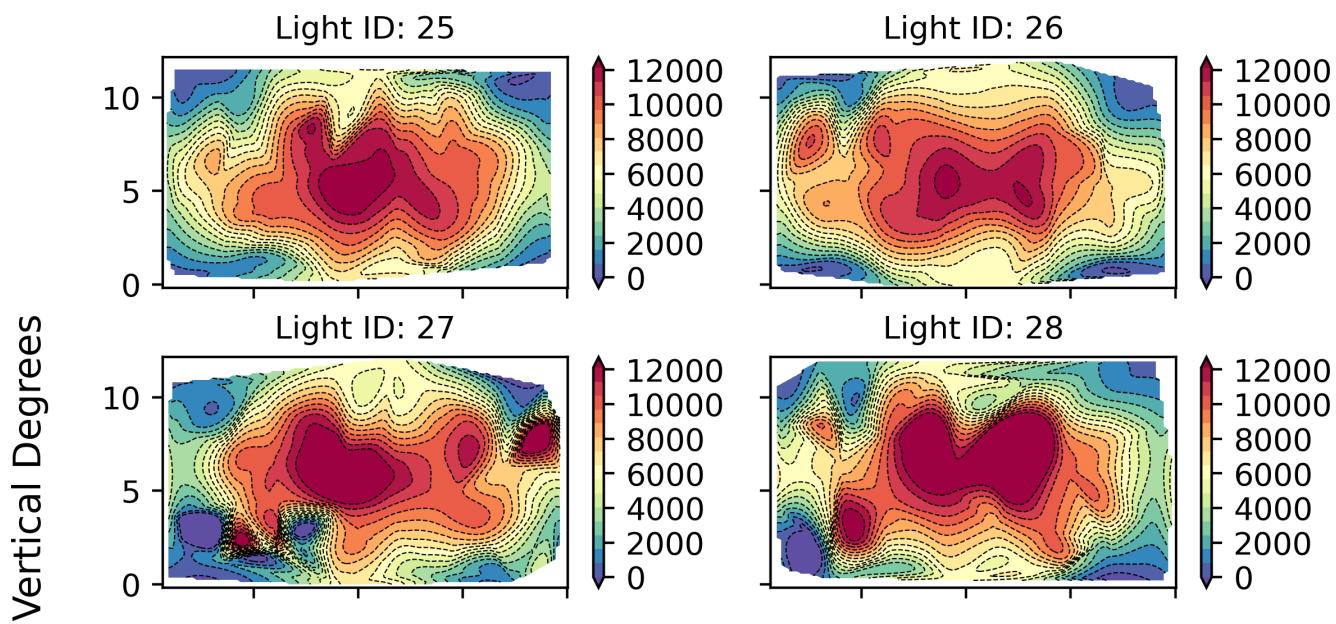
## Vertical Scanning

%ICAO	lavg	Imax	Hmax	Vmax	C	S
Light ID							
25	163.72	5632.946607	12084.25	-2.43	6.33	R	X
26	66.40	5637.804107	12083.93	-1.52	4.62	R	X
27	170.41	5634.050893	12109.43	-1.93	4.38	Y	✓
28	159.15	5634.603571	12075.95	-1.40	4.86	Y	✓
