Aviation Investigation Final Report

Location:	Eden, North Carolina	Accident Number:	ERA21FA195
Date & Time:	April 28, 2021, 13:24 Local	Registration:	N53DE
Aircraft:	BELL HELICOPTER TEXTRON CANADA 429	Aircraft Damage:	Destroyed
Defining Event:	Part(s) separation from AC	Injuries:	1 Fatal, 2 Serious
Flight Conducted Under:	Part 91: General aviation - Aerial observation

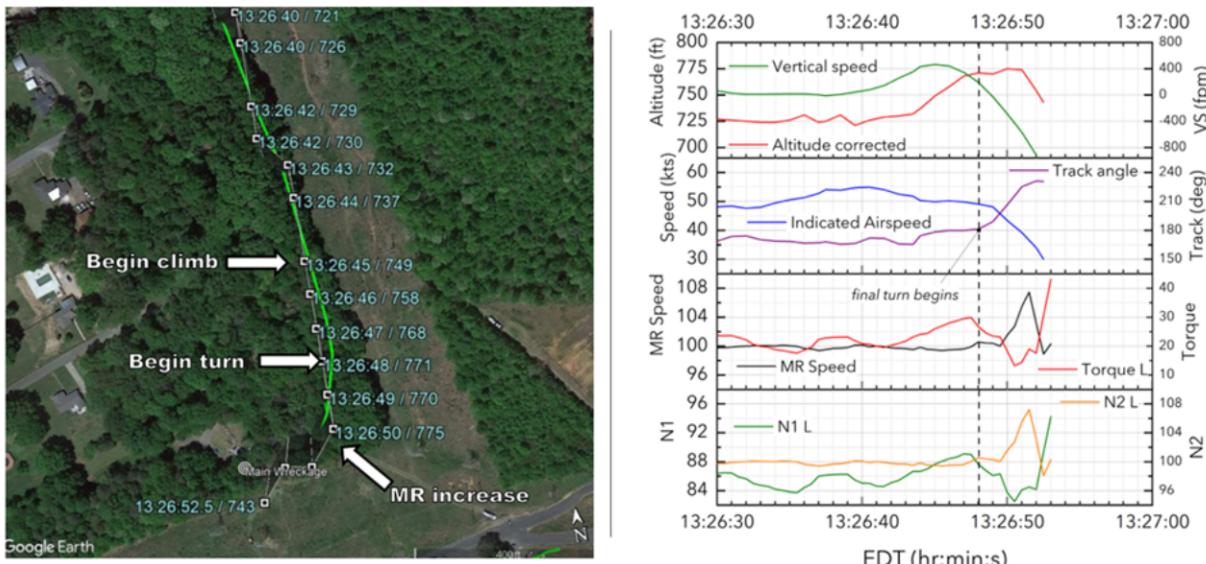
During the final minutes of flight, the helicopter was traveling at an airspeed between 50 and 60 kts parallel to powerlines at an altitude between 700 and 775 ft msl (Figure 1). Nr was near 100%, torque varied between 15% and 25%, and the engine gas generator (N1) speeds were between 84 and 88%.

Figure 1- Combined map of flight track with corresponding flight parameters.

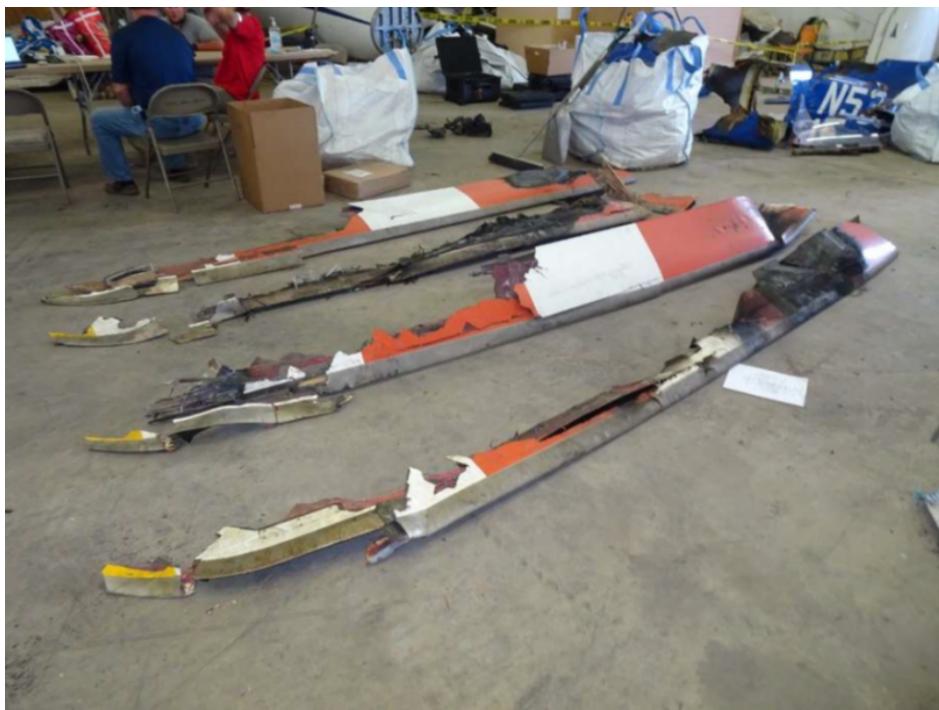
The four main rotor blades were reconstructed in their respective positions and laid out by their designated colors, Green, Red, Orange, and Blue (Figure 2). Three separated leading edge pieces near the tip end, including the tip cap lap joint, were found in the debris field surrounding the main wreckage. Two swept tip ends, which were fractured and separated,

Figure 2- A reconstruction of the four main rotor blades; From top to bottom, Green, Red, Orange, and Blue.

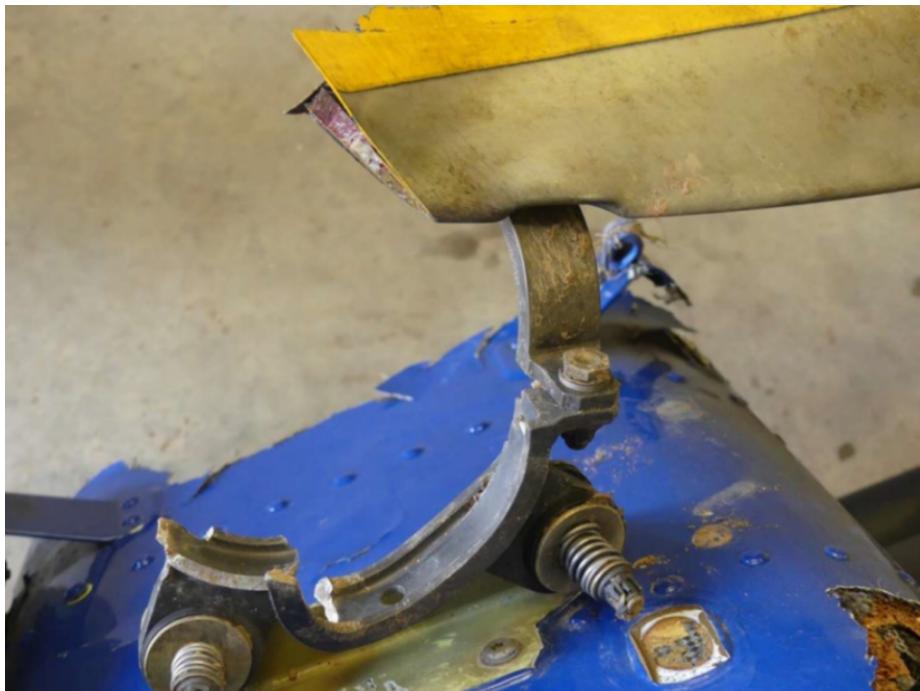
were reconstructed by the investigation team to the 'blue' and 'orange' main rotor blades. Two additional swept tip ends, also fractured and separated, exhibited impact damage with a width consistent with contact with the tail rotor drive system aft snubber and belonged to the 'red' and 'green' main rotor blades (Figure 3). All four swept tip ends were found in the debris field leading up to and around the main wreckage.

Figure 3- An approximate reconstruction of rotor blade impact damage on the blade tip that is consistent with the dimensions of the snubber housing.

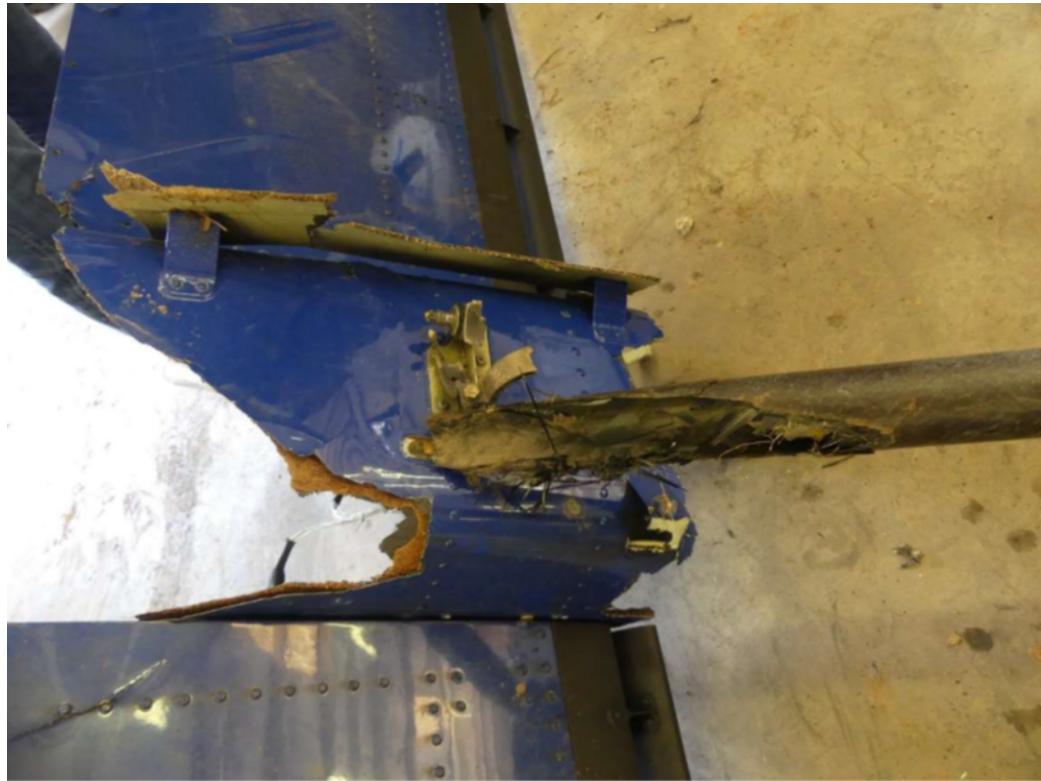
The steel tail rotor drive shaft was continuous to the fan blower shaft. The fan blower shaft and oil cooler blower remained installed on the airframe but were crushed from impact forces. The drive shaft was attached at its forward end to the shaft segment running through the oil cooler blower assembly, one of the lobes (or “ears”) on the adapter assembly was fractured. The forward segmented drive shaft was fractured about 25 inches aft of its forward attachment flange. Two additional pieces from the forward segmented drive shaft were recovered: 1) the midsection of the forward segmented drive shaft, containing the stainless steel snubber sleeve, was found in the wreckage adjacent to the tail boom and 2) the aft section of the forward segmented drive shaft, about 40 inches in length, remained attached to a separated section of the tail boom and remained connected to a forward portion of the aft segmented drive shaft, about 23 inches in length, and the hanger bearing between them. The segmented drive shaft hanger bearing and its mount remained attached to the tail boom. A 34-inch -long section of the aft segmented drive shaft was found embedded near-vertically into the ground, with about 18 inches buried. The aft portion of the 34-inch section of the aft segmented drive shaft exhibited an angled cut (Figure 4).

Figure 4 - The 34-inch section of the aft segmented drive shaft, the aft end of which exhibited the angular cut.
