Aviation Investigation Final Report

Location:	Superior, Arizona	Accident Number:	WPR16FA040
Date & Time:	December 15, 2015, 17:23 Local	Registration:	N74317
Aircraft:	AIRBUS Helicopters AS350	Aircraft Damage:	Substantial
Defining Event:	Low altitude operation/event	Injuries:	2 Fatal, 1 Serious
Flight Conducted Under:	Part 135: Air taxi & commuter - Non-scheduled - Air Medical (Discretionary)

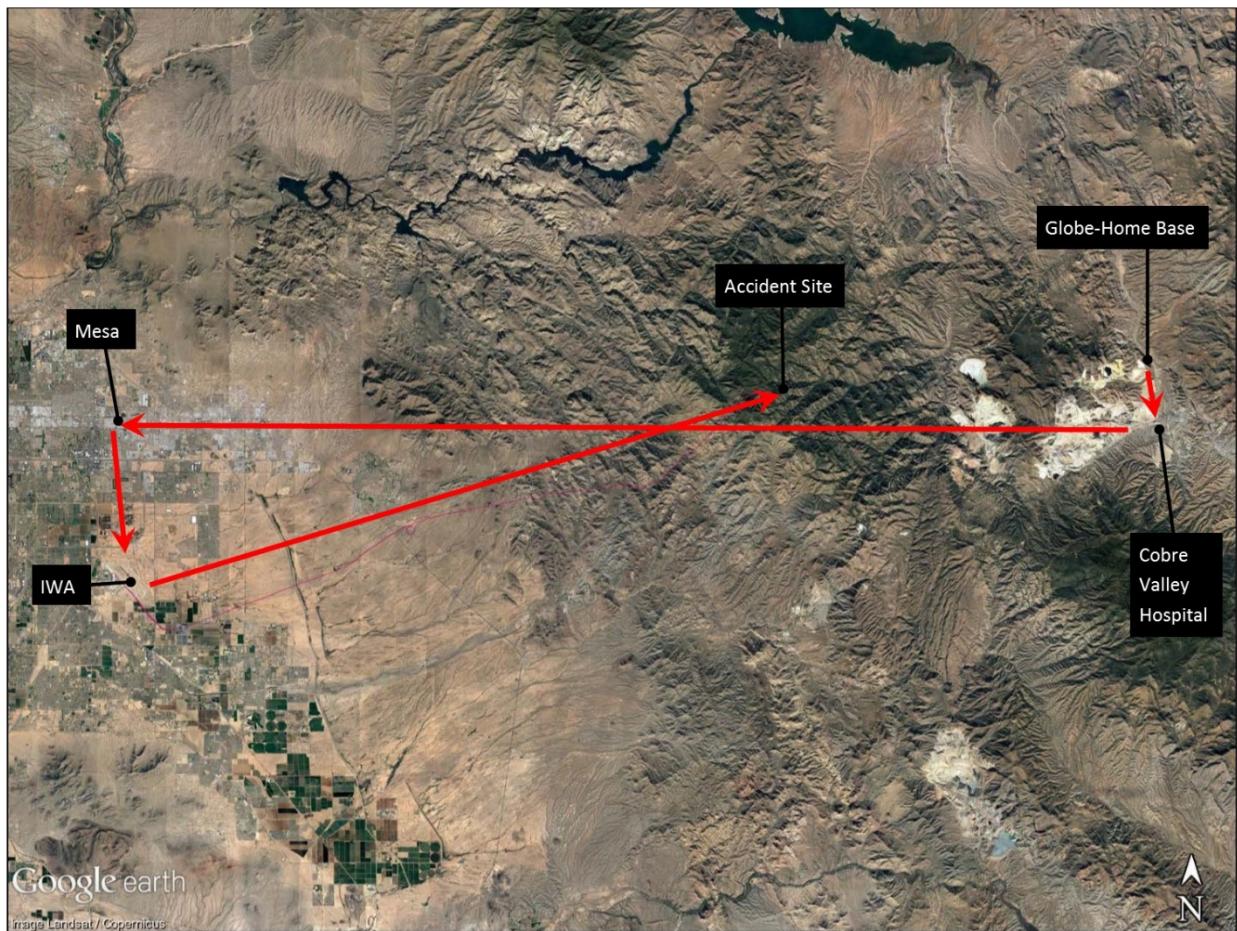
Figure 1-Overview of Flights

According to the operator, the helicopter was based in Globe and had transported a patient from the Cobre Valley Community Hospital in Globe to the Baywood Heart Hospital in Mesa. After transporting the patient, the pilot flew the helicopter to IWA for refueling before the return flight to Globe. (See figure 1)

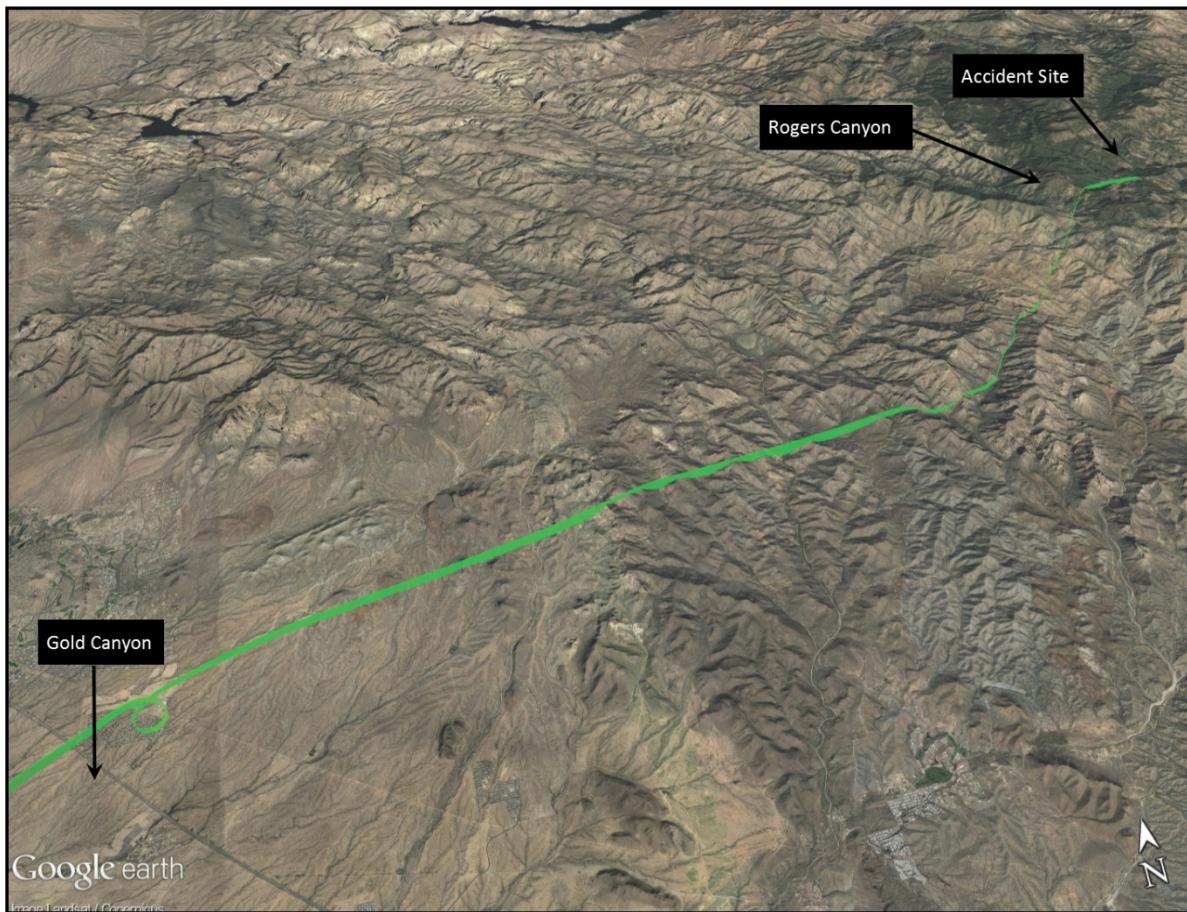
Figure 2-Aerial View of Accident Flight

About 1719, the helicopter entered mountainous terrain, and the height of the helicopter above the terrain began to vary as the terrain elevation rose and fell. Between 1718 and 1720, the altitude varied between 240 ft agl and 1,150 ft agl. Between 1720 and the end of the flight, the altitude varied between 30 ft agl and 770 ft agl. About 1721, the helicopter turned from a heading of about 80° to a heading of about 45° and followed a canyon beneath its ridgelines. (See figure 2)

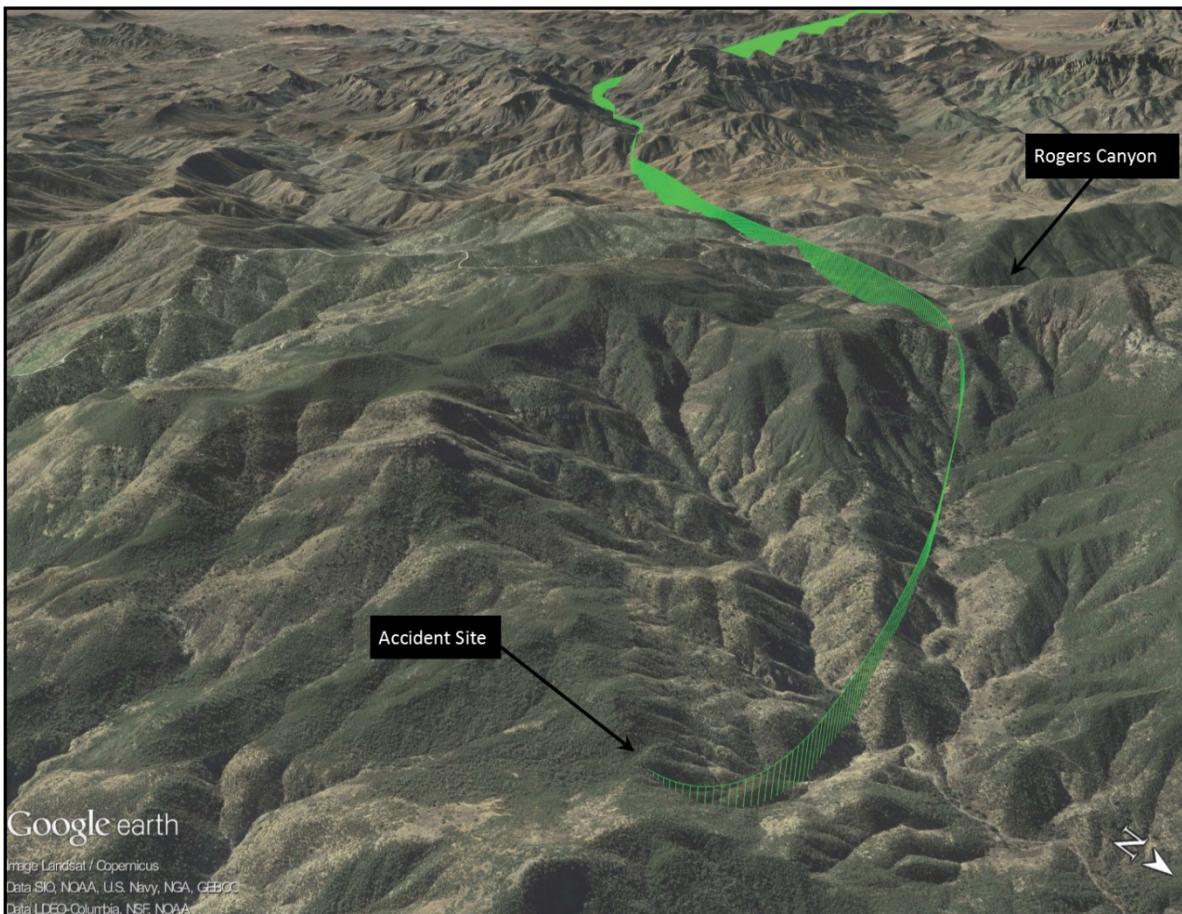
Figure 3-Aerial View of the Accident Flight and Accident Flight

The helicopter flew nearly perpendicularly over the north-south oriented Rogers Canyon, and at 1723:07, it continued through a saddle on the canyon's east wall, clearing the terrain by about 30 ft. As it passed over the eastern ridgeline, the helicopter banked to the right, changing from a ground track of about 43° to 76° , and reached a ground speed of about 120 knots. After the helicopter cleared the ridge, it started to descend and accelerate. The ground speed reached a maximum of 148 knots at 1723:21. The helicopter banked right (about 5° to 10° of roll), and its heading changed from 76° at 1723:18 to about 90° at 1723:32. (See figure 3)
