# Aviation Investigation Final Report

<b>Location:</b>	Peach Springs, Arizona	<b>Accident Number:</b>	WPR18MA087
<b>Date &amp; Time:</b>	February 10, 2018, 17:19 Local	<b>Registration:</b>	N155GC
<b>Aircraft:</b>	Eurocopter EC130	<b>Aircraft Damage:</b>	Destroyed
<b>Defining Event:</b>	Loss of control in flight	<b>Injuries:</b>	5 Fatal, 2 Serious
<b>Flight Conducted Under:</b>	Part 135: Air taxi & commuter - Non-scheduled - Sightseeing

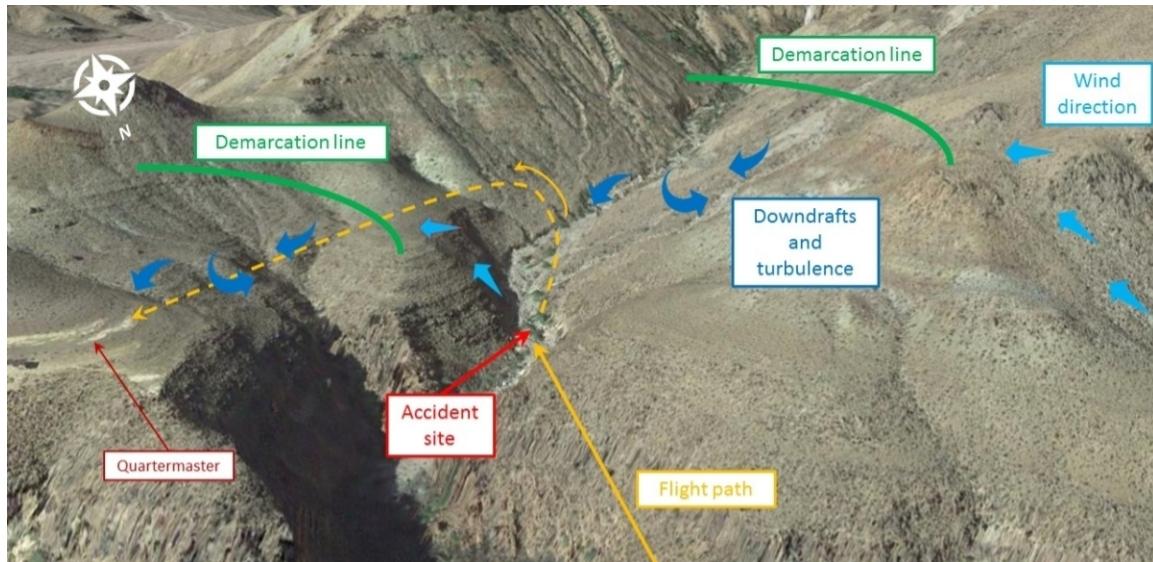
The landing site was located on a plateau and provided limited approach options due to its local topography. At the time of the accident, potential demarcation lines (boundaries of updrafts and downdrafts) would have been on the pinnacles of ridges located along the approach to the Quartermaster west pads. Figure 8 shows a conceptual illustration of potential demarcation lines and wind directions based on the terrain and wind environment present around the accident site at the accident time, and suggests areas where downdrafts, updrafts and turbulence could have impacted the accident flight's approach to the landing site.

*Figure 8. Conceptual display of demarcation lines at accident site*

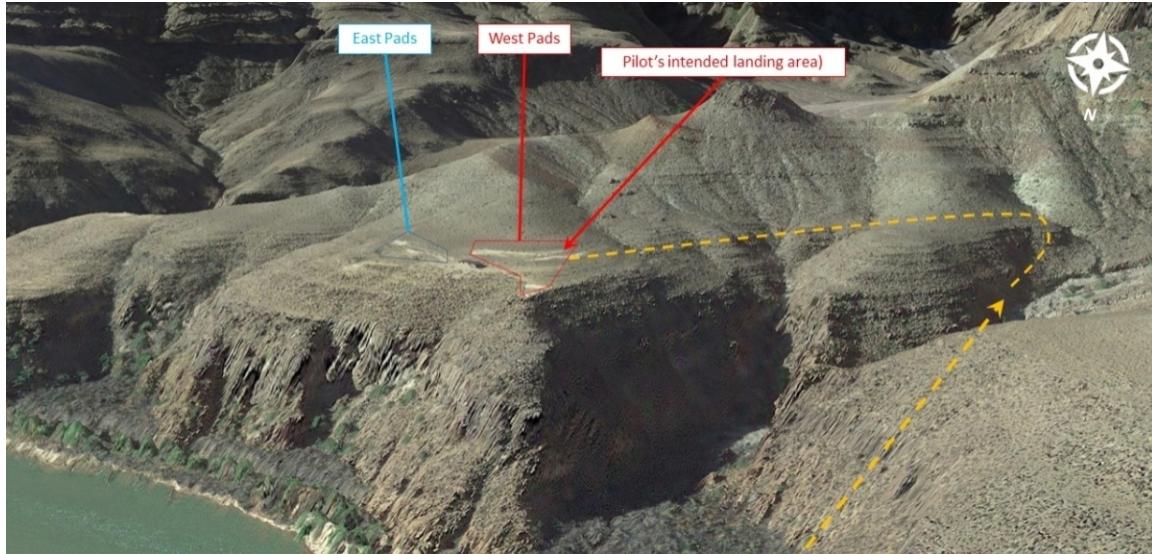
The pilot stated that he normally remained on the north side of the Colorado River, crossing the river between 200 and 300 ft above ground level (agl) while approaching Quartermaster for landing. After crossing the river, he entered a left turning descent toward the landing area. (See figure 1.) He stated

that, as he made the left turn, the helicopter encountered what he described as a “violent gust of wind” and began to spin, and as a result he was unable to maintain directional control.

Figure 1. Graphical representation of typical approach to west pads

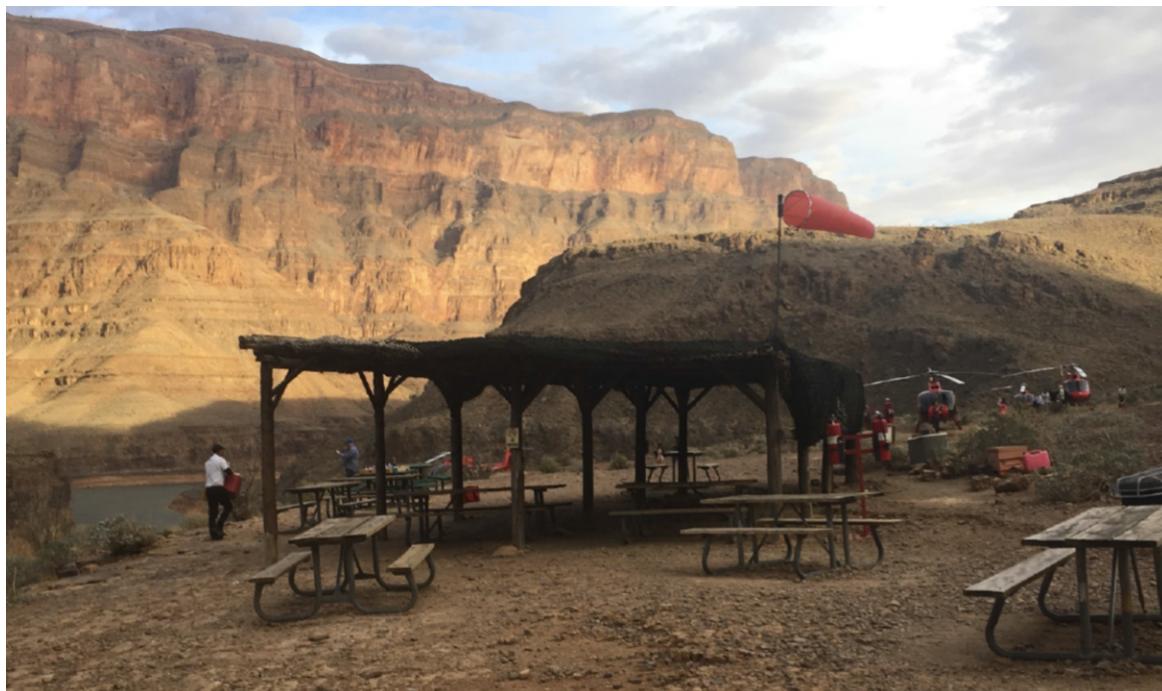
Quartermaster was equipped with a windsock that was located near the landing pads. A photo of the windsock taken about 1713 showed the windsock in its fully extended position, consistent with a wind velocity of 15 kts or greater. (See figure 2.)

Figure 2. Photograph taken at 1713 MST of windsock at Quartermaster

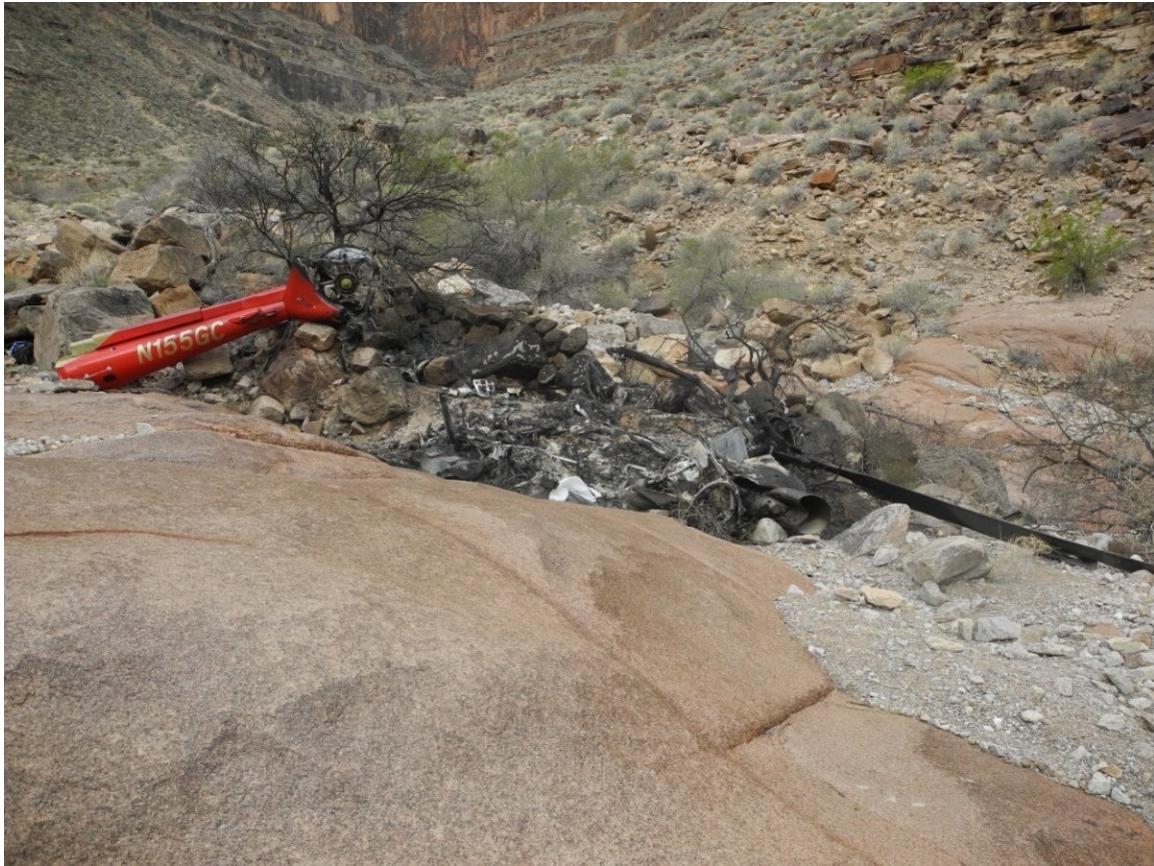
The helicopter came to rest upright in rocky terrain about 300 ft below the landing site on a heading of 222° magnetic. Most of the wreckage was consumed by the postcrash fire except for the tail boom and fenestron, which had separated from but were collocated with the fuselage. (See figure 3.) The engine, still attached to the engine deck, was found in the main wreckage and sustained fire damage. All three main rotor blades remained attached to the main rotor hub and exhibited damage consistent with high rotational energy. The tail stinger, fenestron hub cover, a toe from a skid step, and small pieces of transparent windshield were found on a canyon slope east of the main wreckage.

Figure 3. Photograph of accident site

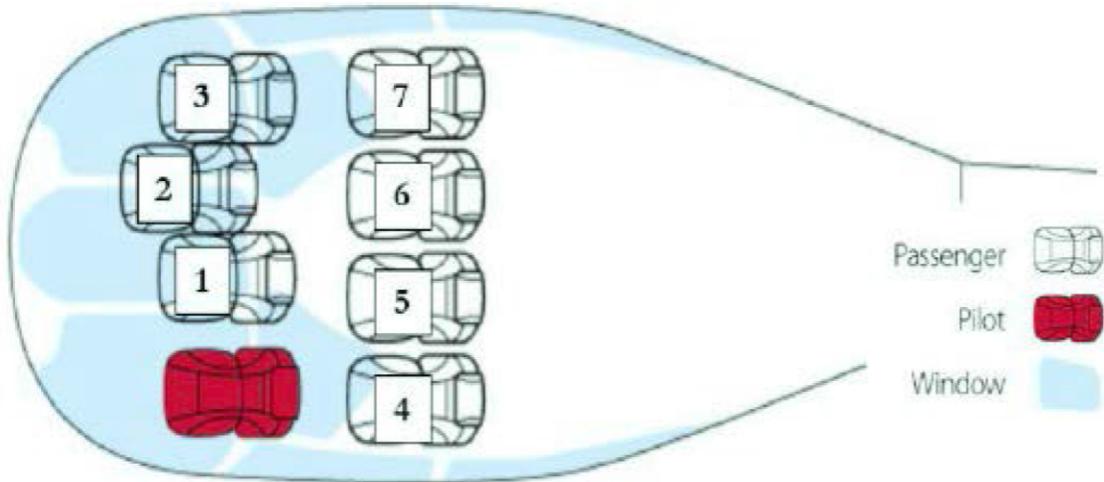
Figure 4: Accident Helicopter Seat Configuration

The fire extinguisher was normally stowed in a bracket on the floor between the pilot seat and passenger seat No. 1. The fire extinguisher was charred and found in the wreckage. Seat no. 1 was unoccupied.

Passengers in seat Nos. 2, 6, and 7 did not have either the ability or opportunity to evacuate and died due to burns and smoke inhalation injuries; no blunt force traumatic injuries were noted by the medical examiner.

The pilot and passengers in seat Nos. 3, 4, and 5 sustained serious thermal injuries. Passengers in seat Nos. 3 and 4 succumbed to their burn injuries several days after the accident. In addition to their thermal injuries, the passenger in seat No. 5 sustained a spinal fracture. The pilot sustained an open left leg fracture.

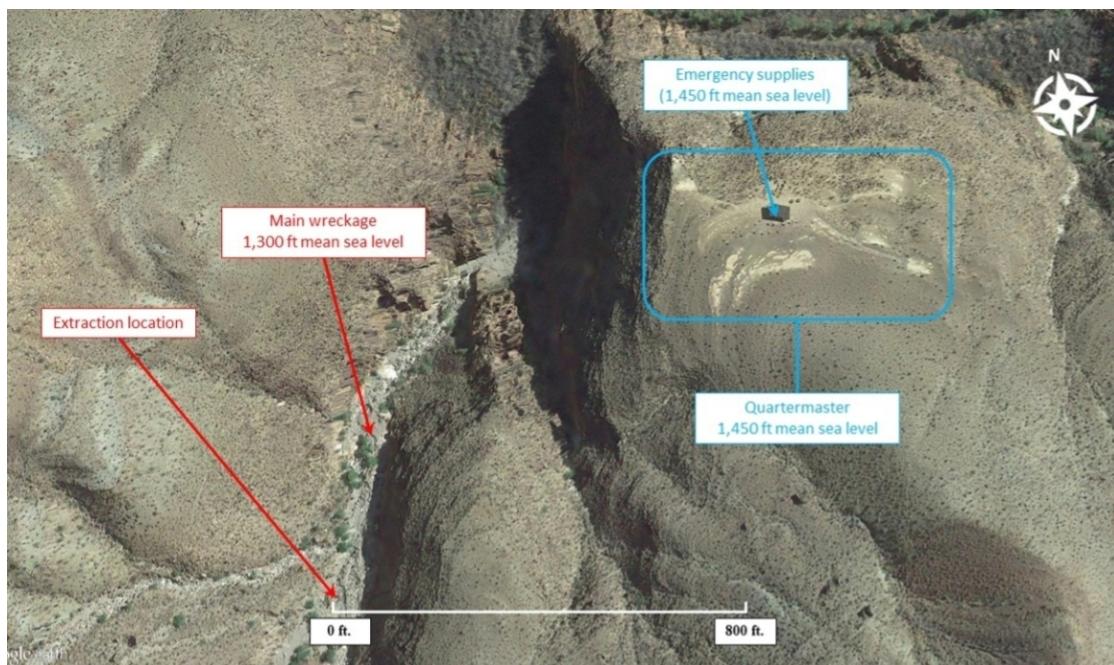
Numerous individuals, including pilots and passengers from other helicopters, were at Quartermaster at the time of the accident. Several Papillon pilots and members of the Royal Australian Air Force (RAAF) retrieved first aid kits from other helicopters and responded to the accident site, arriving about 20 minutes after the accident. They observed the burning helicopter and the pilot and three seriously injured passengers who were outside the helicopter. (See figure 5.)

Figure 5. Quartermaster landing zone, accident site, and extraction location

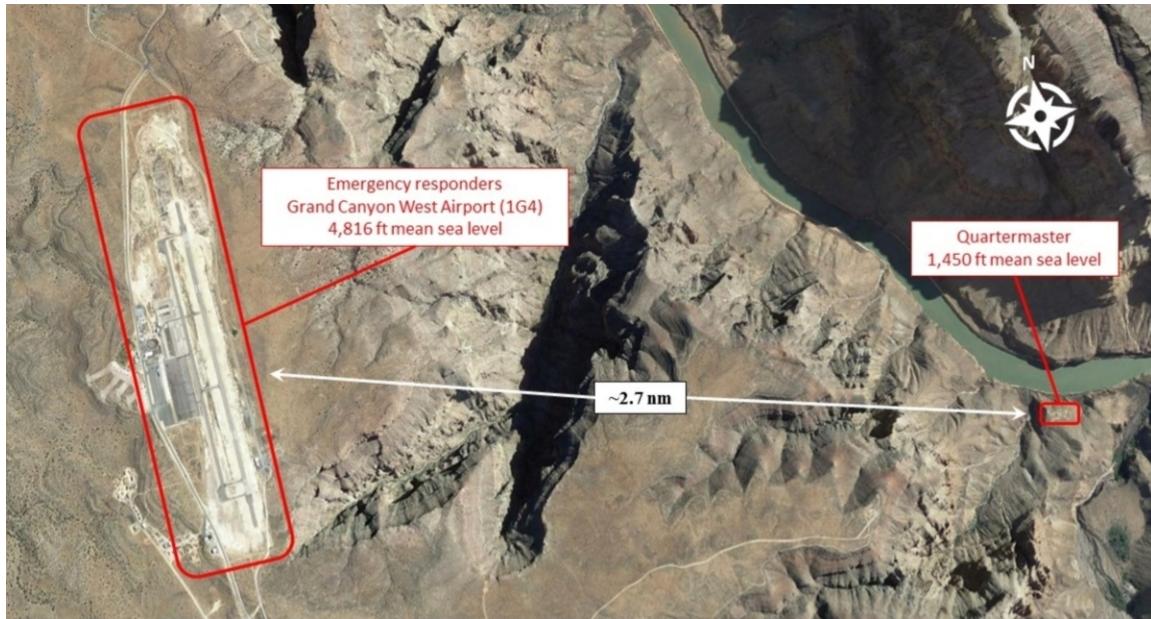
The location of the accident site posed significant challenges and extended the response time for emergency personnel, who had to be flown in by helicopter. (See figure 6.) These first responders reached the accident site about 45 minutes after the accident.

Figure 6. The location and terrain elevation difference between first responders at Grand Canyon West Airport and Quartermaster

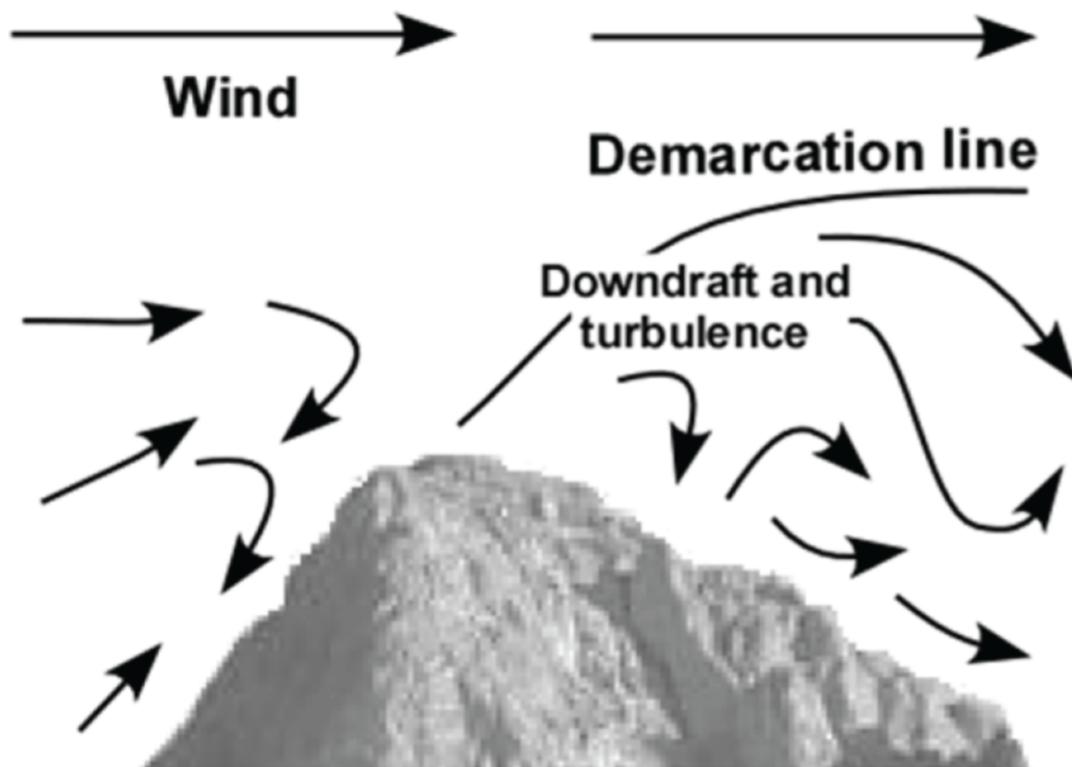
*The demarcation line is the point separating upflow air from downflow air. It forms at the mountain's highest point and extends diagonally upward. The velocity of the wind and steepness of the uplift slope determines the position of the demarcation line. Generally, the higher the wind speed and steeper the terrain, the steeper the demarcation line...As wind increases above 20 kts, the demarcation line moves forward to the crest's leading edge. It then matches the slope's steepness. The severity of updrafts, downdrafts, and turbulence also increase. Under these conditions, the best landing spot is close to the forward edge (windward side) of the terrain feature. (See figure 7.)*

Figure 7: Excerpt showing demarcation line in strong wind from United States Army Helicopter Manual
