Aviation Investigation Final Report

Location: Kodiak, Alaska Accident Number: ANC21LA020

Date & Time: March 2, 2021, 15:39 Local Registration: N1767

Aircraft: ROBINSON HELICOPTER CO R66 Aircraft Damage: Destroyed

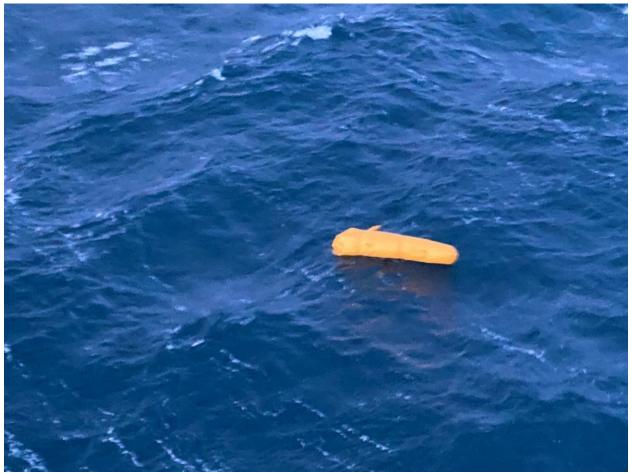
During the search and rescue (SAR) operation, the United States Coast Guard (USCG) dispatched a rescue helicopter that located an inflated yellow pop-out float believed to be from the accident helicopter (see figure 1). The USCG stated that an emergency locator transmitter beacon was not received from the accident helicopter. No distress calls from the helicopter were reported. The search continued with additional SAR assets; however, minimal debris

Figure 1. Inflated yellow pop-out float believed to be from the helicopter- (Photo courtesy of the USCG)

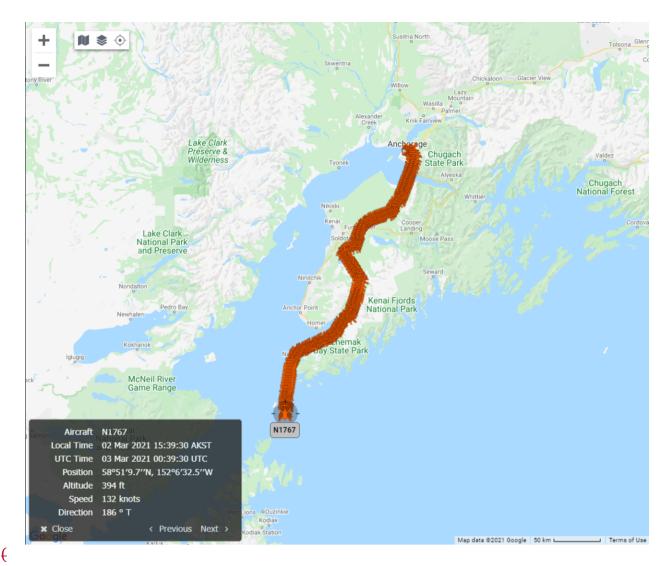
A review of the archived Spidertracks data revealed that after departure, the helicopter flew south down the Kenai Peninsula and then out over the ocean on course for Kodiak. At 1539, the last data point was recorded as the helicopter passed between Ushagat Island and West Amatuli Islands (two of the Barren Islands), at an altitude of 394 ft mean sea level (msl), on a heading of 186°, and at a groundspeed of 132 knots (see figure 2).

Figure 2. Spidertracks Data from Accident Flight
