# Aviation Investigation Final Report

<b>Location:</b>	Wingate, North Carolina	<b>Accident Number:</b>	ERA21FA200
<b>Date &amp; Time:</b>	May 2, 2021, 13:18 Local	<b>Registration:</b>	N4528T
<b>Aircraft:</b>	ROBINSON HELICOPTER R44	<b>Aircraft Damage:</b>	Substantial
<b>Defining Event:</b>	Low altitude operation/event	<b>Injuries:</b>	1 Fatal
<b>Flight Conducted Under:</b>	Part 137: Agricultural

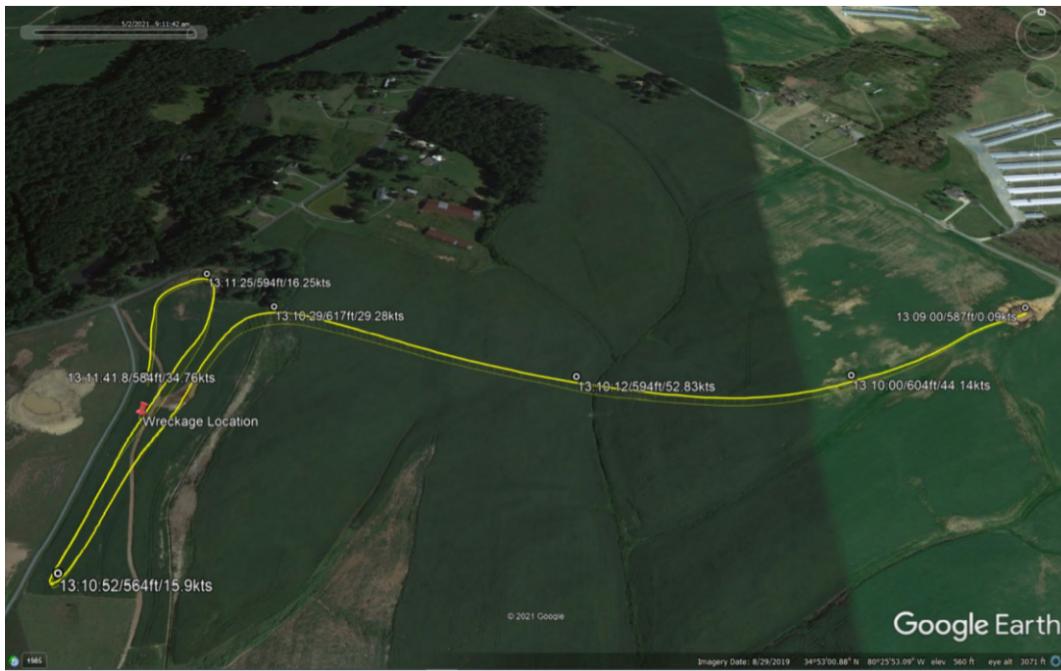
Figure 2 - Flight track of the helicopter (yellow) with the final resting location of the wreckage annotated.

The non-volatile memory (NVM) was removed from the device and sent to the GPS manufacturer for processing. The processed data showed the accident flight, which lasted about 2 minutes and 41 seconds. (Figures 2 and 3.) The main wreckage location is shown with a red pin. According to the GPS manufacturer, the data recording could have ended up to 10 seconds before the accident occurred due to data buffering on the device. Review of the data

revealed that, during the first two passes, the track showed a climb and descent near the wire; however, on the final southerly pass, the climb and descent occurred immediately after the final turn to the south and before the wire. The track showed that the helicopter was descending toward the power lines where the main wreckage came to rest before the data ended.
